# Entune Audio Head Unit Software Update (Denso-Ten)

## Entune Audio Head Unit Software Update (Denso-Ten)

### Introduction

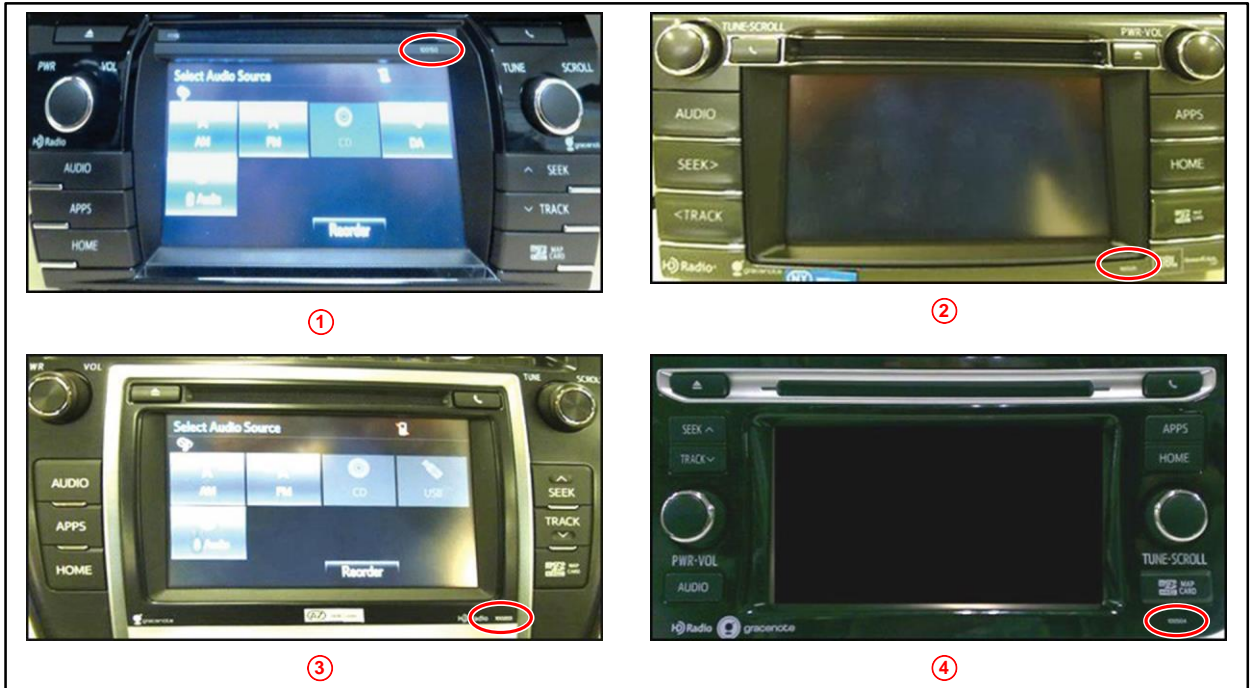
**Figure 1.**

1. Confirm the audio system type by checking the panel ID printed above the top right or bottom right of the display.

<b>1</b>	<b>Corolla</b>	<b>3</b>	<b>Camry, Camry HV</b>
<b>2</b>	<b>RAV4, RAV4 HV</b>	<b>4</b>	<b>Prius C</b>

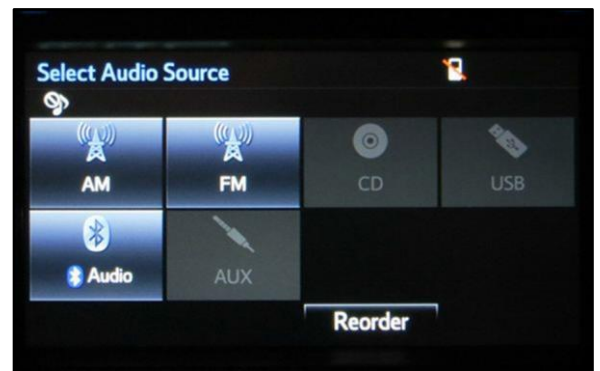
**Figure 2.**

5. When the Select Audio Source screen displays, continue to the next step.

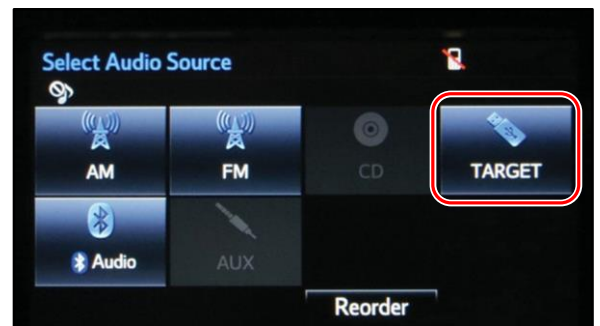
**Figure 3.**

6. When the USB source icon highlights and displays the USB name with the icon, continue to the next step.

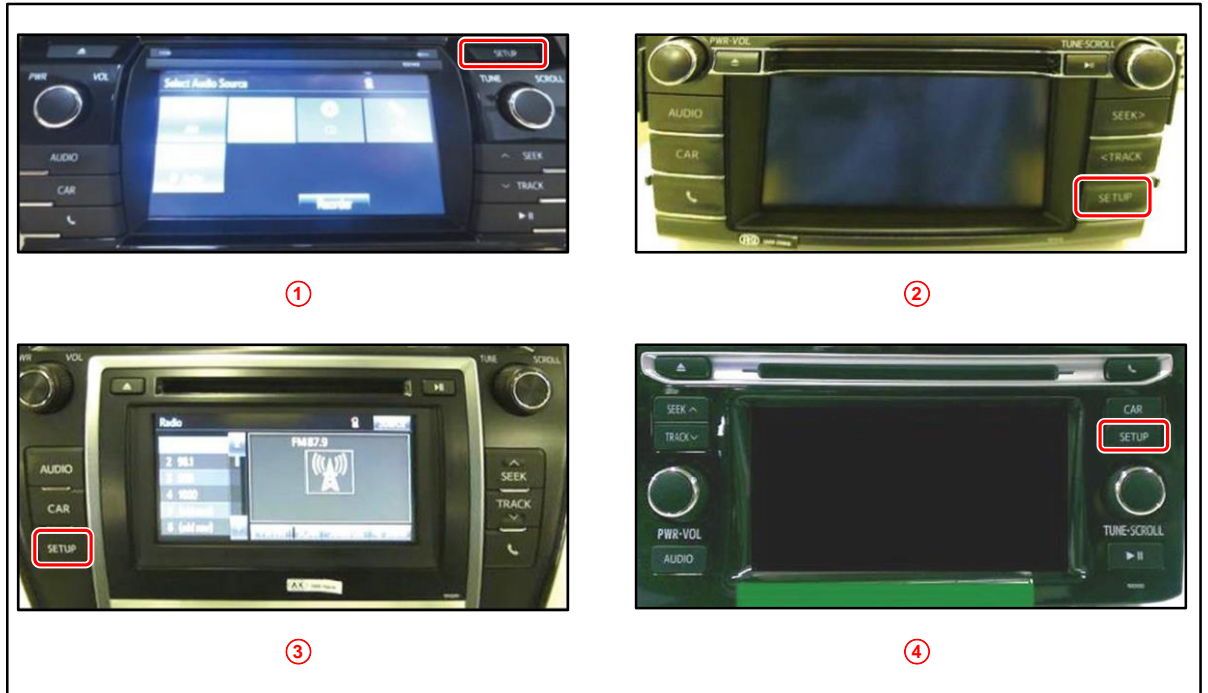
**Figure 4.**

7. Go to the Setup screen.
  - A. For Entune™ Audio:  
Press the Setup button on the panel.

<b>1</b>	<b>Corolla</b>
<b>2</b>	<b>RAV4, RAV4 HV</b>

<b>3</b>	<b>Camry, Camry HV</b>
<b>4</b>	<b>Prius C</b>

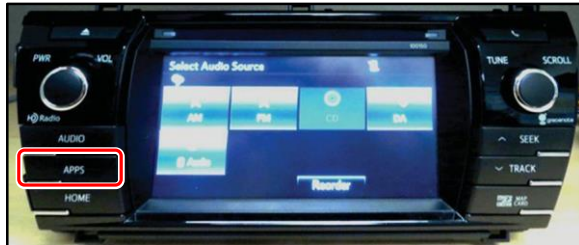
**Figure 5. Camry, Camry HV, Corolla, RAV4, RAV4 HV**

(1) Press the Apps button on the left or right of the panel.

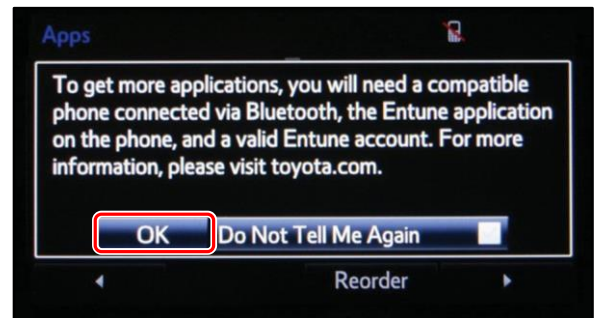
**Figure 7.**

If the Entune™ pop-up displays, select OK.

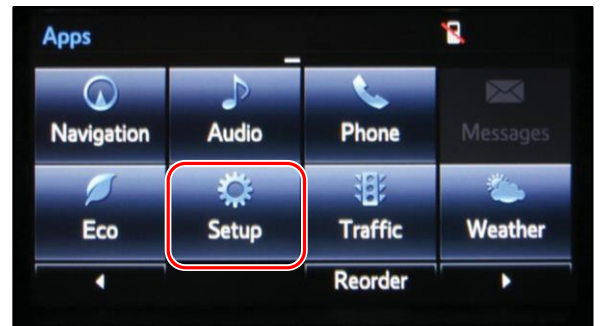
**Figure 8.**

(2) Select Setup on the Apps screen.

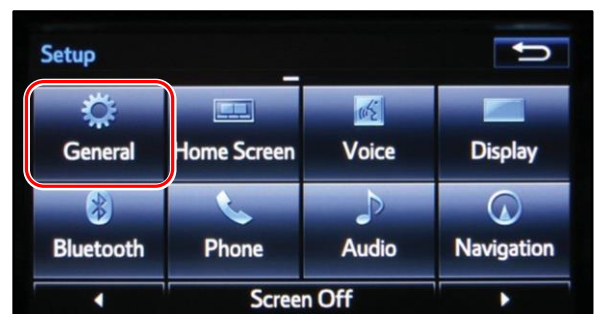
**Figure 9.**

8. Select General on the Setup screen.

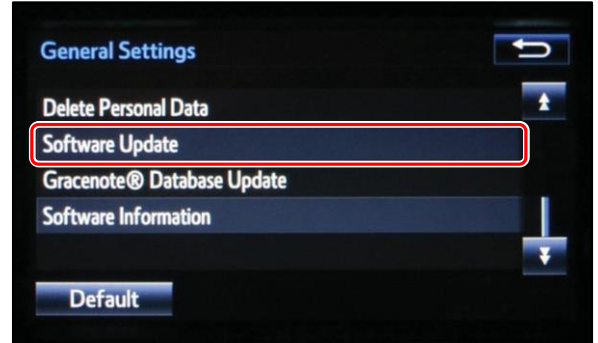
**Figure 10.**

9. Select Software Update from the list on the General Settings screen.

**HINT**  
 Scroll down the list until Software Update displays.

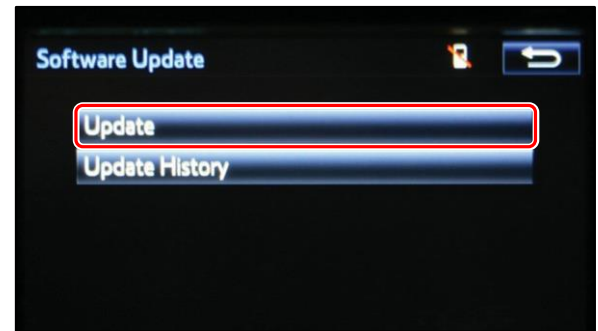
**Figure 11.**

10. Select Update on the Software Update screen.

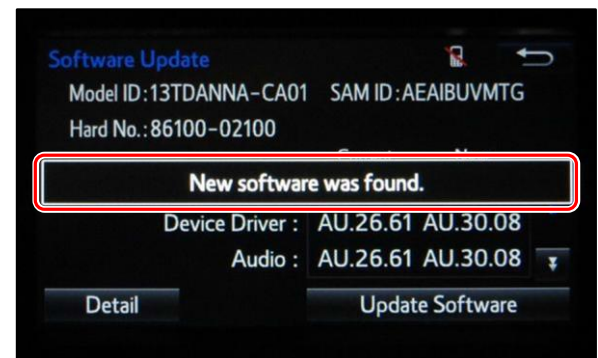
**Figure 12.**

**NOTE**  
 If software is detected properly, a "New Software was found." pop-up will display.

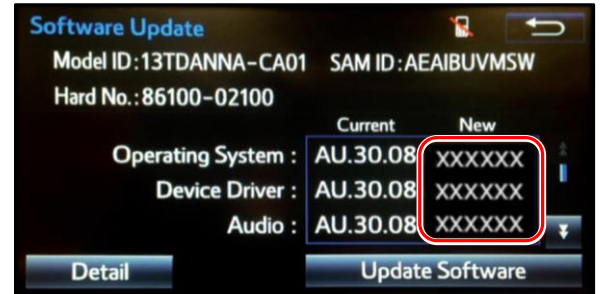
Figure 13.

- Verify that the NEW software is up to date on the Software Update screen.

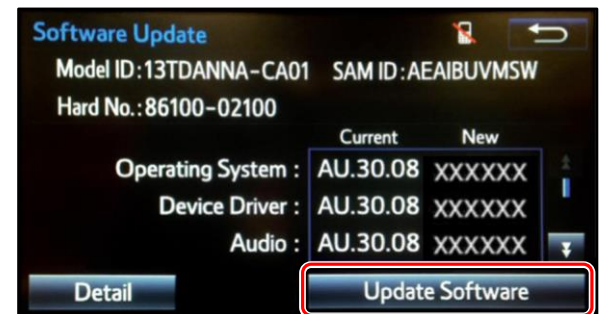
Figure 14.

- Select Update Software on the Software Update screen.

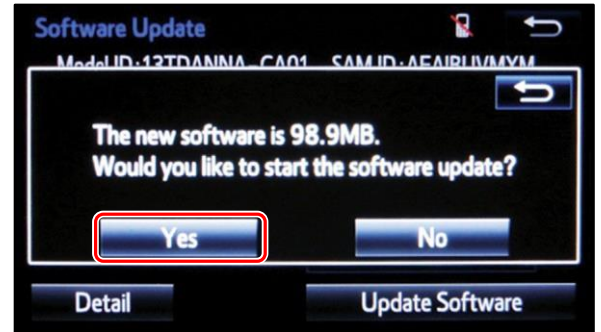
**Figure 15.**

13. Select Yes on the “Would you like to start the software update?” pop-up.

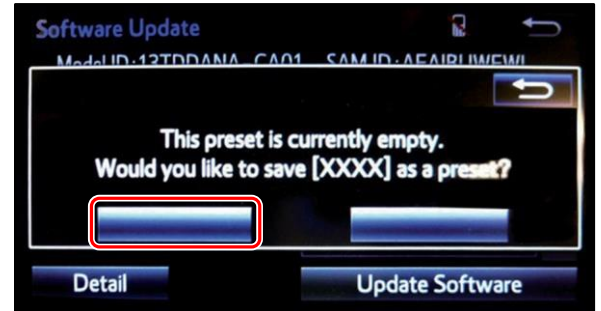
**Figure 16.**

**NOTE**  
 Entune™ Audio Plus ONLY: Select the left box on the “This preset is currently empty. Would you like to save [XXXX] as a preset?” pop-up.

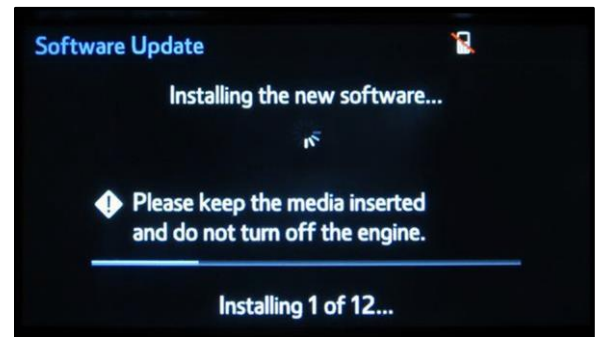
**Figure 17.**

14. This unit will begin installation.

**NOTE**  
 Do NOT turn off ACC before the software is ready for updating.

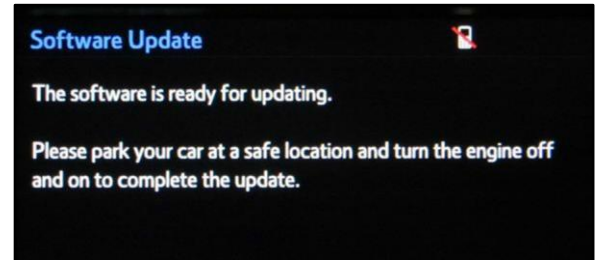
**Figure 18.**

- When “The software is ready for updating” displays, cycle the ignition OFF, wait 30 seconds, then cycle the ignition ON again.

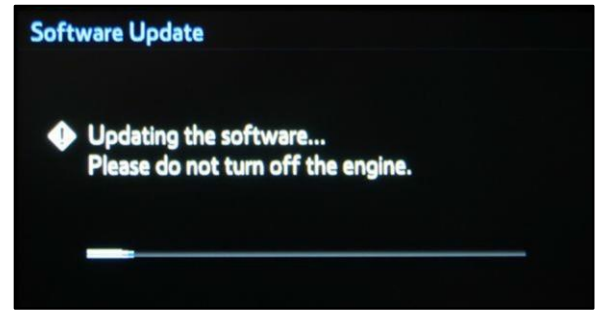
**Figure 19.**

- Wait for the audio system to complete the software update.

**NOTE**  
Do NOT turn off ACC before the next Toyota logo screen displays.

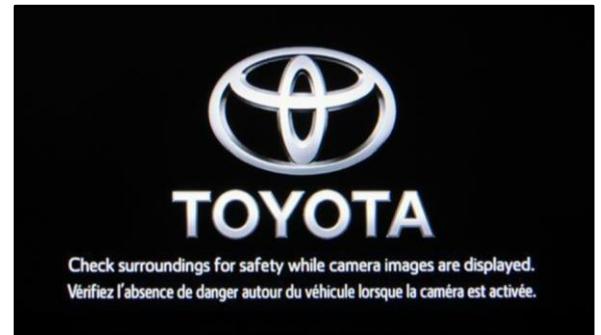
**Figure 20.**

When the Toyota logo screen displays, the update is complete.

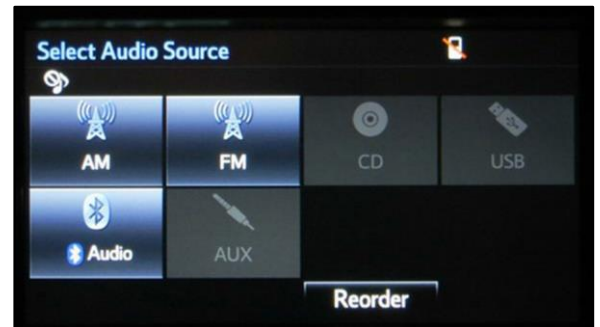
**Figure 21.**

- Remove the USB flash drive from the vehicle USB port.
- When the the Select Audio Source screen displays, continue to the next step.
