Release Date	04/08/2020	Technical Service Bulletin	
97ED UPDATE Convenience System Update (auto-lock) – (NVLW)

This Update has been proactively released to prevent the following condition(s) from occurring in the vehicle:	
Criteria	Technical Background
01	The “Auto Lock” function, which locks the vehicle at speeds over 9 mp/h (15 km/h), may be deactivated on delivery from the factory.

Criteria	Remedy
01	Update Comfort System Central Control Module – 0046 AND perform OBD basic settings for Comfort System Central Control Module

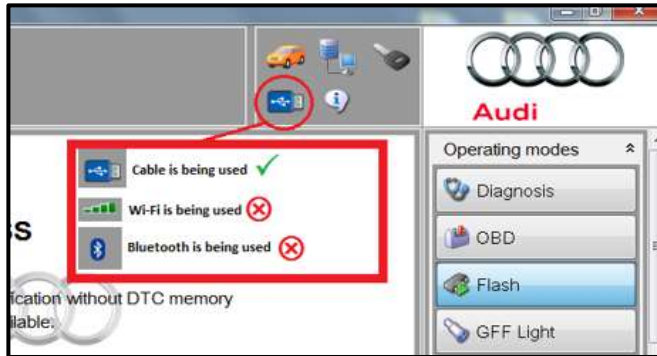
- Confirm that scan tool is communicating with the diagnostic head by USB cable.
 - If the Bluetooth or WiFi symbol is shown, then disconnect the diagnostic head from the vehicle and reconnect the USB cable to the diagnostic head and then reattach to the vehicle.

The VAS Diagnostics Interface MUST ONLY be connected to the tester with a USB cable.
 - Performing a software update using a Bluetooth or WiFi connection increases the risk of losing connection during the update, which could result in damage to the control module. It also greatly increases the time required to perform the update. Requests for additional time or parts will be denied if the GFF log shows the update was performed using Bluetooth or WiFi.

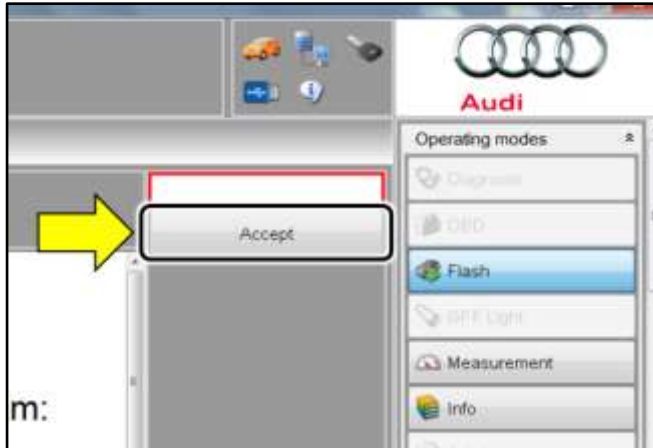
- Enter the corrective action code (SVM code) as listed below.

97EDA126

- Select "Accept" <arrow>.
- Follow the on-screen prompts.
