Technical Service Bulletin

92 Wiper knocks against the A-pillar, DTC B139007 and/or B139004 stored in the BCM 1

92 20 25 2059157/1 April 10, 2020.

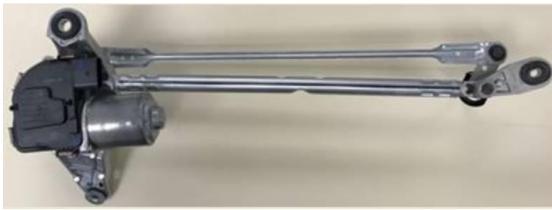
Windshield wiper bracket with wiper motor	01

Replace the windshield wiper bracket and motor assembly 83B 955 023 A. Only improved parts are available.
