Multimedia System Enhancements (Pioneer)

Service Category Audio/Visual/Telematics

Section Audio/Video

Introduction

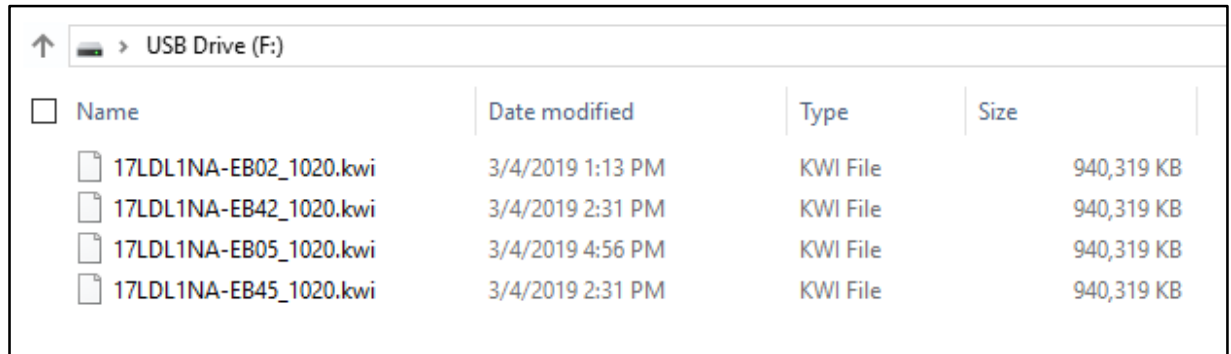
Figure 1.

The USB flash drive must NOT contain ANY additional folder names above the content folders or files (root directory). The head unit will NOT be able to search past an unrecognized folder name to view the internal folders and files. See the example in Figure 1 below.

Name	Date modified	Type	Size
17LDL1NA-EB02_1020.kwi	3/4/2019 1:13 PM	KWI File	940,319 KB
17LDL1NA-EB42_1020.kwi	3/4/2019 2:31 PM	KWI File	940,319 KB
17LDL1NA-EB05_1020.kwi	3/4/2019 4:56 PM	KWI File	940,319 KB
17LDL1NA-EB45_1020.kwi	3/4/2019 2:31 PM	KWI File	940,319 KB

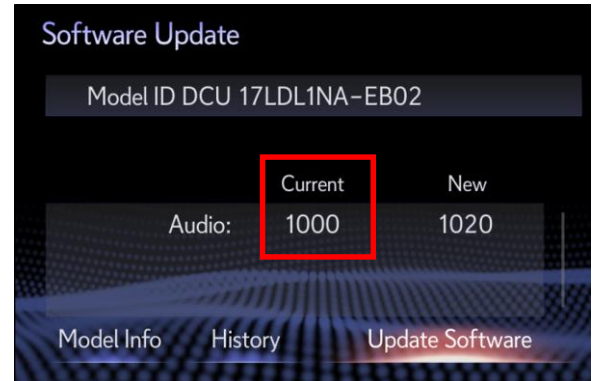
Figure 4.

- Verify the current audio software version using the table below.

Does the current audio software version match one of the current software versions in Table 1?

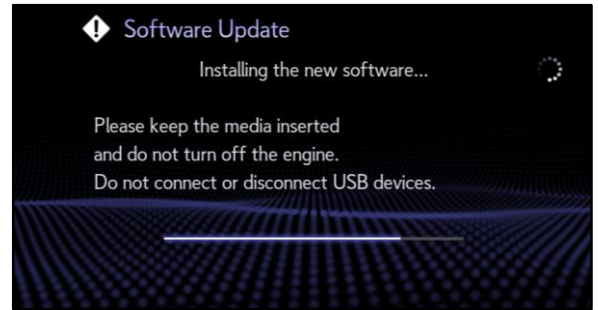
Figure 9.

- Once the head unit begins installation, the update will take approximately 10 minutes.

- Do NOT turn OFF the ignition or ACC BEFORE the software is ready for updating.
- Do NOT remove the USB flash drive until instructed.

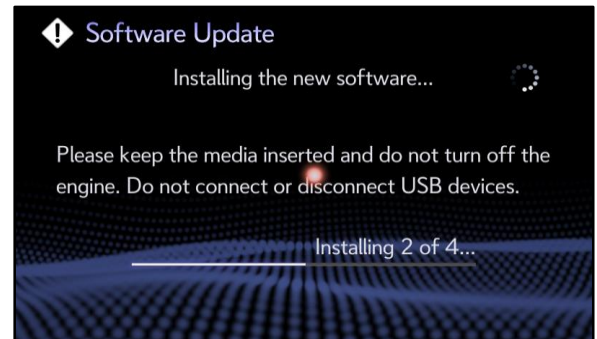
Figure 12.

17. The head unit will begin the second software installation phase.

- Do NOT turn OFF the ignition or ACC BEFORE the software is ready for updating.
- Do NOT remove the USB flash drive until instructed.
- If a “New software is not compatible with system.” pop-up occurs at this step, complete the following:
 - (1) Turn the vehicle OFF.
 - (2) Remove the USB flash drive.
 - (3) Verify ALL files mentioned in the Software Download and Extraction Procedure section are present.
 - (4) Begin the Software Update Procedure again.

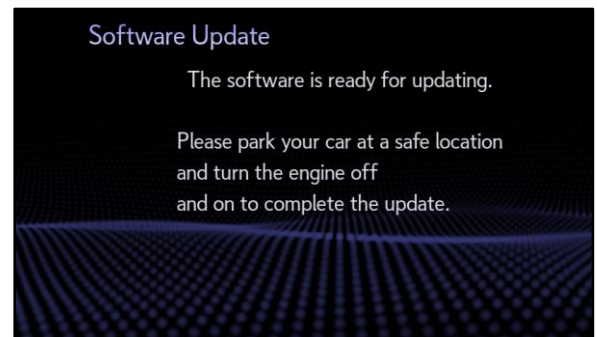
Figure 13.

18. When “The software is ready for updating” screen appears, the head unit will automatically be rebooted.
