Entune Audio Head Unit Software Update (Panasonic)

YEAR(S)	MODEL(S)	ADDITIONAL INFORMATION
2018 - 2019	Camry, Camry HV, Sienna

Some 2018 – 2019 model year Camry, Camry Hybrid, and Sienna vehicles equipped with Entune™ 3.0 Audio Plus (version 1010) or Entune™ 3.0 Premium Audio (version 1010) or earlier may exhibit one or more of the following conditions:

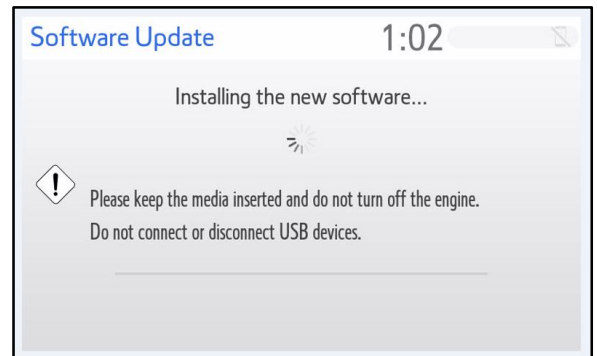
Figure 7.

18. Once the head unit begins installation, the update will take about 10 minutes.
