Service Bulletin

Bulletin No.: 19-NA-121

Subject: Shake and/or Shudder During Light Throttle Acceleration Between 25 and 80 MPH (40 and 128 KM/H) at Steady Speed

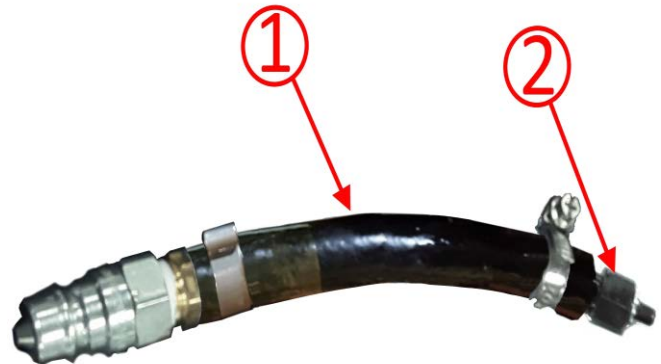
5182541

3. Install the DT-45096-31 TransFlow adapter (1) to the DT-51190 fluid fill adapter (2).

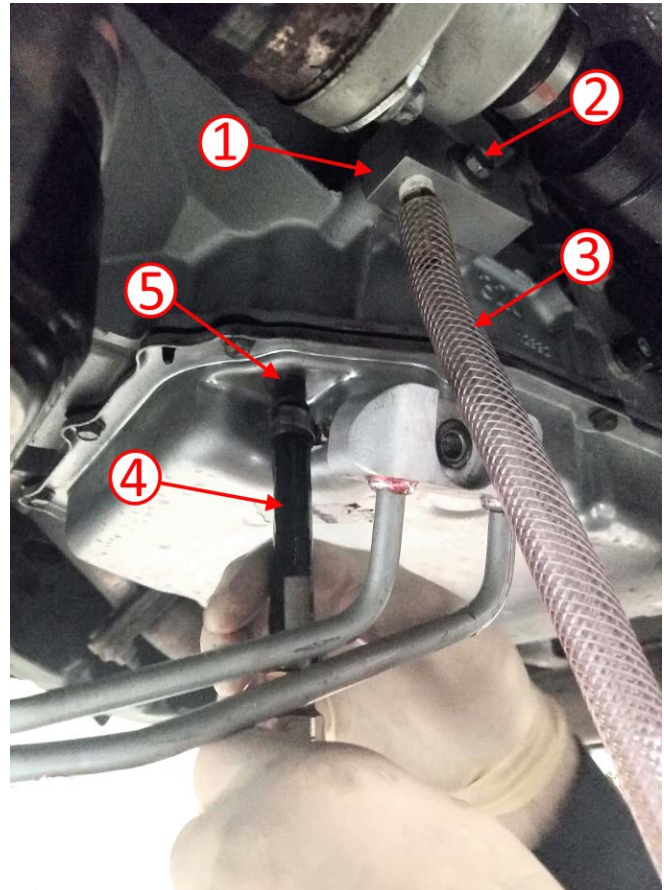
5180563

4. Remove the transmission oil cooler pipe assembly from the transmission.
5. Install the DT-52263-1 Adapter Block Assembly (1), reusing the seal from the transmission oil cooler pipe assembly.
6. Tighten the bolt (2) to 22 N•m (16 lb ft).

- 7. Place the hose (3) in the GE-47716-2 Graduated Measuring Bucket, utilizing a Spring Clamp to retain the hose.

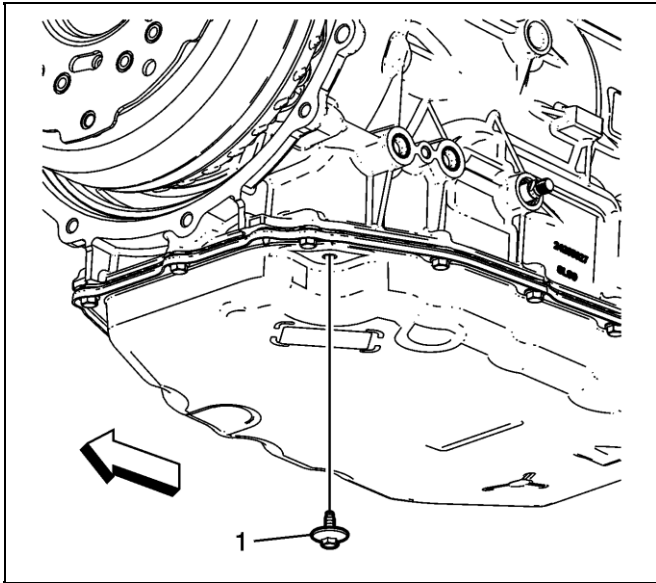
3723844

- 8. Remove the level set plug (1) from the transmission.

- 9. Install the DT-51190/DT-45096-31 assembly and hand tighten as shown in the graphic above.

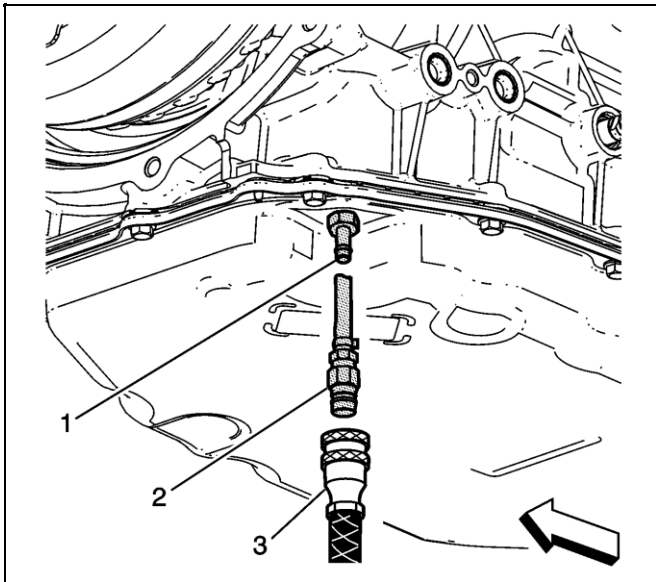
3723839

- 10. Connect the TransFlow fluid feed (supply) line (3) to the DT-45096-31 adapter (2).
- 11. Lower the vehicle.

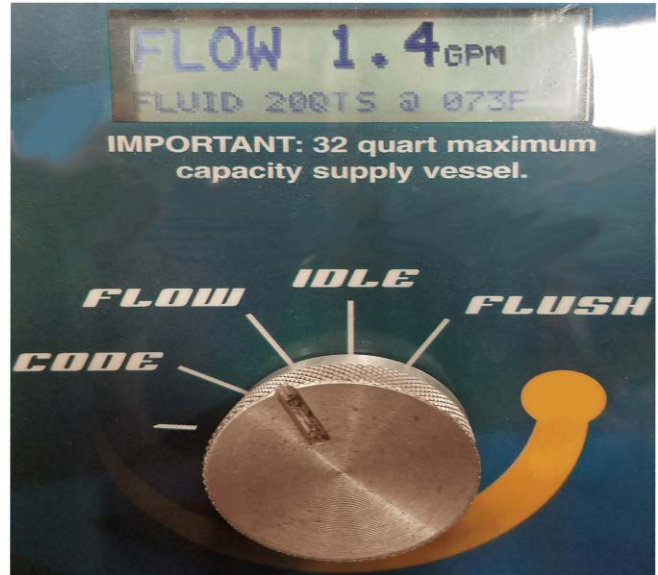
5181027

- 15. Switch the DT-45096 TransFlow to Flow and add 4 quarts of HP to the transmission.

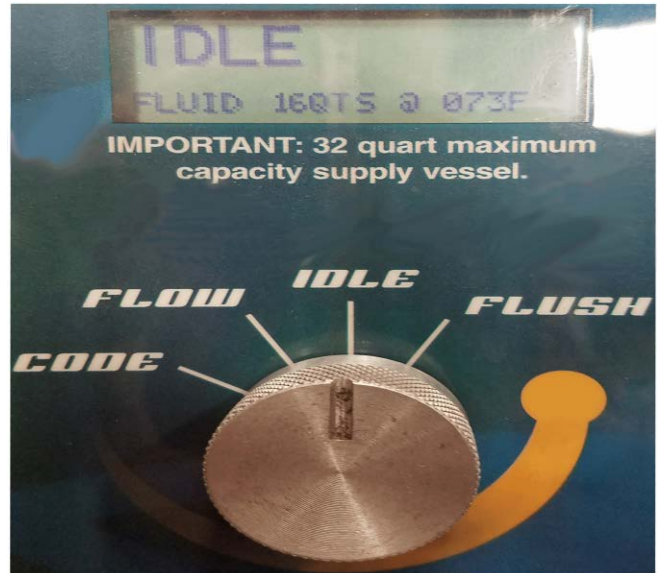
5181020

- 16. Switch the DT-45096 TransFlow to Idle (Reducing fluid level in the TransFlow from 20-16).

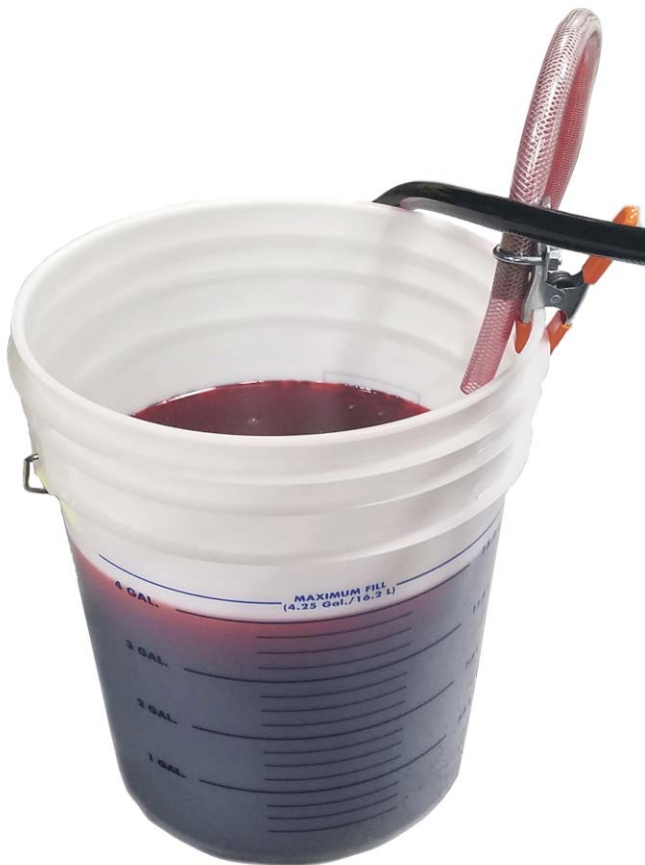
5181401

17. Switch the TransFlow DT-45096 to Flow and start the engine:
 - 17.1. Add a maximum of 4 quarts of HP Fluid to the transmission, turn the TransFlow switch to idle once 4 quarts have been added, while allowing 4 additional quarts of oil to fill the DT-graduated bucket (Reducing fluid level in the TransFlow from 16 – 12).
- Note:** DO NOT add additional transmission fluid until the 4 quarts of oil have been removed from the transmission (Reducing fluid level in the TransFlow from 12–8).
- 17.2. Repeat step 17.1.
 - 17.3. Add a maximum of 5 quarts of HP fluid to the transmission while allowing 5 additional quarts of oil to fill the DT-graduated bucket (Reducing fluid level in the TransFlow from 8 – 3).
