GROUP ELE	MODEL 2021MY Seltos (SP2)
	NUMBER 198	DATE April 2020

TECHNICAL SERVICE BULLETIN

SUBJECT: SERVICE ACTION: BCW SOFTWARE UPDATE (SA422)

This bulletin provides the procedure to update the logic of the Blind Spot Collision Warning (BCW) on some 2021MY Seltos (SP2) vehicles, produced from November 20, 2019 through March 27, 2020, which may exhibit MIL ON with DTC(s) C2702 – C2703. To correct this concern, apply the improved logic to the BCW using the KDS ECU Upgrade function as described in this bulletin. For confirmation that the latest reflash has been applied to a vehicle you are working on, verify the ROM ID using the table on page 2 of this bulletin. Before conducting the procedure, verify the vehicle is included in the list of affected VINs.

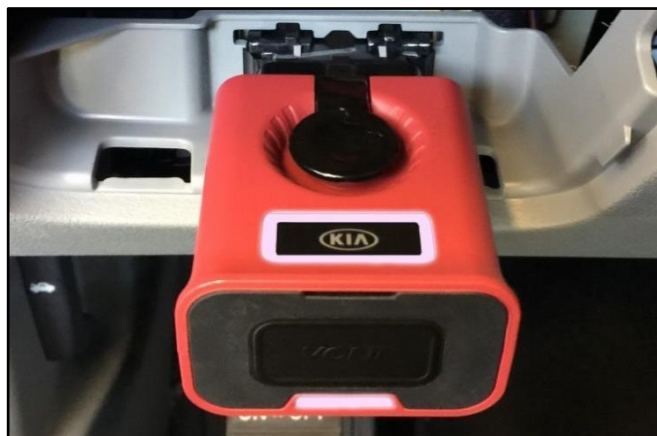
2. With the ignition ON, turn ON the KDS tablet. Select **KDS** from the home screen.

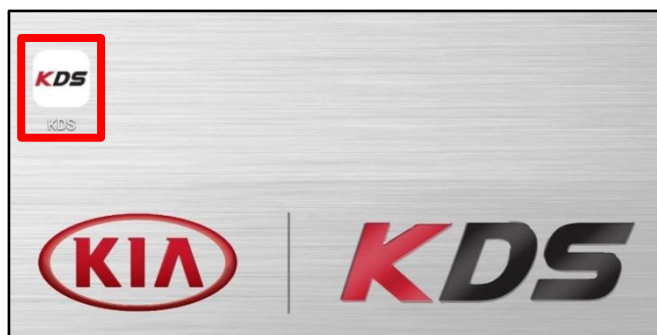
3. Confirm communication with VCI (A) and then configure the vehicle (B) using the **AUTO VIN** (C) feature.

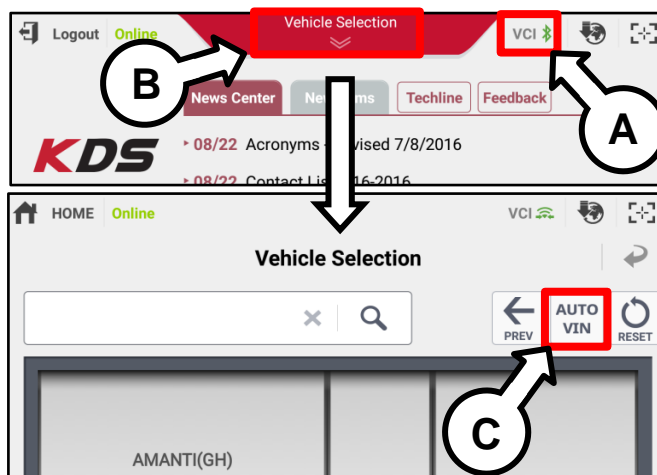
4. Select **ECU Upgrade**.

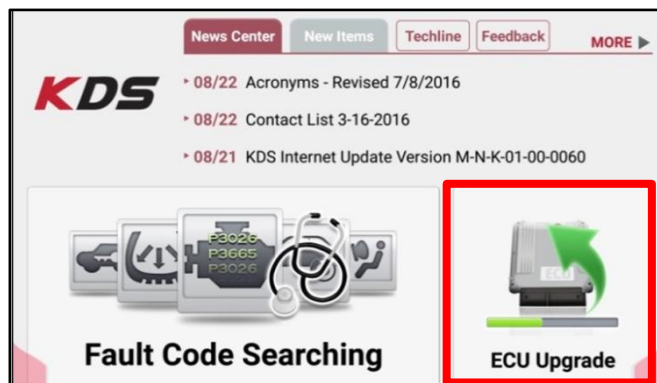
- The KDS will check the server for recently uploaded Events and then automatically download **Upgrade Event #492**.

After the download is complete, the program will shut down to install. Please wait until the program restarts.

KDS screenshot shown above is for demonstration purposes only. Events shown in screenshot are not applicable to this bulletin.

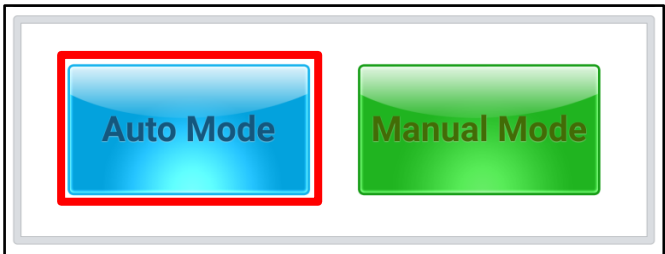
- Select the **BCW** system under the System selection menu.

Touch **ID Check** (D) and confirm that the latest update is available.

Select **Upgrade Event #492** and select **Upgrade** to continue.

- The ECU upgrade will begin and the progress of the upgrade will appear on the bar graph. Upgrade part (1/2) (E) will download the upgrade event to the VCI-II. Upgrade part (2/2) (F) will upgrade the ECU.

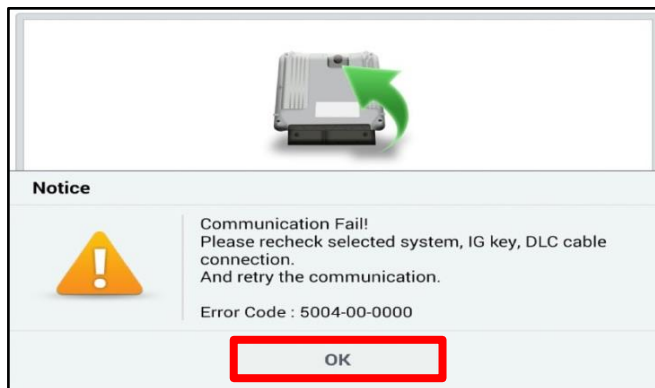
10. When instructed on the KDS, turn the ignition **OFF** for ten (10) seconds then back on. Touch **OK** to continue.

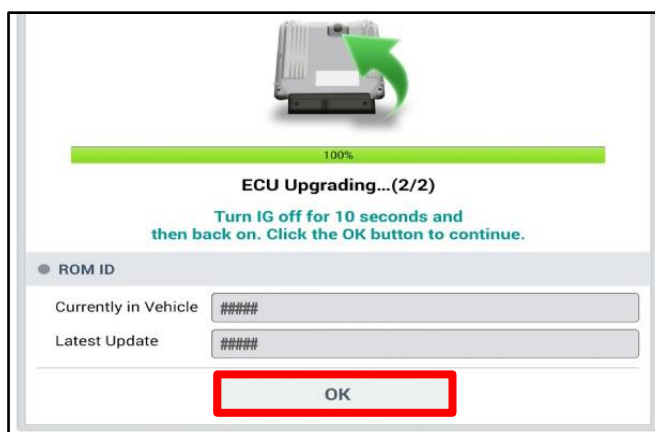
11. Once the upgrade is complete, touch **OK** to finalize the procedure.

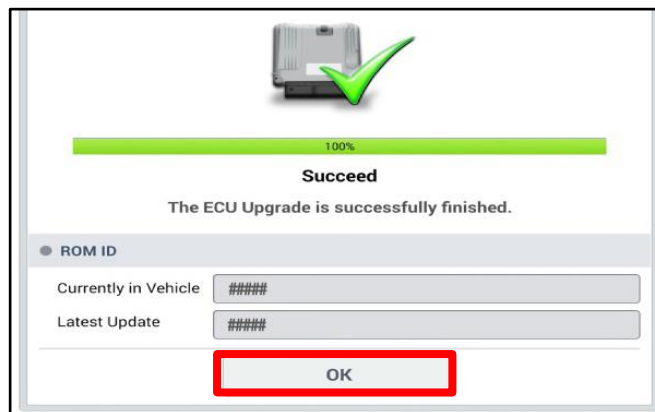
12. When prompted, select **YES** to check for Diagnostic Trouble Codes (DTC) and erase any DTCs stored such as EPS, ESC, and TPMS that may have been set during the upgrade.

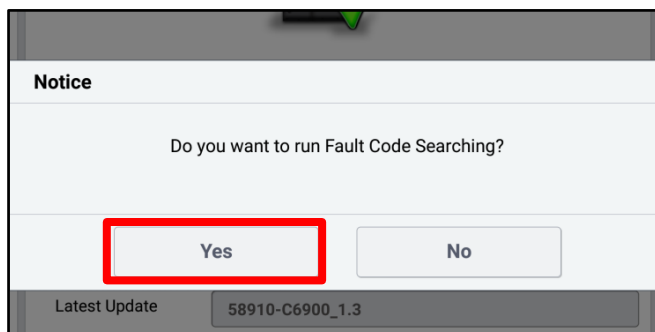
13. Using the KDS, perform the '**BCW (BSD) Variant Coding**' in the 'S/W Management'.
