Subject: TEMPERATURE SETTING MAY NOT CHANGE WHEN OPERATED VERY SLOWLY	Bulletin No.: 07-002/20
	Last Issued: 04/15/2020

2019-2020 Mazda3 with automatic climate control
2020 CX-30 with automatic climate control

MDARS ECU Reprogramming Procedure

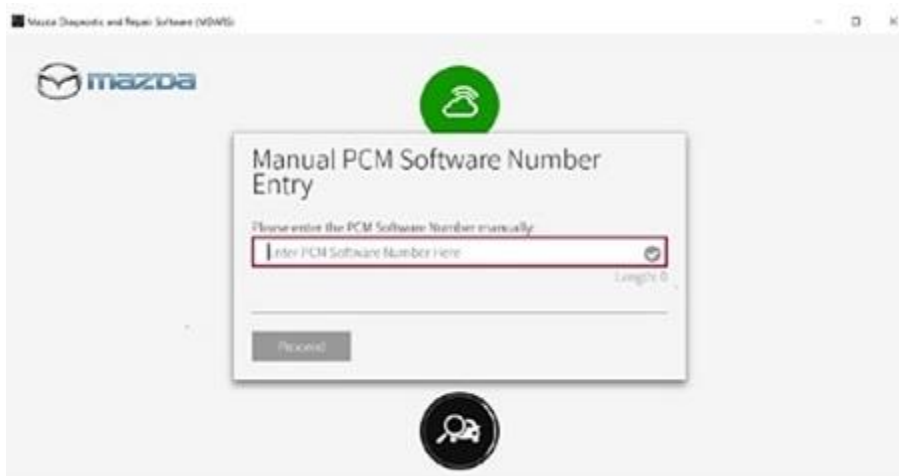
- Turn off all electrical loads (i.e. A/C blower, audio system, rear defogger and headlights).
- Perform a self-test and verify no DTCs are stored. If any DTCs are stored, repair the concern and delete the DTCs.
- Disconnect any aftermarket accessories (non-genuine Mazda accessories).
- Terminate all programs other than MDARS on the PC. Running other programs may interfere with the MDARS performance, resulting in the PC freezing or other problems.
- Perform reprogramming with a proper internet connection. When using a wireless network, make sure the connection is strong.
- Make sure to keep enough free space on the PC's hard disc. Insufficient free space (less than 1 GB) may result in the PC freezing during reprogramming.
- **If MDARS requires Manual PCM Software Number Entry, follow these steps.**

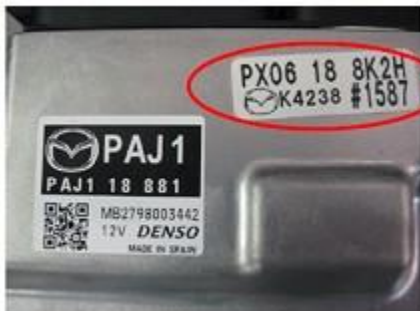
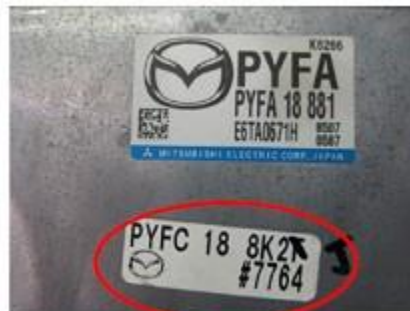
a. Look for the small sticker on the PCM that has the software number “**** 18 8K2*” printed on it.

b. Enter the software number adding “-” instead of a space. **Example:** If “PX06 18 8K2H” is printed, enter “PX06-18-8K2H”.

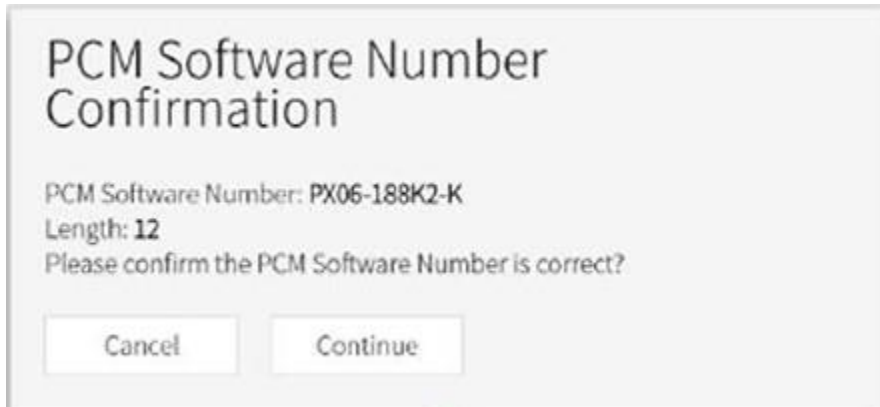
CAUTION: Entering wrong Software Number can lead to inappropriate software downloading and may result in abnormal operation of the vehicle.

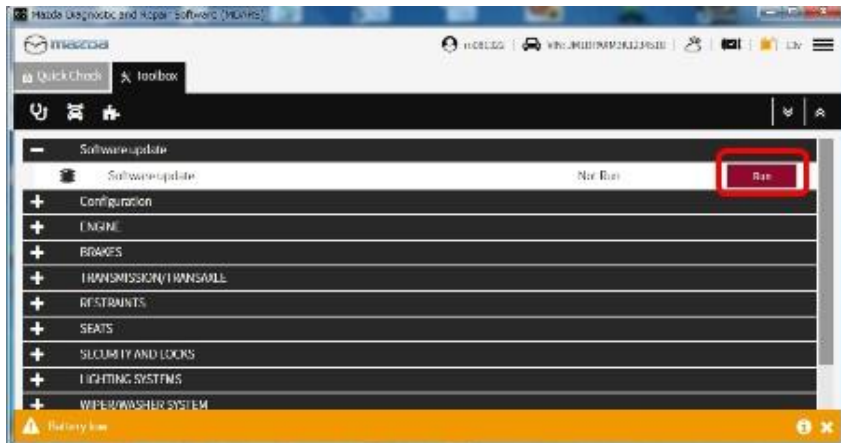
6. Select "Software update", then click "Run".

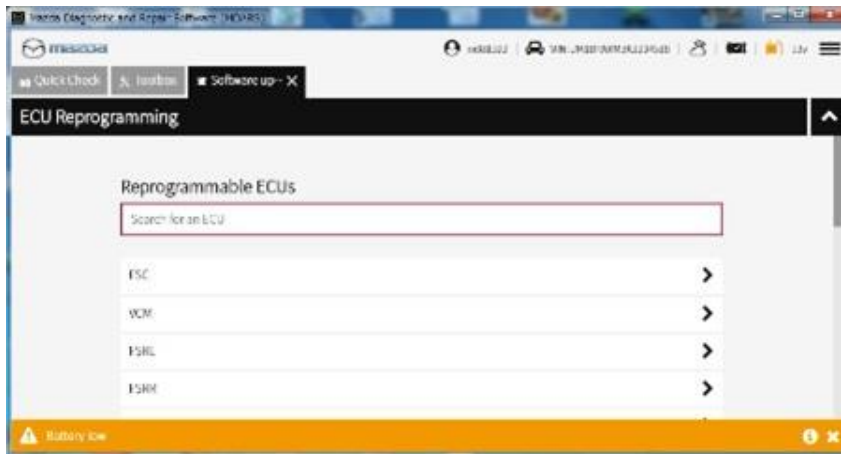
7. Select the ECU to be reprogrammed.

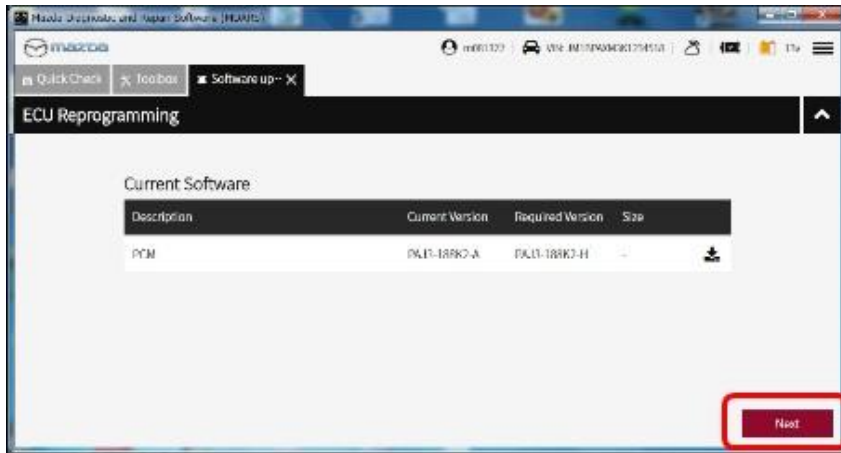
8. Confirm the current and new software versions, then click “Next”.
NOTE: When reprogramming the BCM, two softwares will be shown.

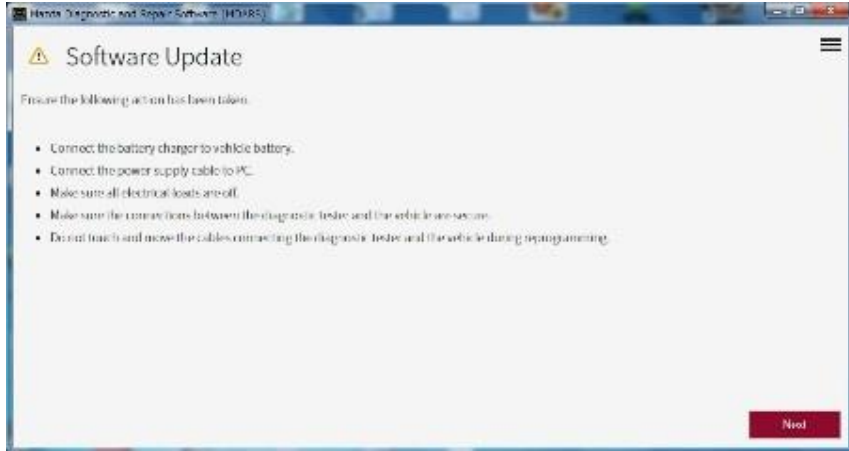
10. Read the screen instructions, then click “Next”.

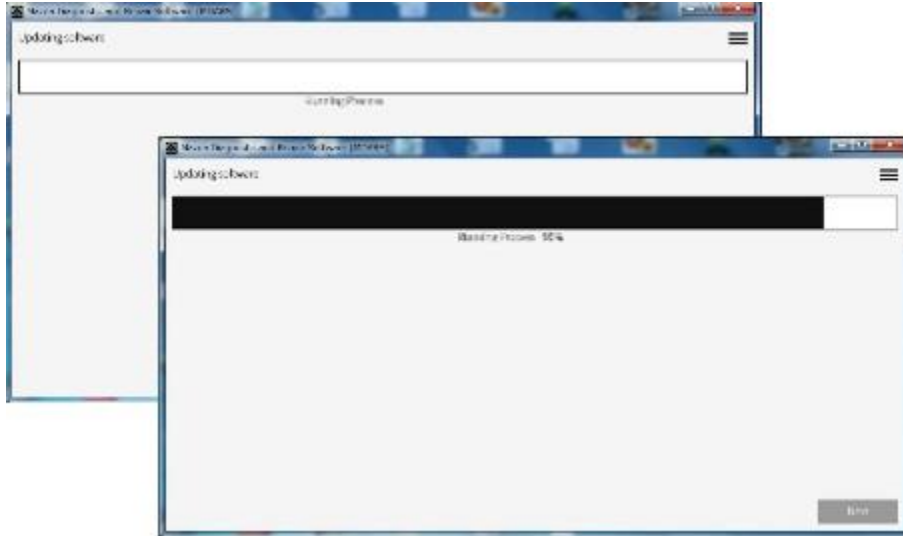
12. Wait for the reprogramming to complete.

- The progress bar will stay at 90% for 30 seconds. This is not a failure.
- When reprogramming the BCM, this process will occur twice.

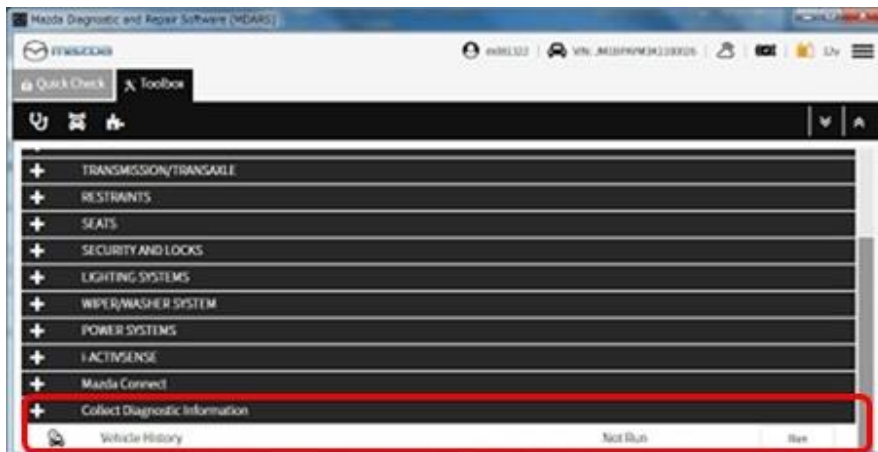
- Select "Vehicle History" under "Collect Diagnostic Information", then click "Run".
