Technical Service Bulletin

TEMPERATURE SETTING MAY NOT CHANGE WHEN OPERATED VERY SLOWLY

Bulletin No.: 07-002/20

2019-2020 Mazda3 (Japan built) vehicles with automatic climate control and VINS lower than JM1BP*****174392 (produced before March 14, 2020)

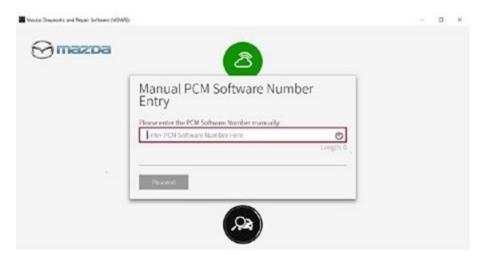
a. Look for the small sticker on the PCM that has the software number "**** 18 8K2*" printed on it.

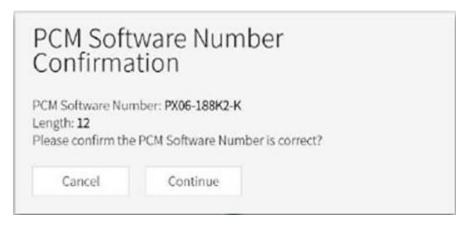
b. Enter the software number adding "-" instead of a space. **Example:** If "PX06 18 8K2H" is printed, enter "PX06-18-8K2H".

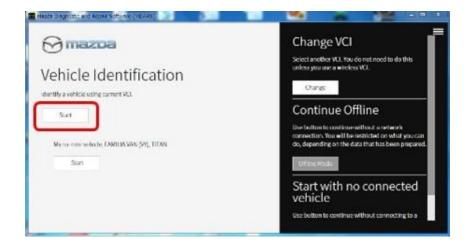
- 1. Connect the M-MDS to the vehicle.
- 2. Launch the Mazda Diagnostic And Repair Software (MDARS).
- 3. Turn the ignition on, then click "Start".

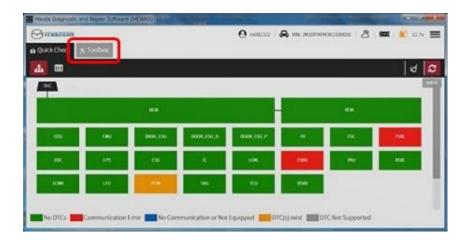
4. Select the "toolbox" tab.

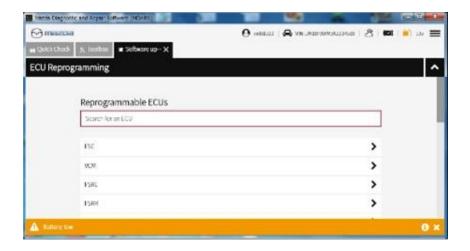
7. Select the ECU to be reprogrammed.

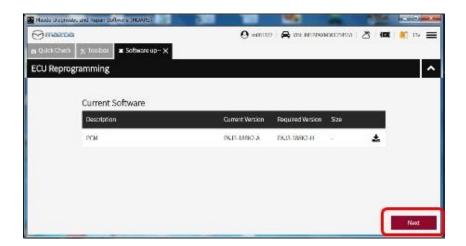
8. Confirm the current and new software versions, then click "Next". **NOTE:** When reprogramming the BCM, two softwares will be shown.

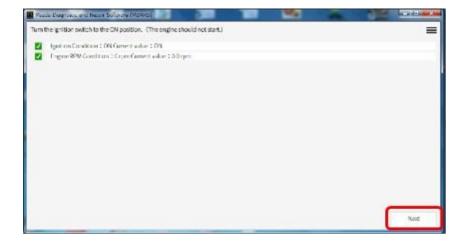
11. Follow the instructions on the screen, then click "Next".

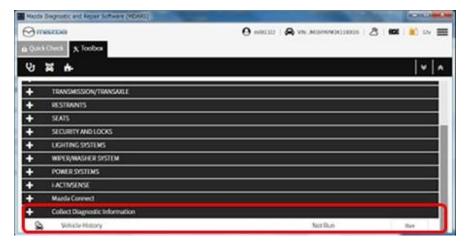
• Select "Vehicle History" under "Collect Diagnostic Information", then click "Run".

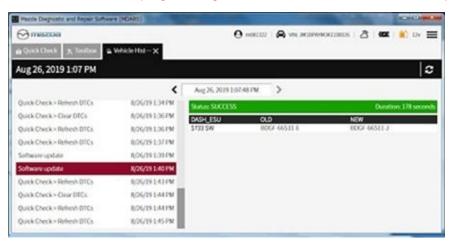
Confirm the reprogramming on the screen and save the screen copy as a record.
