# DCM Firmware Update (LG)

**Section** Cellular Communication

Some 2020 model year Camry, Camry Hybrid, Corolla Hatchback, RAV4, and RAV4 Hybrid vehicles may exhibit a condition in which the Toyota app does not accept the activation code and/or becomes inoperative, and/or the SOS call center does not receive the vehicle's location data in a timely manner. Follow the Firmware Update Procedure in this bulletin to address these conditions.

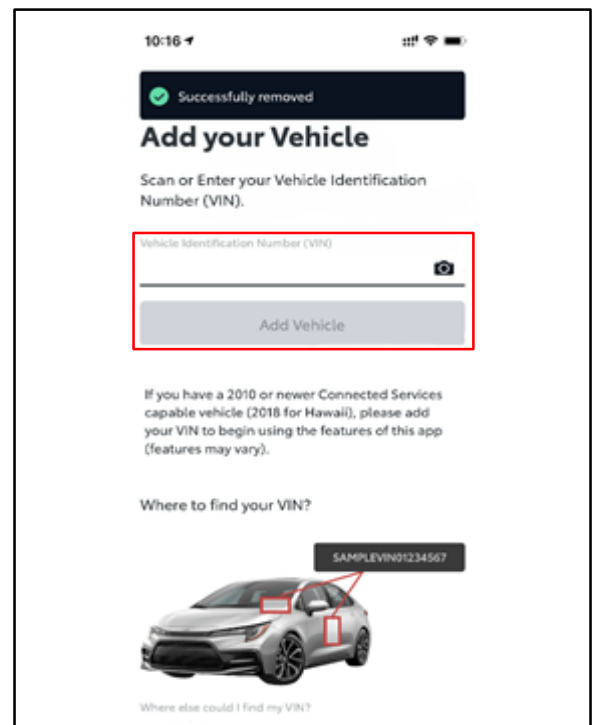
Figure 11.

19. Click on Add Vehicle to perform the enrollment again.
