**NUMBER:** 08-040-20

Radio Enhancements

This bulletin involves updating the radio with the latest available software **\*\*23.02.30.10.\*\***

2017 - 2018	(MP)	Jeep Compass
2017 - 2018	(M1)	Jeep Compass
2018	(M6)	Jeep Compass

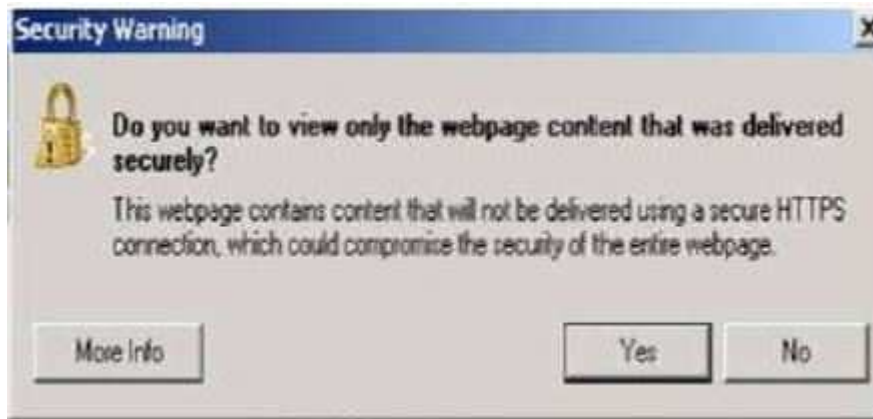
Fig. 1  
Pop-up Security Message

1. Has a USB flash drive been created?
  - YES>>> Proceed to [Step 5](#).
  - NO>>> Proceed to [Step 2](#).
2. Go to DealerCONNECT> Service> Uconnect Command Center> Uconnect> Dealer software downloads to download the files.
3. If a security message appears "Do you want to view only the web page content that was delivered securely?" ([Fig. 1](#)) Press No to continue.

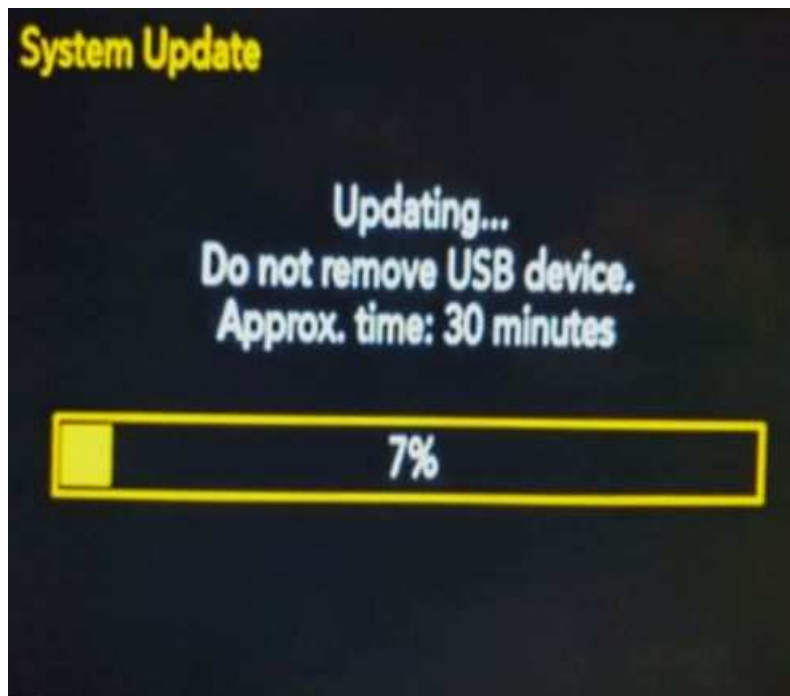
Fig. 2  
Percentage Completed Screen

**NOTE:** There will be a variety of screens displayed throughout the update process. A black screen will appear multiple times in the process for a few minutes ([Fig. 2](#)).

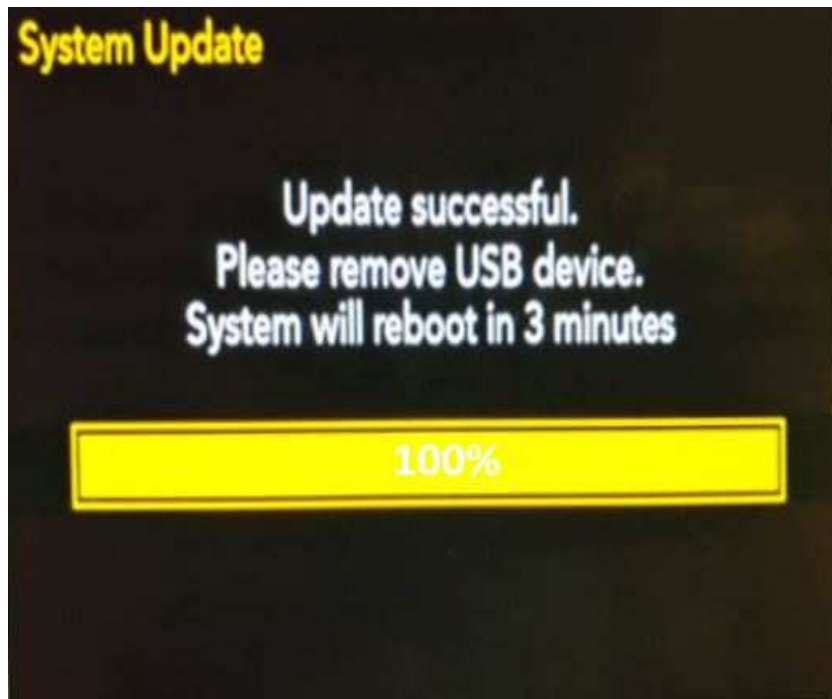
Fig. 3  
Update Successful Screen

10. After the update is done the screen will display "Update successful" (Fig. 3) .
