# Service Bulletin

Bulletin No.: 20-NA-073

**Subject: Loss of Brake Assist, Various Messages Displayed in Driver Information Center (DIC), Brake Pedal Travel and Apply May Feel Different, DTC C0024 Set**

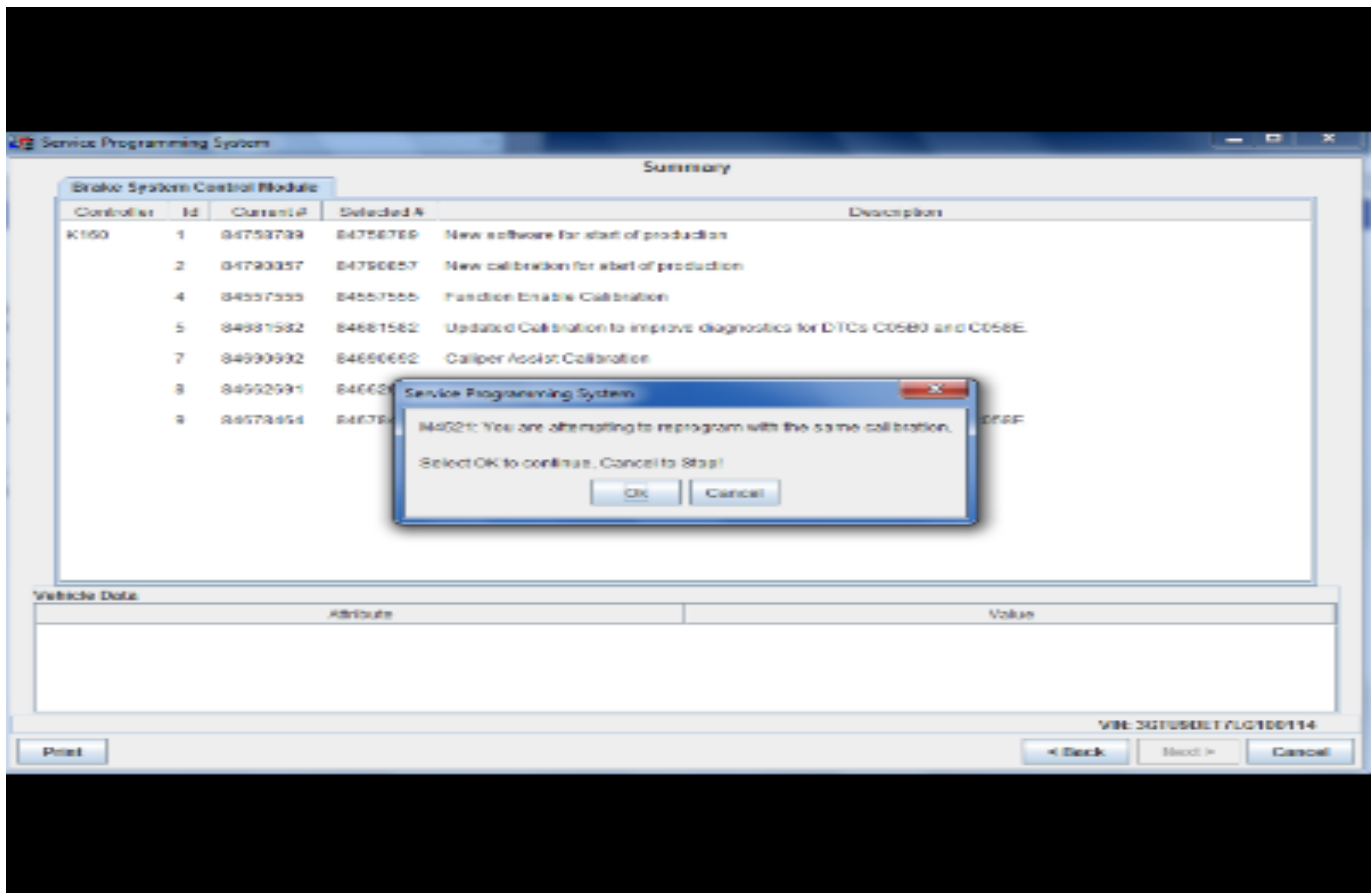
5431207

**Important:** TIS2WEB screen shown. Techlink Connect screen is similar and will be included in the near future.
