Technical Service Bulletin

SUBJECT:			No: TSB-20-54-002
POOR SOUND QUALITY DURING HANDS-FREE PHONE CALL WITH APPLE CAR PLAY			DATE: April 2020
			MODEL: See below
CIRCULATE TO:	<input type="checkbox"/> GENERAL MANAGER	<input checked="" type="checkbox"/> PARTS MANAGER	<input checked="" type="checkbox"/> TECHNICIAN
<input checked="" type="checkbox"/> SERVICE ADVISOR	<input checked="" type="checkbox"/> SERVICE MANAGER	<input checked="" type="checkbox"/> WARRANTY PROCESSOR	<input type="checkbox"/> SALES MANAGER

Customers may report poor sound quality when receiving or making a hands-free phone call using Apple Car Play with the Smartphone Link Display Audio built by JVC Kenwood. Voice quality may get worse and become muffled, making it hard for both parties to hear and understand each other. This may be due to an improper parameter setting for echo and noise processing.

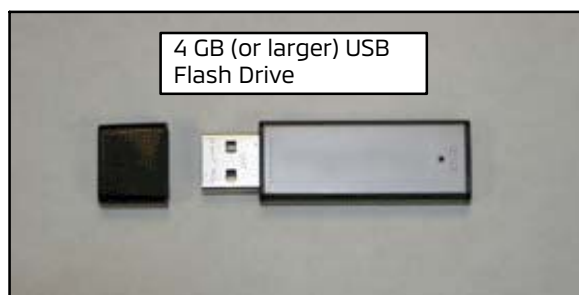
The update procedure for all audio types requires a dedicated USB flash drive (a.k.a. thumb drive) formatted to FAT32.

A USB version 2.0 standard flash drive (thumb drive) with a **minimum capacity of 4.0 GB**, formatted to FAT32 is required for this procedure. Formatting to FAT32 will erase all data from the flash drive. The flash drive must have no other files or folders saved to it.

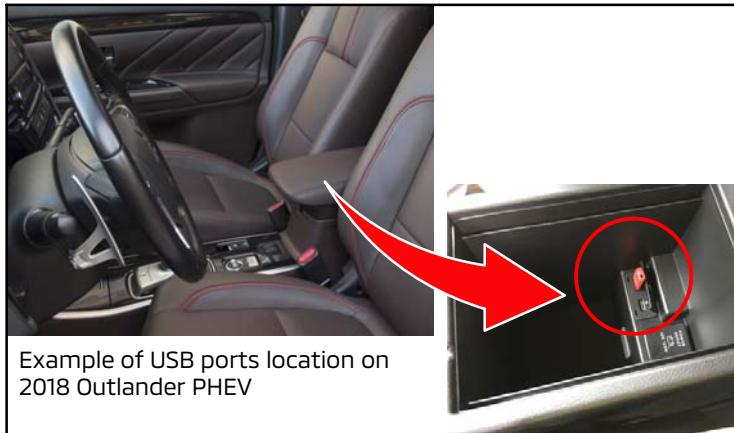
1. **For Outlander vehicles:** Turn vehicle ON, and keep the engine idling for the entire update procedure.
For Outlander PHEV: Put vehicle in READY mode for the entire update procedure.
2. Plug in the USB flash drive containing the **CORRECT software update file* for that vehicle** into the vehicle's USB port.
***Refer to step 4 of "B. Transfer Files to USB Flash Drive" in this TSB for correct file identification.**
 - Depending on model year, USB ports are located inside the center console or in the front lower dash. For front dual ports, either port may be used for the update.

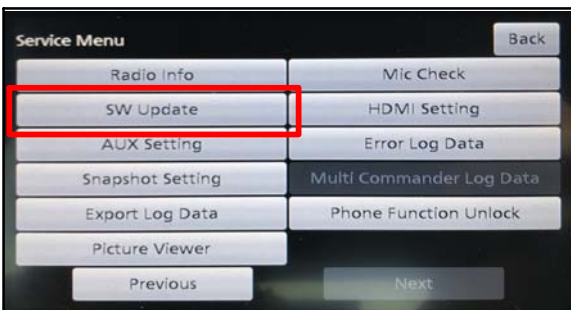
- f. On the SW Update screen, touch the "Update" button.

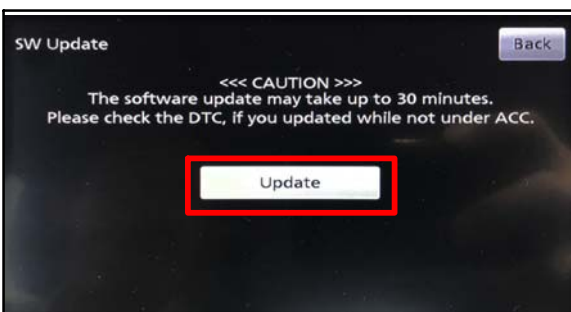
- g. Touch "Yes" to start the software update.
NOTE: Do NOT turn the power OFF or remove the flash drive during the update.

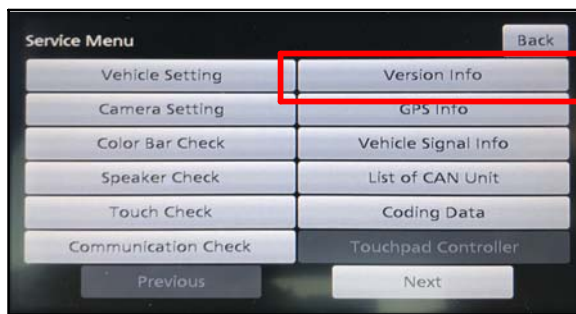
e. Touch the "Next" button.

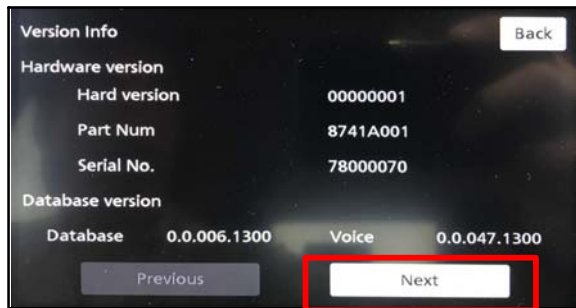
f. Confirm the software version has been updated and matches the New version shown for the applicable model in the "**Display Audio Software Version Chart**," on page 2 of this TSB.
