Symptom - Body Exterior - Passenger's Side Mirror Lowering Does Not Swivel Back to Original Position: Re-programming Door Control Units (SY 49/20)

Model line: **Cayenne (9YA)**

Subject: **Door control unit**

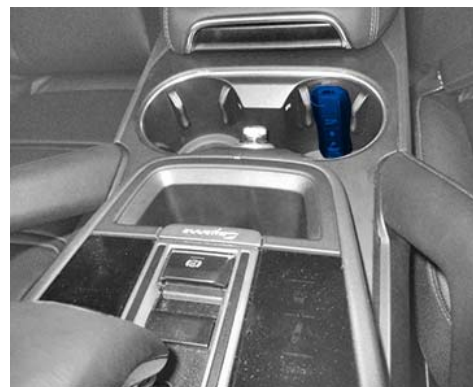
Emergency start tray

- 1 Position the driver's key in the rear area of the left cupholder in the center console between the holding struts (emergency start tray) in order to guarantee a permanent radio link between the vehicle and driver's key ⇒ *Emergency start tray*.
- 2 **9900 - PIWIS Tester 3** must be connected to the vehicle communication module (VCI) via the **USB cable**. Then connect the communication module to the vehicle and switch on the PIWIS Tester.
- 3 Switch on the ignition.
- 4 On the PIWIS Tester, call up the '**driver 's-side door**' control unit and '**Extended identifications**' menu.
