# Service Action

## Code: 24FN

**Subject** Remote Start System Software (USA Only)

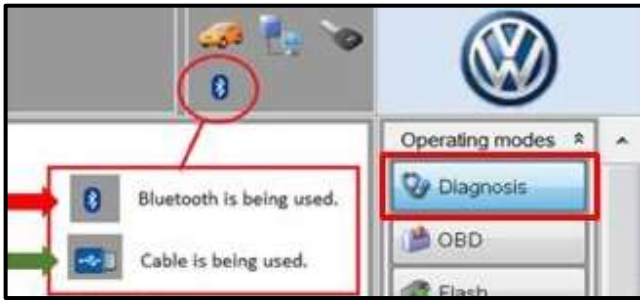
- Confirm that scan tool is communicating with the diagnostic head by USB <Green Arrow>.
  - If the Bluetooth symbol is shown <Red Arrow> then disconnect the diagnostic head from the vehicle and reconnect the USB cable to the diagnostic head and then reattach to the vehicle.
- Upon ODIS startup, verify the “Diagnosis” operating mode is selected <as shown>.
- Once the GFF scan is complete, select “Special functions” <arrow 1>, then “Adapting software” <arrow 2>, then select “Perform test” <arrow 3>.

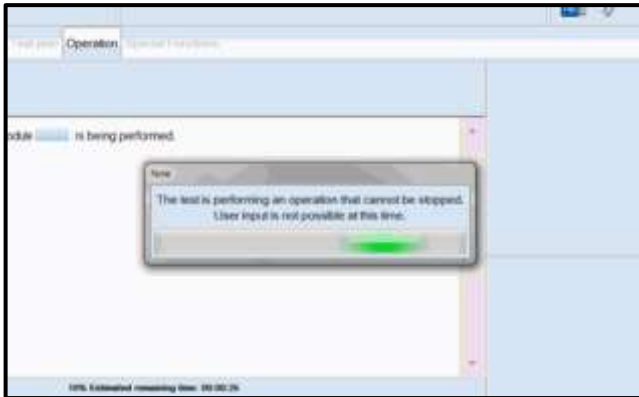
- Select "Accept" <arrow> and follow the on screen prompts.
- During the flash, this screen appears when each operation is performed:
