# Service Action

## Code: 93G1

<b>Subject</b>	<b>e-tron Service Package</b>																		
<b>Release Date</b>	May 13, 2020																		
<b>Affected Vehicles</b>

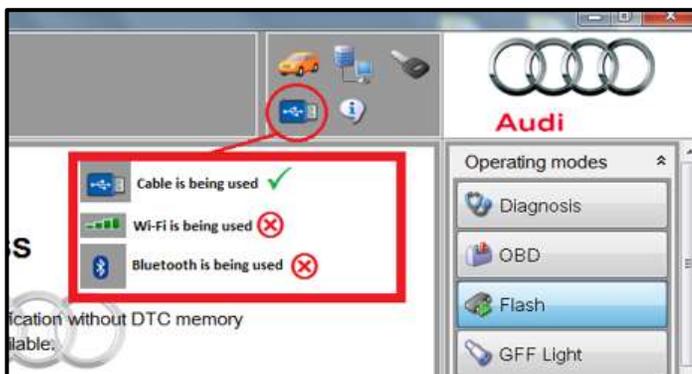
- Confirm that scan tool is communicating with the diagnostic head by USB cable.
  - If the Bluetooth or WiFi symbol is shown, then disconnect the diagnostic head from the vehicle and reconnect the USB cable to the diagnostic head and then reattach to the vehicle.

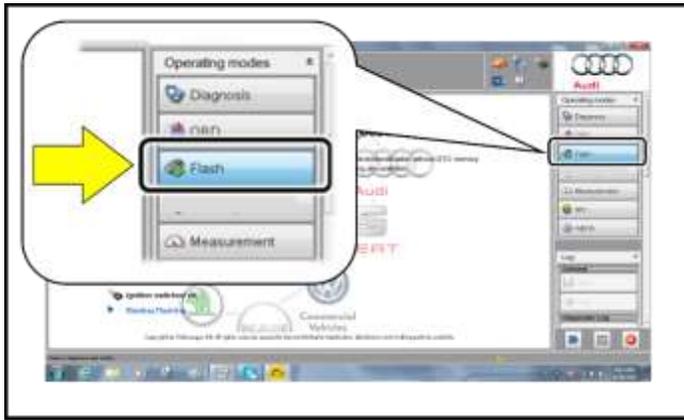
- From the home screen of the scan tool highlight “Flash” <1>.
- Follow the on-screen prompts.

**! NOTE**  
 Operating mode “Flash” must be used. Performing this update using “Diagnosis” (Guided Fault Finding) could result in non-payment of the claim.

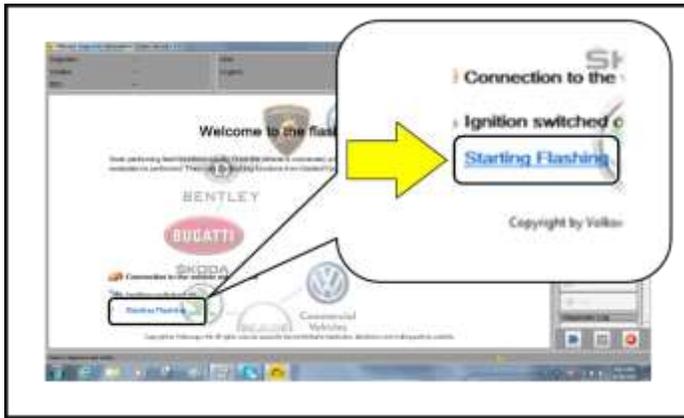
- Select “Starting Flashing” and follow the on-screen prompts.

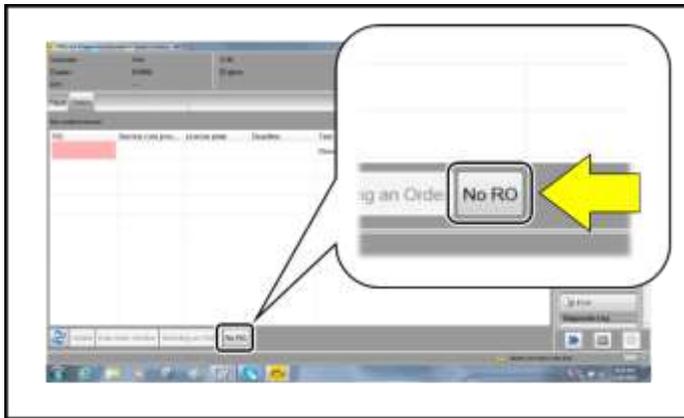
- Select “No RO”.

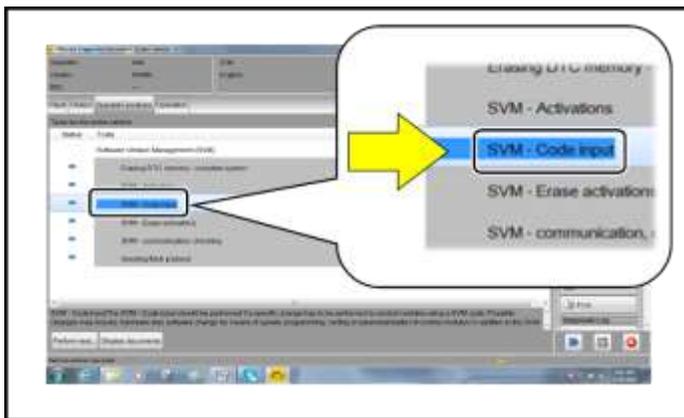
- Highlight “SVM – Code Input”.

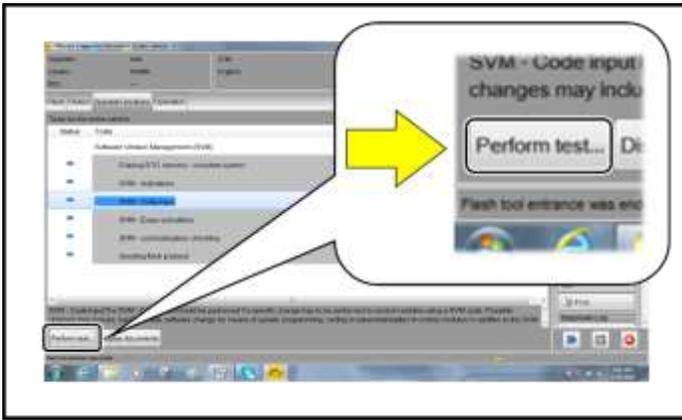
- Select "Perform test".

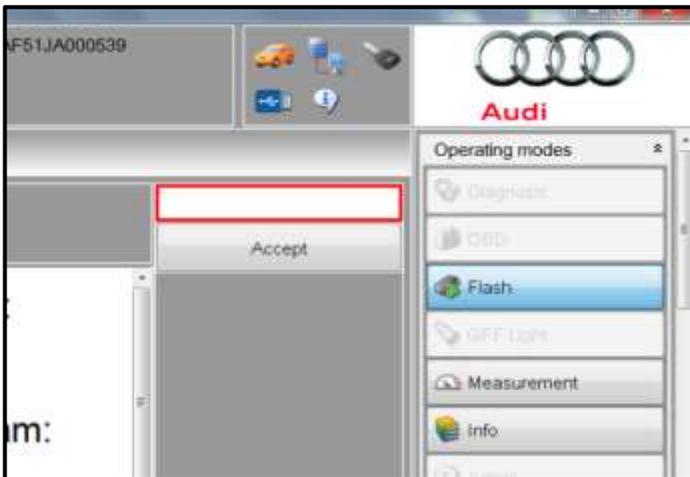
- Enter the corrective action code (SVM code) as listed below.

SVM code
<b>93G1A189</b>

- Select "Accept".
- Follow the on-screen prompts.

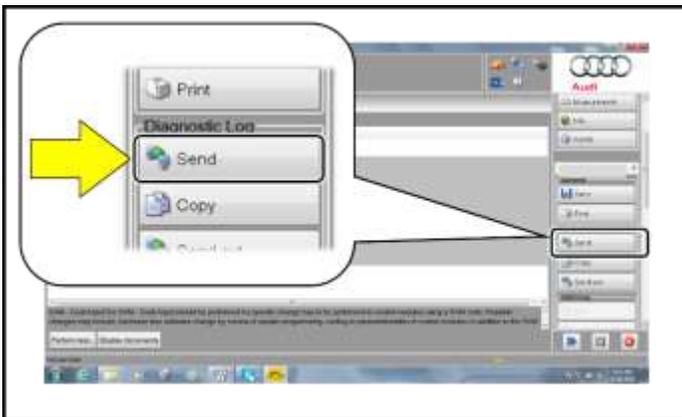
- After receiving confirmation that the flash completed successfully, select "Send" to send the diagnostic protocol online.
- Follow the on-screen prompts.

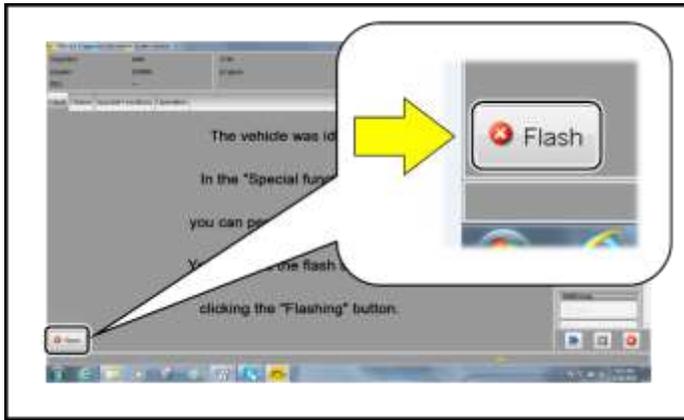
- Click "Flash" to exit the flash session.

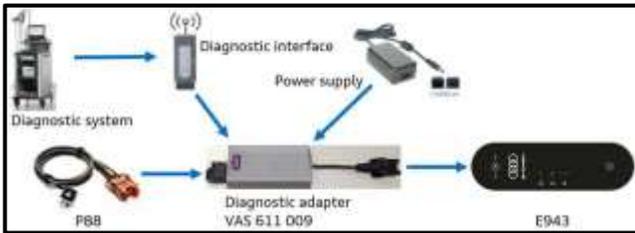
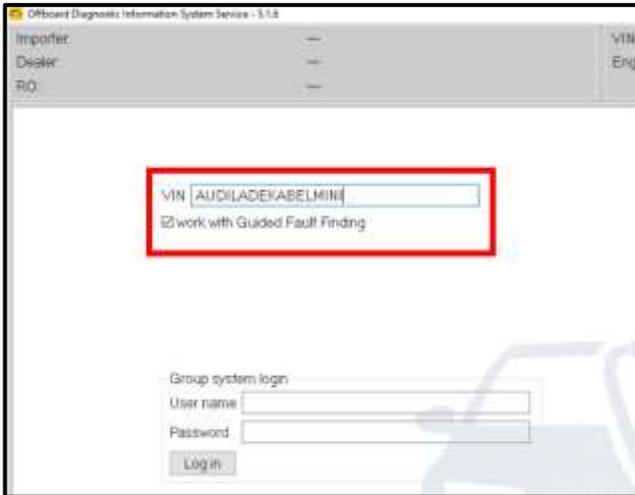
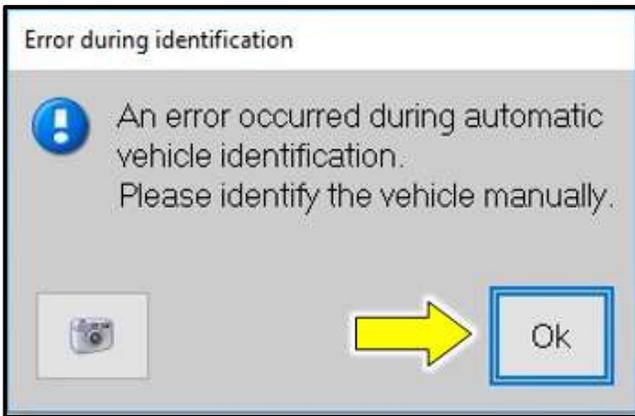
- Using the VAS611009, establish a connection between the Diagnostic Tester and the Mobile Charger -E943-.
- Enter **AUDILADEKABELMINI** in the VIN field populated in ODIS.
- Ensure “work with Guided Fault Finding” is checked.
- An error will occur during VIN identification. Press “OK” <arrow> to continue.

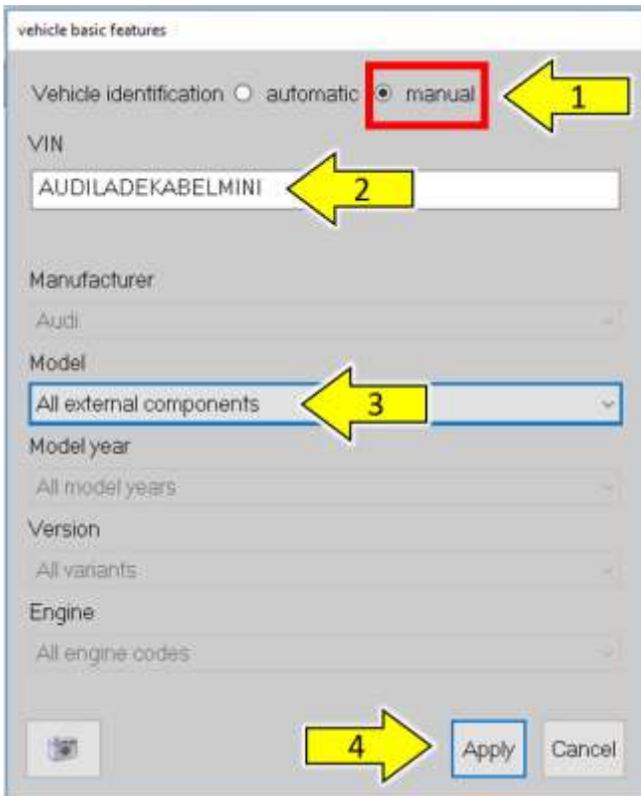
- Perform the following to manually identify the charger:
  1. Select “manual” Vehicle identification.
  2. Enter **AUDILADEKABELMINI** in the VIN field.
  3. Select “All external components” for the Model.
  4. Select Apply.

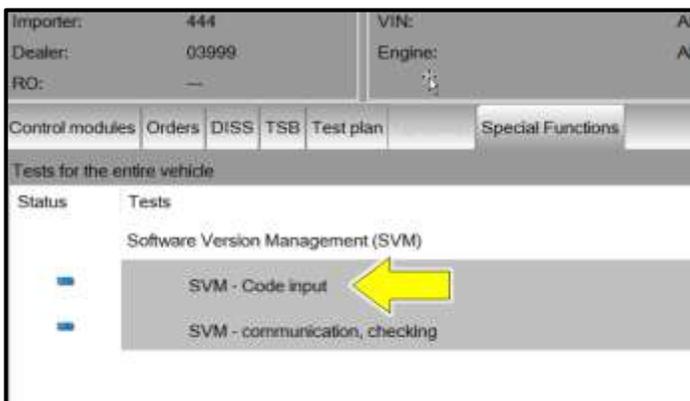
- Select SVM – Code Input <arrow>.

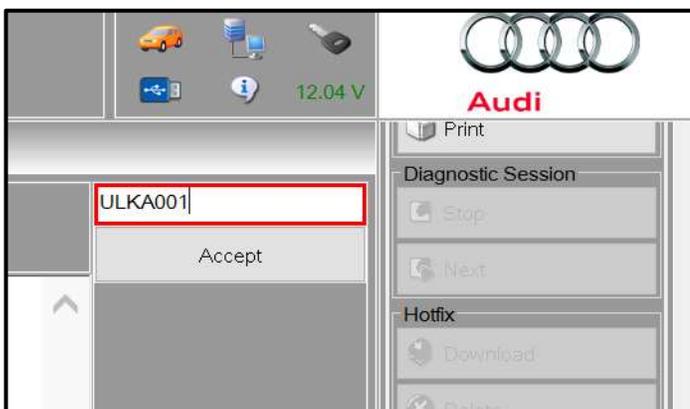
- Enter the corrective action code (SVM code) as listed below.

<b>SVM code</b>
<b>ULKA001</b>

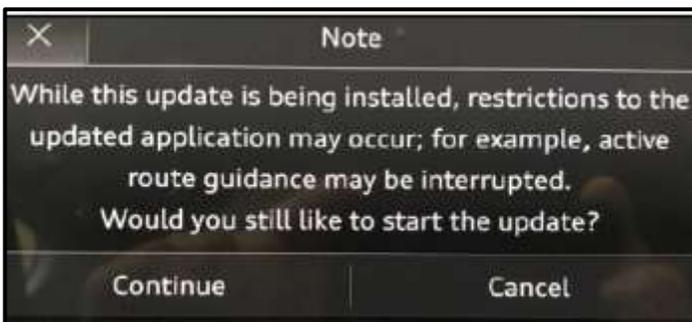
- Insert SD card for navigation system. The message “Update medium detected. Analysing update data.” will appear.

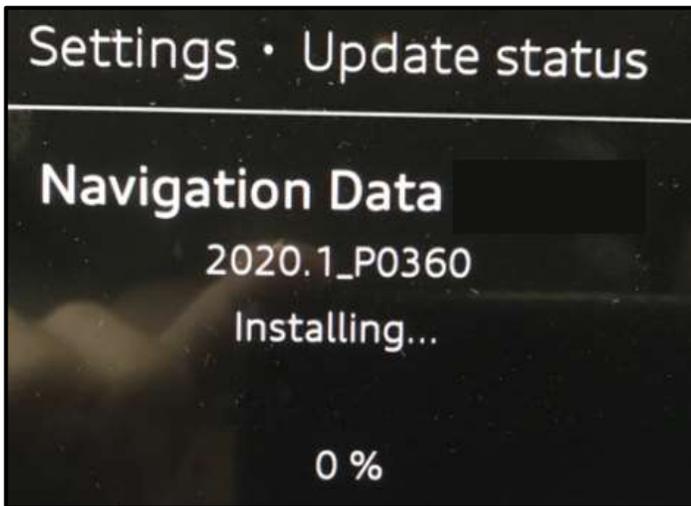
- As soon as the update is ready to install, confirm with “Continue.”
