# SERVICE BULLETIN

Classification: EL20-008a	Reference: NTB20-016a	Date: May 18, 2020
------------------------------	--------------------------	-----------------------

## RADIO INTERMITTENTLY REBOOTS DURING AUDIO PLAYBACK VIA BLUETOOTH CONNECTED IPHONE

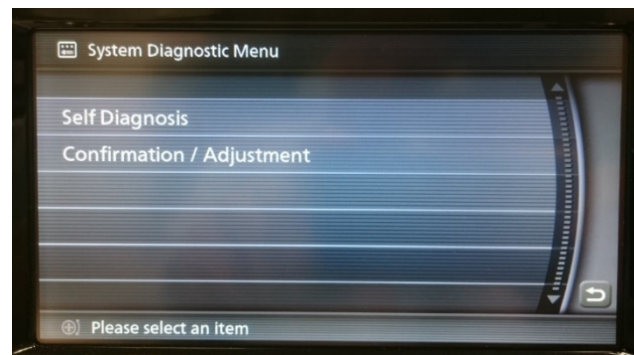
1. Turn the ignition ON.
2. Turn the audio system OFF.
3. Access the System Diagnostic Menu as follows:
  - a. Press and hold the **MENU** button.
  - b. Turn the **VOLUME** knob 40 or more clicks in either direction.

**NOTE:** The screen in Figure 2 should display.

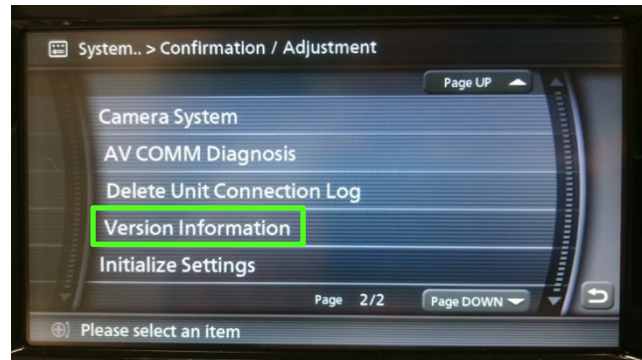
Figure 5

6. Select **Version Information**. Version information should display as shown in Figure 6.

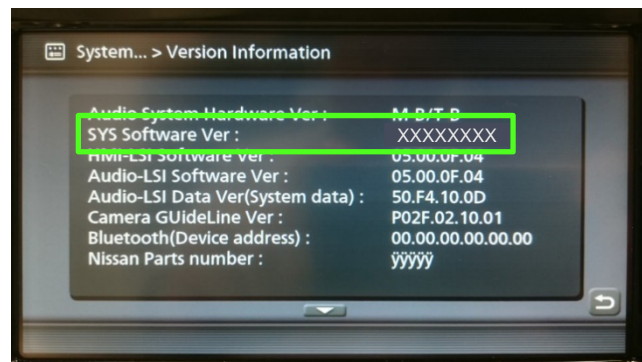
Figure 6

- If the **SYS Software Version #** is less than the numbers shown below, turn the ignition OFF and continue to step 7 on page 4.
- If the **SYS Software Version #** is equal to or greater than the numbers shown below, no software update is needed. Go to ASIST for further diagnostic and repair information.

- For 2018-2019 Sentra, Versa Note and Versa Sedan: 80856035
- For 2020 Versa Sedan and 2018-2020 Kicks: 80851035
- For 2018-2020 NV: 80856235
- For 2018-2019 Frontier: 80856135

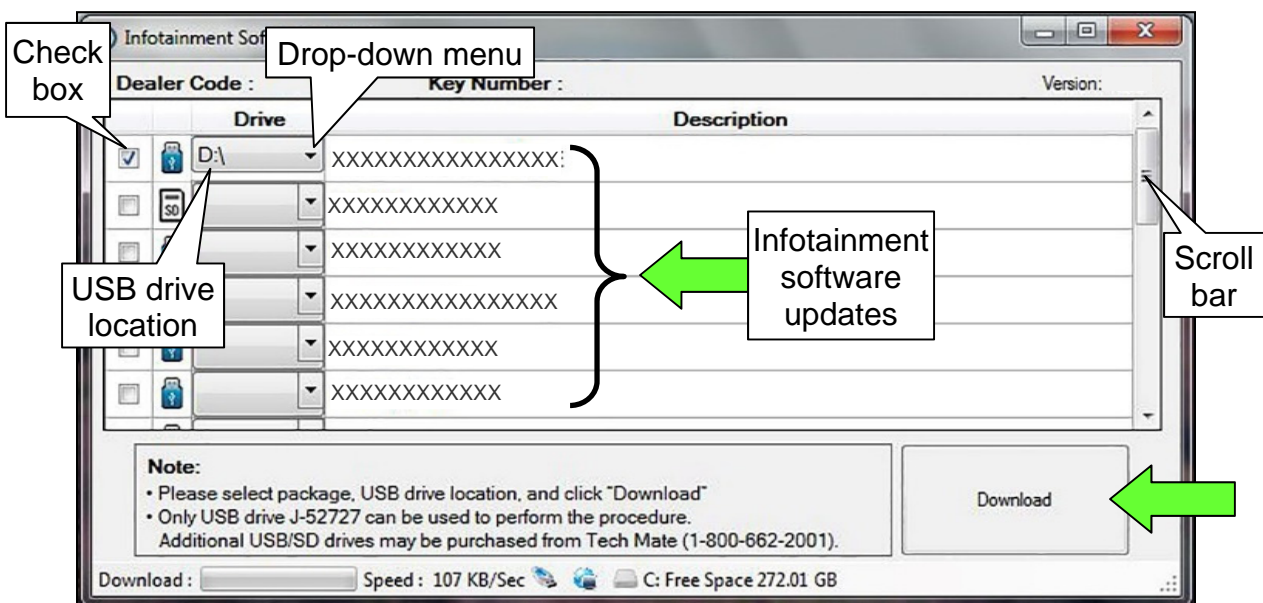
- Select the check box next to the correct update software package (Figure 8).
  - Locate update file #1 (LD001) and update file #2 (see **Table A** above).
  - Only one (1) update will be loaded at a time, starting with update #1 (LD001).

**HINT:** The **Description** section in Figure 8 may be different than on your C-III plus screen.

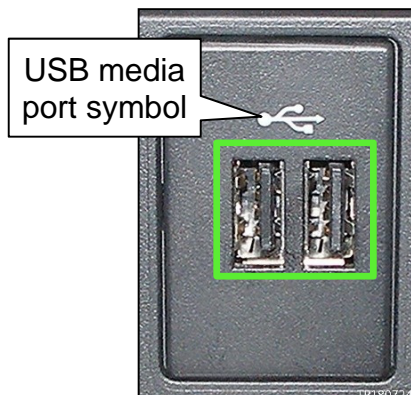
Figure 11

20. Turn OFF the audio system.
21. Insert the special tool USB drive J-52727 into the USB media port (Figure 11).

**NOTICE** Do not insert the USB drive into a charging port (Figure 12). If used, the update software and/or USB drive may become damaged. Only insert the USB drive in a USB media port.
