Entune Audio Head Unit Software Update (Pioneer)

Service Category Audio/Visual/Telematics

Section Navigation/Multi Info Display

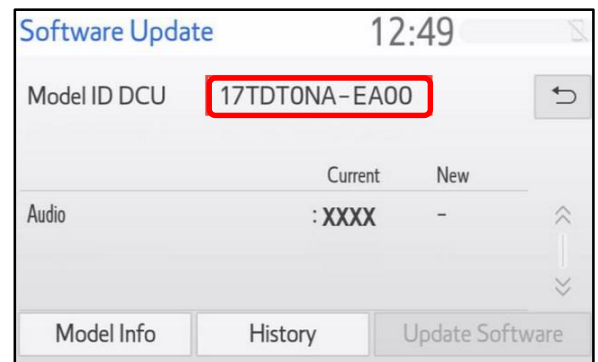
Figure 4.

5. Record the Model ID.
6. Match the Model ID to the software update file, then download the appropriate multimedia software update file from the Software Update Information section.

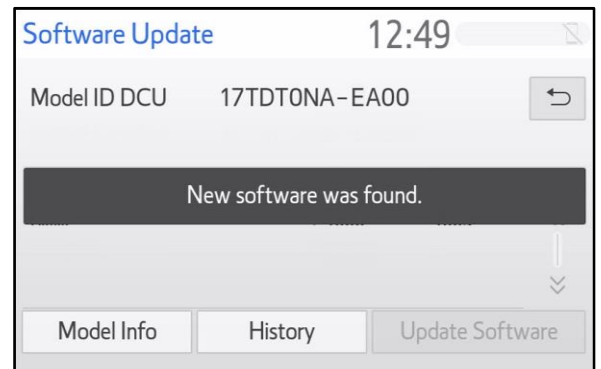
Figure 6.

9. Insert the prepared USB flash drive into the vehicle's USB port.

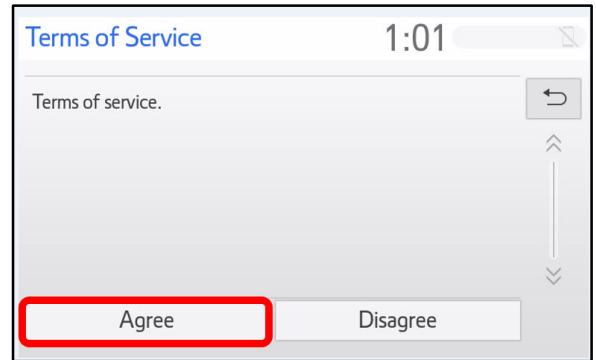
Figure 9.

13. Select Agree on the Terms of Service screen.
