TT8643EN  
May 26, 2020  
Page 1 of 4

SUBJECT: Incorrect Engine Retarder Selection Calibration Setting in Navistar Vehicles

MODELS AFFECTED: Navistar Vehicles with 1000/2000 Series™ Transmissions with 5th Generation Controls

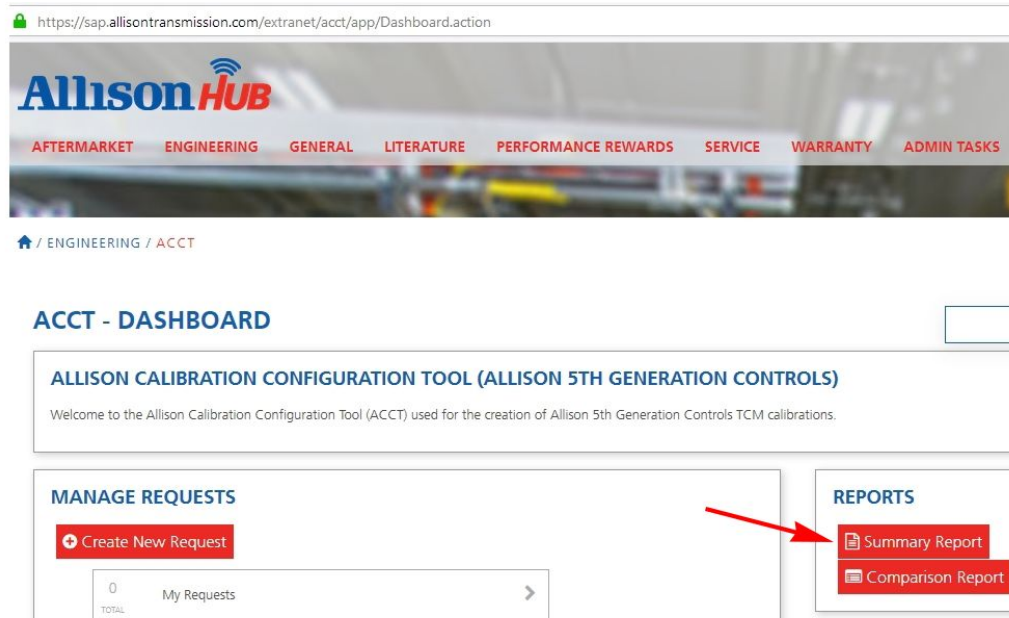
**Figure 1. ACCT Dashboard**

- a. Choose Summary Report from the ACCT Dashboard on the Allison HUB. See [Figure 1](#).

6. Using ACCT, which can be found in the Engineering section of the Allison HUB, verify that parameter **J1939 Reception: EBC1 Engine Retarder Selection [28040]** is set to **Enabled [1]** on the Calibration Summary Report.
