Preliminary Information

PIP5684A GE-52250 Power Smoke Diagnostic Leak Detector Turbocharger Charge Air And Induction System Tester MIL Reduced Engine Power

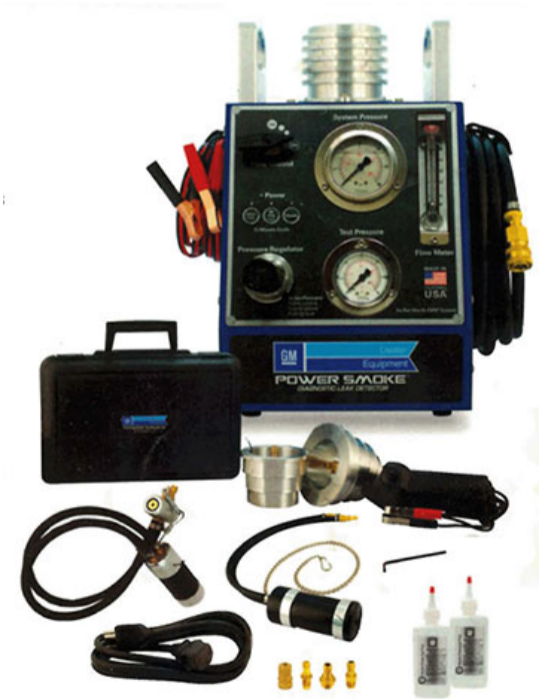
GE-52250 is shown below.

Note: The adapters may vary as the tool evolves.

The technician should follow SI diagnostics. If no cause for the concern is found or during diagnosis a leak check is required, power smoke diagnostic leak detector GE-52250 can be very helpful in locating leaks.

NOTE: Do not use GE-52250 to diagnose EVAP system leaks due to the high pressure output this tool produces.
