# AfterSales TSO – Circular Letter

## MAS002199

MCL 20-05

## New ETM Software Volta 6 – Troubleshooting guides

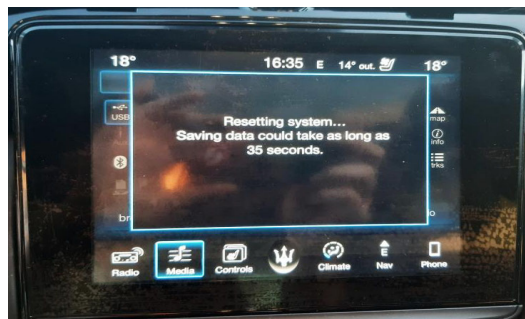
- B.1.** BRIDGE software installation (ETM update). Follow the table in this bulletin (MY 17 Sedans) for the vehicles requiring this s/w..
- B.2.** Download the software from the MARKETING DEALER MANUAL (4ME-THRON) (Follow Section A)
- B.3.** Extract all the files in an empty USB stick with the following specifications (as per Bulletin MAS001272):
- USB 3.0
  - At least 8GB or higher
- B.4.** Insert the USB stick in the USB port inside the vehicle.
- B.5.** Follow the on screen prompts.
- Please keep the vehicle in Key ON state (with a battery charger connected to the vehicle) and leave the USB stick inserted for the entire duration of the update.
  - Removal of the USB stick during the update will result in a non-functional head unit.
  - The time may depend on the market, the s/w version and the speed of the USB memory stick. The installation could take up to 1 hour.
