Audio Head Unit Software Update (Denso-Ten)

Service Category Audio/Visual/Telematics

Section Navigation/Multi Info Display

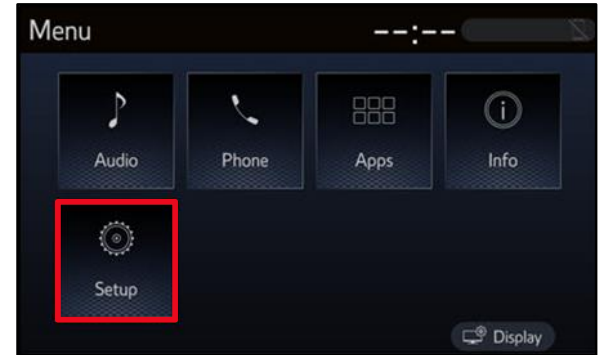
Figure 1.

1. Turn the ignition ON.
2. Press the Menu button on the radio faceplate, then select Setup.

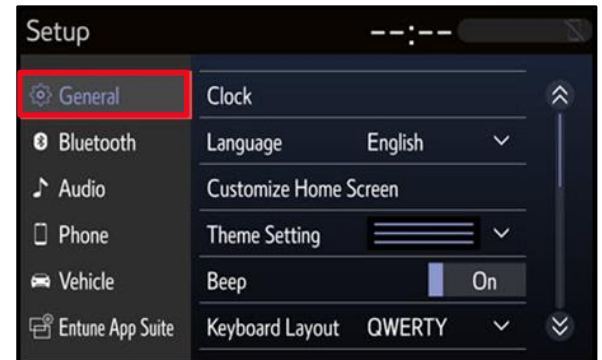
Figure 2.

3. Select General on the Setup screen.

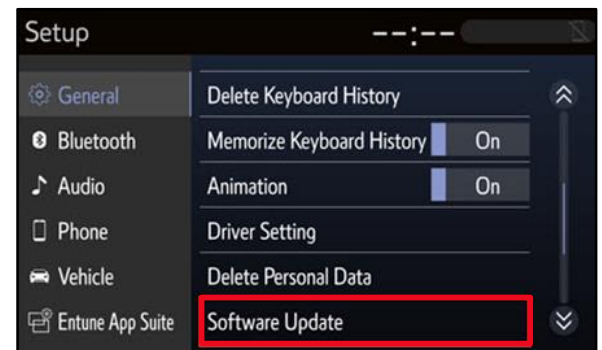
Figure 3.

4. Scroll down and select Software Update.

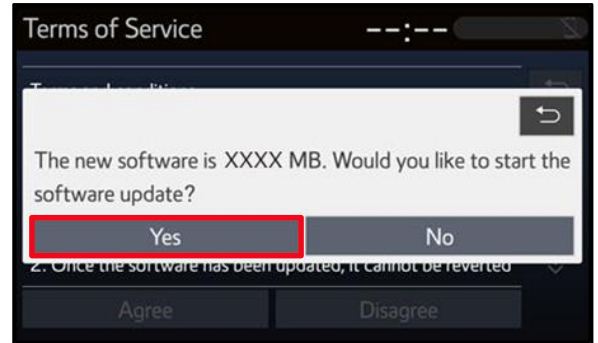
Figure 8.

12. Select Yes on the “Would you like to start the software update?” pop-up.

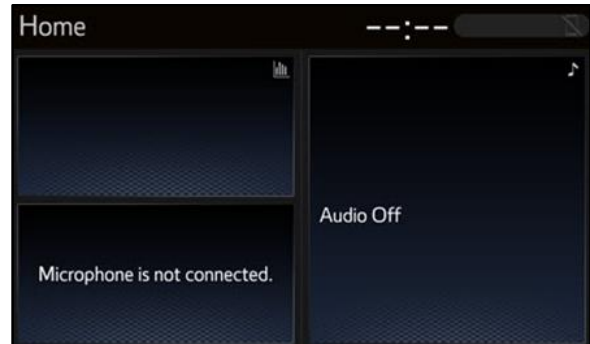
Figure 12.

17. Once the software update is complete and the Home screen appears, remove the USB flash drive.
