June 2020
SF600A

Subject: Cascadia ICC5 Units

Models Affected: Specific Freightliner Cascadia vehicles built June 18, 2019, through October 16, 2019, and equipped with flat panel displays.

The supporting electronic control unit (ECU) for the display will be replaced with an upgraded version.

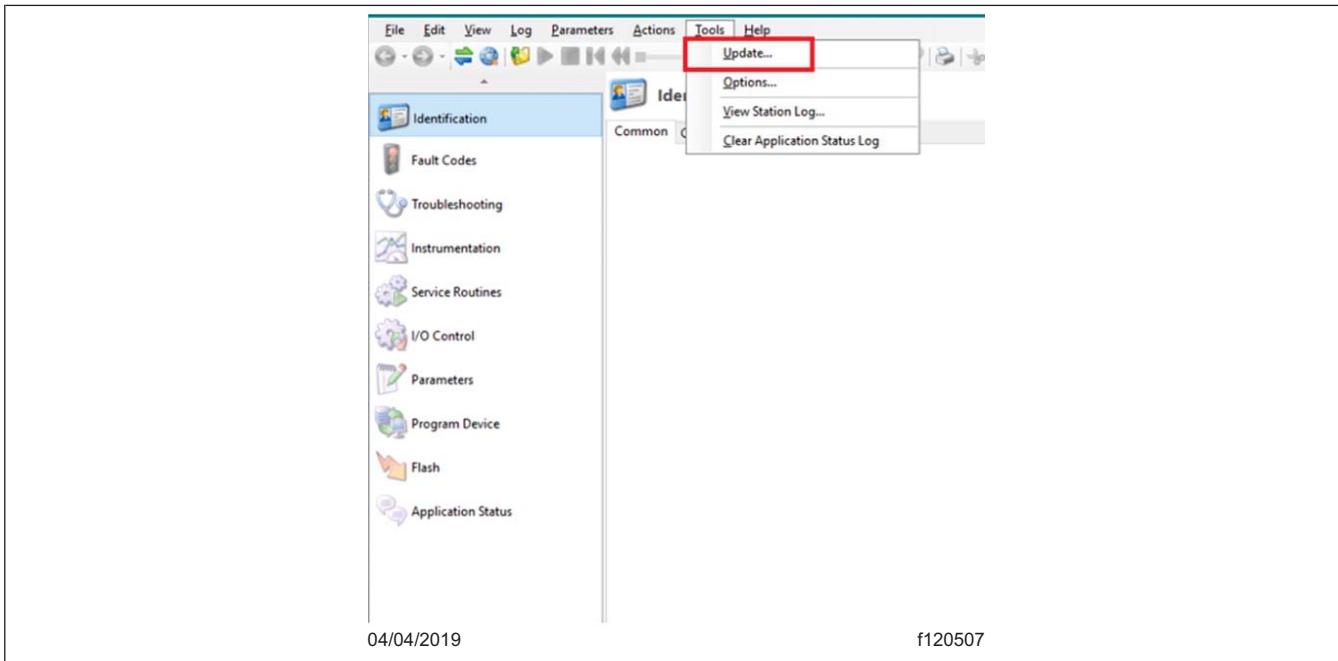
1. Check the base label (Form WAR259) for a completion sticker for SF600 (Form WAR261) indicating this work has been done. If a sticker is present, no work is needed. If there is no sticker, proceed with the programming and replacement.
2. Park the vehicle on a level surface, shut down the engine, and apply the parking brakes. Chock the tires.
3. Connect the vehicle to DiagnosticLink. Make sure that DiagnosticLink is updated to the latest version, 8.11SP4, or newer. To update DiagnosticLink, select "Update" from the dropdown menu under "Tools." See [Fig. 1](#).

Fig. 1, Updating DiagnosticLink to the Latest Version

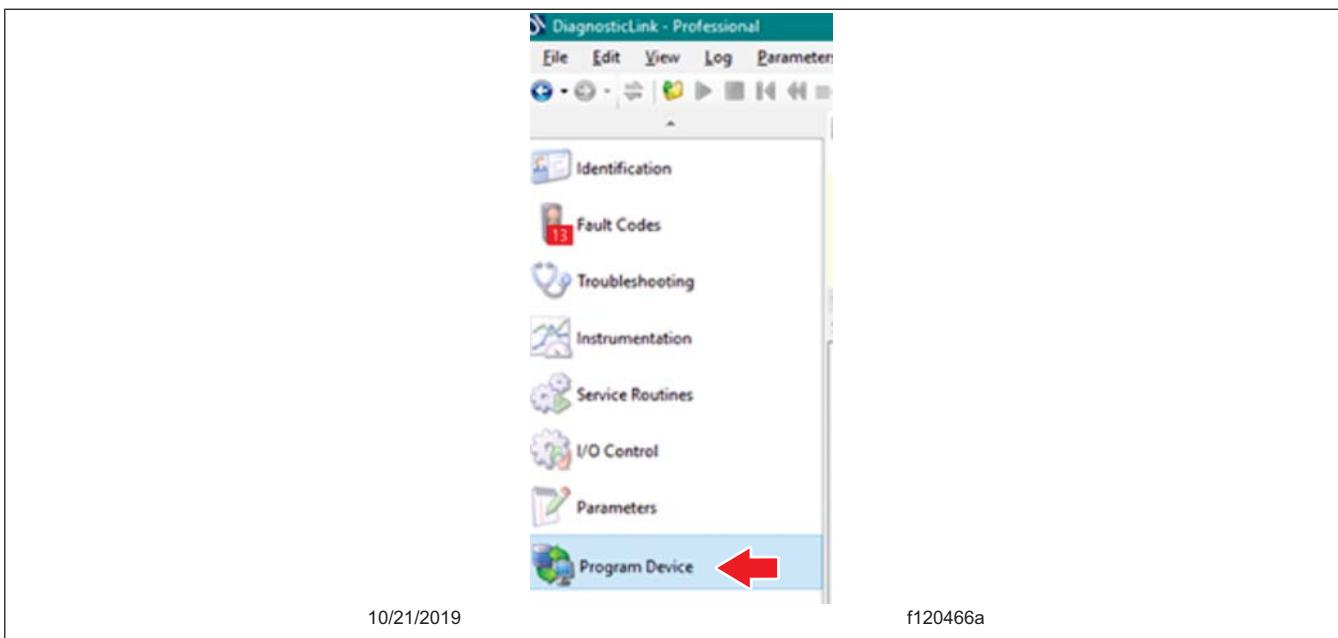
4. Select "Program Device." See **Fig. 2.**

Fig. 2, Program Device Screen

2. Select "Program Device." See [Fig. 2 on page 5](#). If there are any items in the section "Request Pending" downloads, they should be removed. To remove them, select the "Request Pending" list item, then press the "Remove All" button. See [Fig. 3](#) on page 6.
3. Once all controllers are connected, read the vehicle parameters. See [Fig. 17](#).
4. Once all controllers are connected, click the "Parameters" icon on the left hand side of the screen to read the vehicle parameters. See [Fig. 17](#).

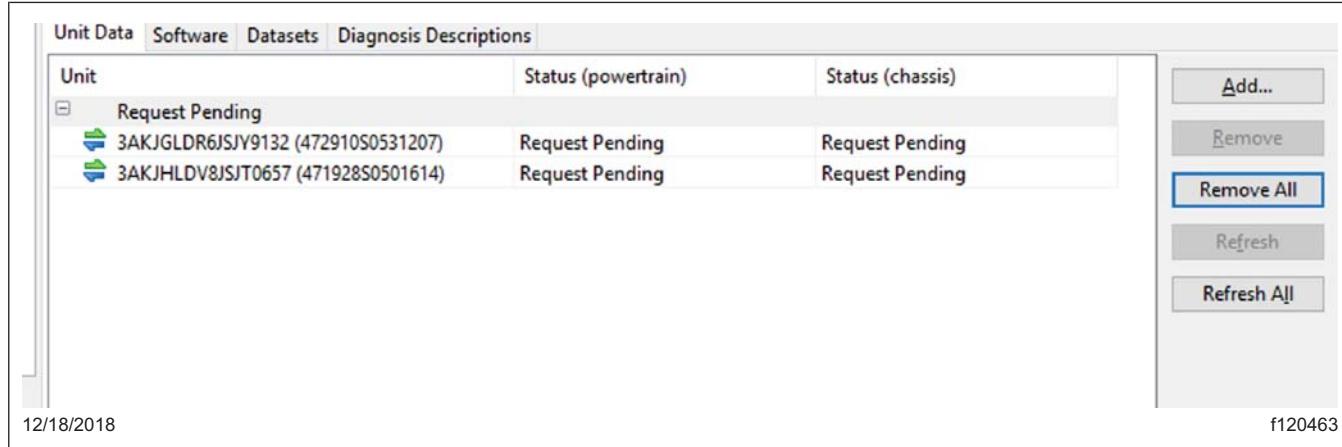
4.1 If there are any items in the section "Request Pending" downloads, they should be removed. To remove them, select the "Request Pending" list item, then press the "Remove All" button. See [Fig. 3](#).

The screenshot shows a software interface for managing vehicle requests. At the top, there are tabs: Unit Data, Software, Datasets, Diagnosis Descriptions, and Diagnosis Descriptions (selected). Below the tabs is a table with three columns: Unit, Status (powertrain), and Status (chassis). The table contains two entries under the 'Request Pending' category. The first entry is '3AKJGLDR6JSY9132 (472910S0531207)' with both status fields 'Request Pending'. The second entry is '3AKJHLDV8JSJT0657 (471928S0501614)' with both status fields 'Request Pending'. To the right of the table is a vertical toolbar with buttons: Add..., Remove, Remove All (which is highlighted in blue), Refresh, and Refresh All. At the bottom left is the date '12/18/2018' and at the bottom right is the identifier 'f120463'.

Fig. 3, Removing Pending Requests

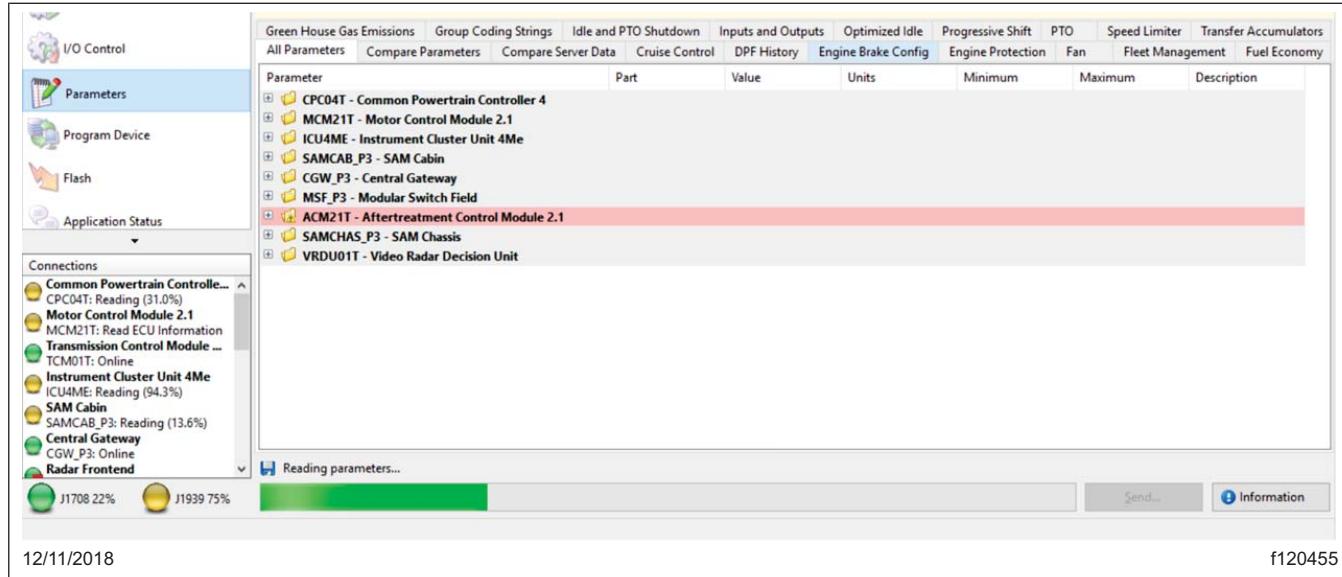
5. Once all controllers are connected, click the "Parameters" icon on the left hand side of the screen to read the vehicle parameters. See [Fig. 4](#).

The screenshot shows the DiagnosticLink software with the 'Parameters' icon selected in the sidebar. The main area displays a list of vehicle modules with their status. A red highlight is applied to the 'ACM21T - Aftertreatment Control Module 2.1' entry. The sidebar also shows 'Connections' and 'Application Status' sections. At the bottom, there are status bars for 'J1708 22%' and 'J1939 75%', and a progress bar labeled 'Reading parameters...'. The bottom right shows the identifier 'f120455'.

Fig. 4, Reading Vehicle Parameters on DiagnosticLink

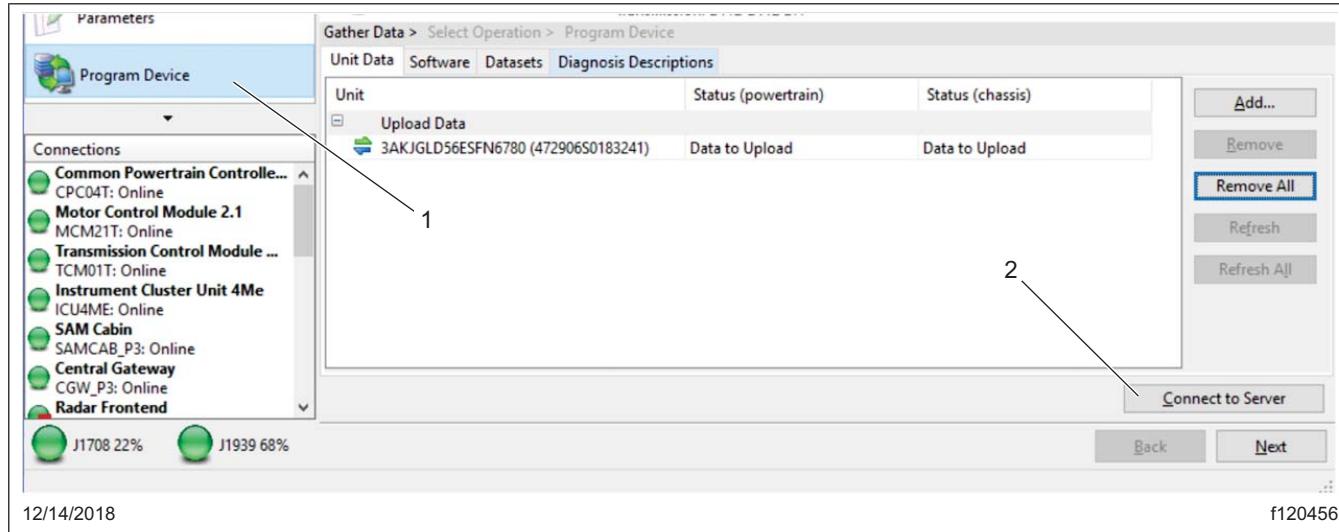
6. Select "Program Device." There should be data to upload. Click "Connect to Server" to upload vehicle parameters to the server. See [Fig. 5](#).

[Fig. 5, Uploading Vehicle Parameters](#)

5. Select "Program Device." There should be data to upload. Click "Connect to Server" to upload vehicle parameters to the server. See [Fig. 5](#) on page 7.

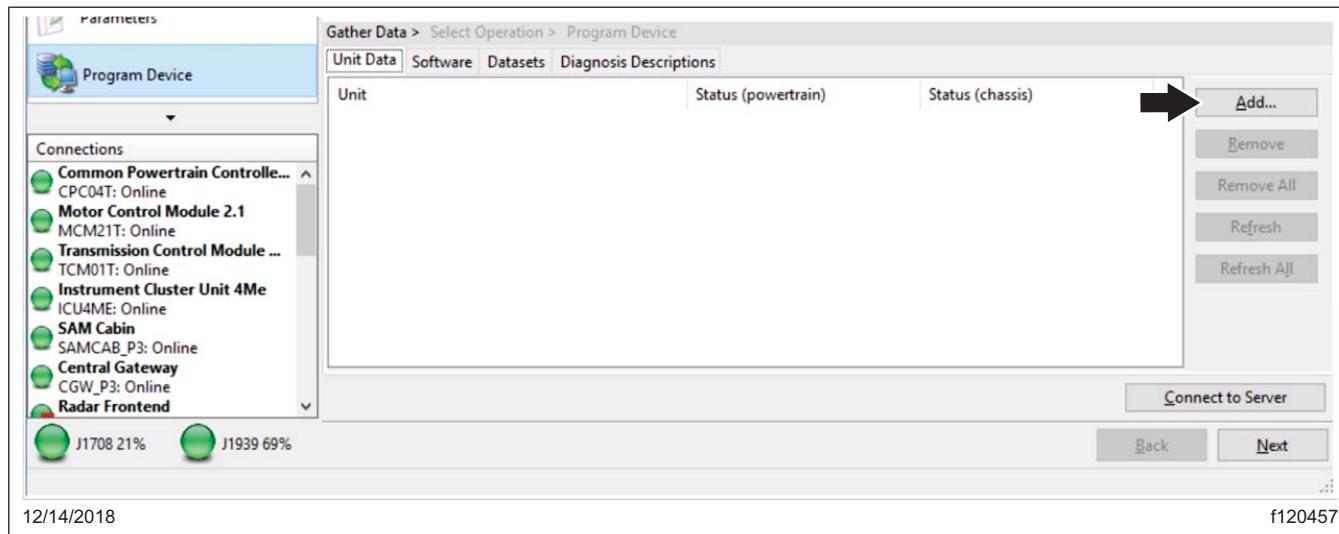
7. Click "Add" to add a download request for the vehicle. See [Fig. 6](#).

[Fig. 6, Adding the VIN to Download Updated Server Data](#)

6. Click "Add" to add a download request for the vehicle. See [Fig. 6](#) on page 7.
7. Make sure the correct VIN and hardware is populated, then click OK. See [Fig. 7](#) on page 8.
8. There should be a request pending status for the VIN. Click "Connect to Server" to download the updated unit data. See [Fig. 8](#). The server will provide any new software available on the server as well as updated parameter sets for the new software, adjusted for the parameter set that was just uploaded from the vehicle.
9. Once the data has been downloaded, click "Next." See [Fig. 9](#) on page 9.

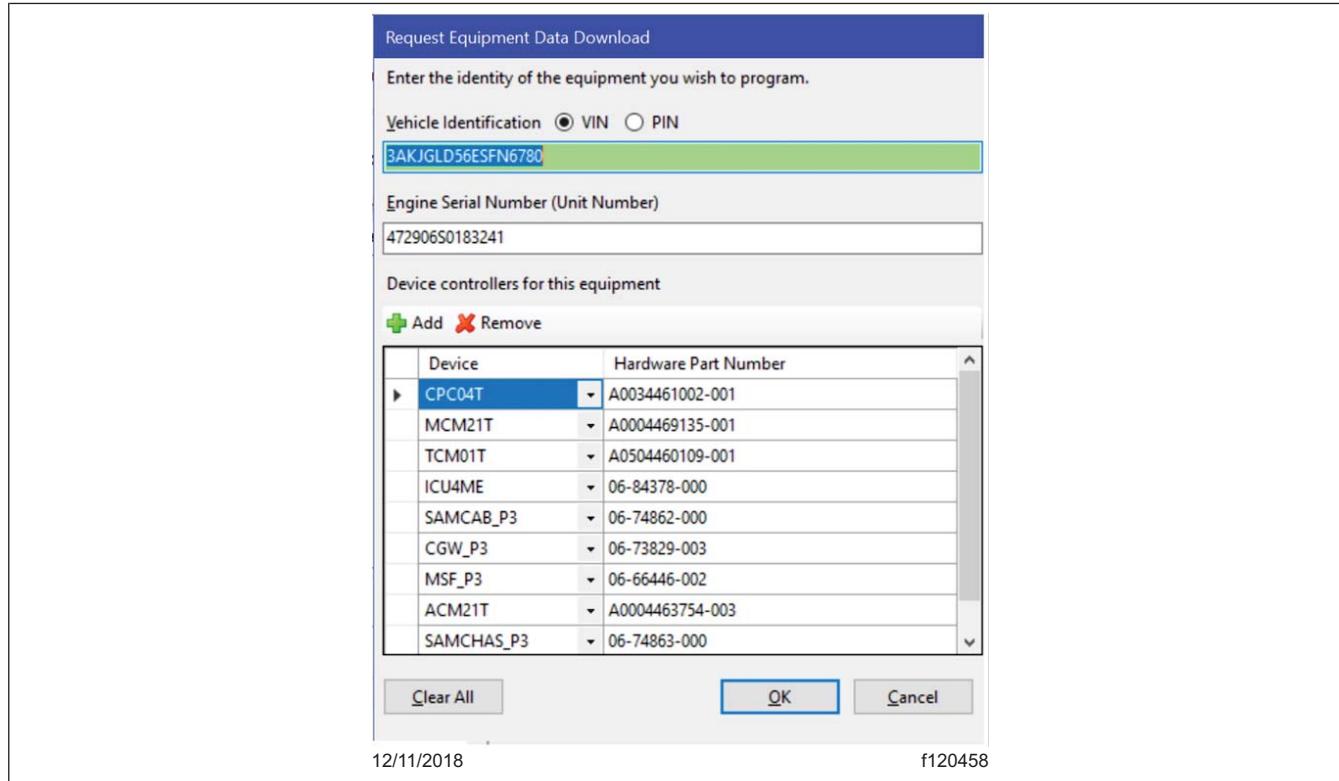
8. Make sure the correct VIN and hardware is populated, then click OK. See [Fig. 7](#).

Fig. 7, Verifying Correct VIN Hardware

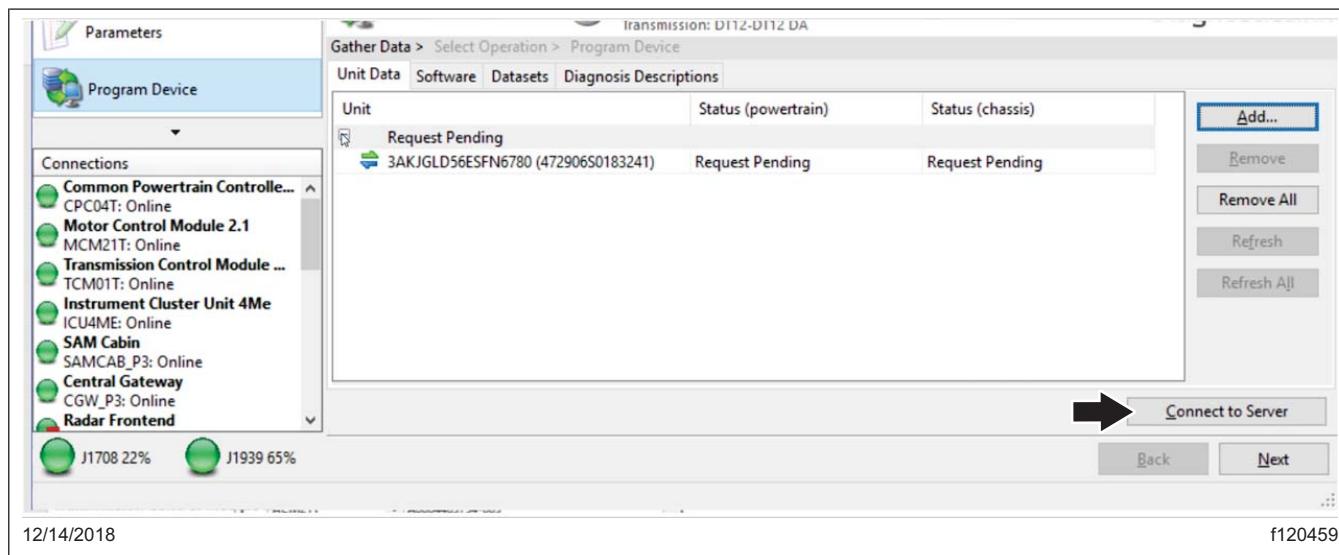
9. There should be a request pending status for the VIN. Click "Connect to Server" to download the updated unit data. See [Fig. 8](#). The server will provide any new software available on the server as well as updated parameter sets for the new software, adjusted for the parameter set that was just uploaded from the vehicle.

Fig. 8, Downloading Updated Unit Data

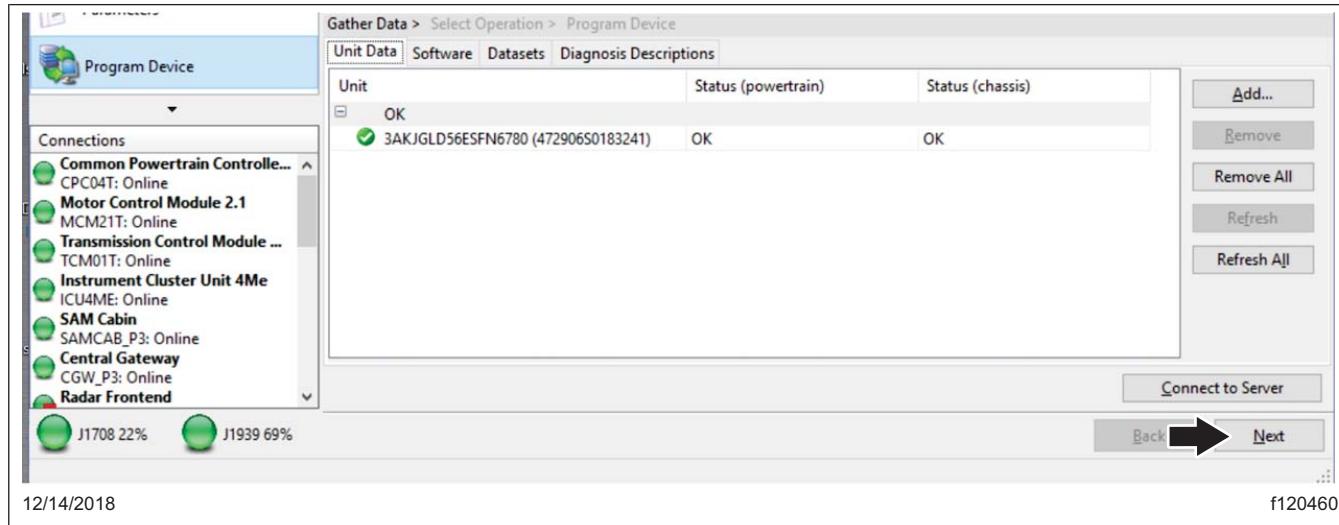
10. Once the data has been downloaded, click "Next." See **Fig. 9.**

Fig. 9, Clicking Next

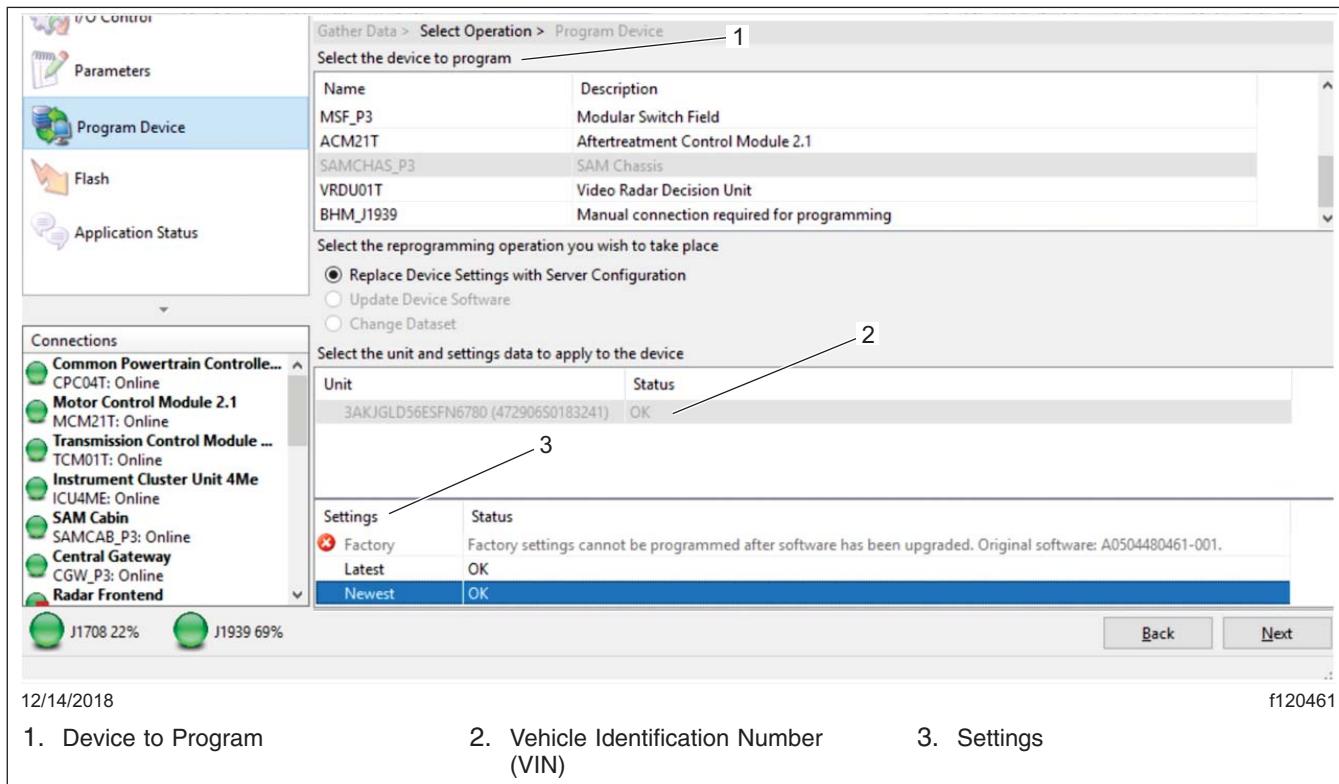
NOTE: "Latest" is the last service record (may be older software), and "Newest" is the most up to date software available for the installed hardware. Both will have parameter sets that have been updated relative to the upload from the vehicle. If the last service record is the most up to date software available, then "Latest" will be the only record visible and there will be no "Newest" record.

11. Select the CGW to program and select the VIN. Then, if a "Newest" record exists, select "Newest." If only a "Latest" record exists, then select "Latest." Click "Next." See **Fig. 10.**

Fig. 10, Selecting "Latest" or "Newest" Software

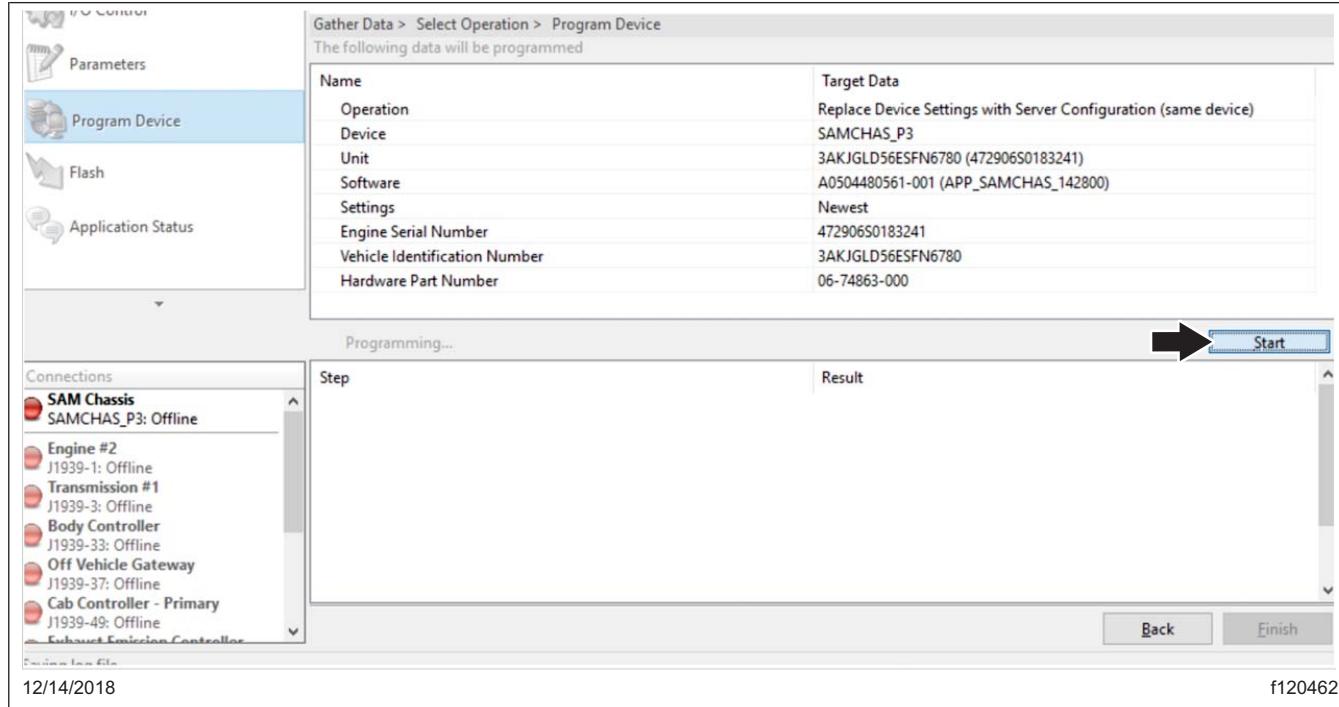
12. Review and verify the VIN and hardware part number. Click "Start" to program the controller. The software will be flashed and the new parameter set will be written to the controller on the vehicle. See [Fig. 11](#).

Fig. 11, Programming the Controller

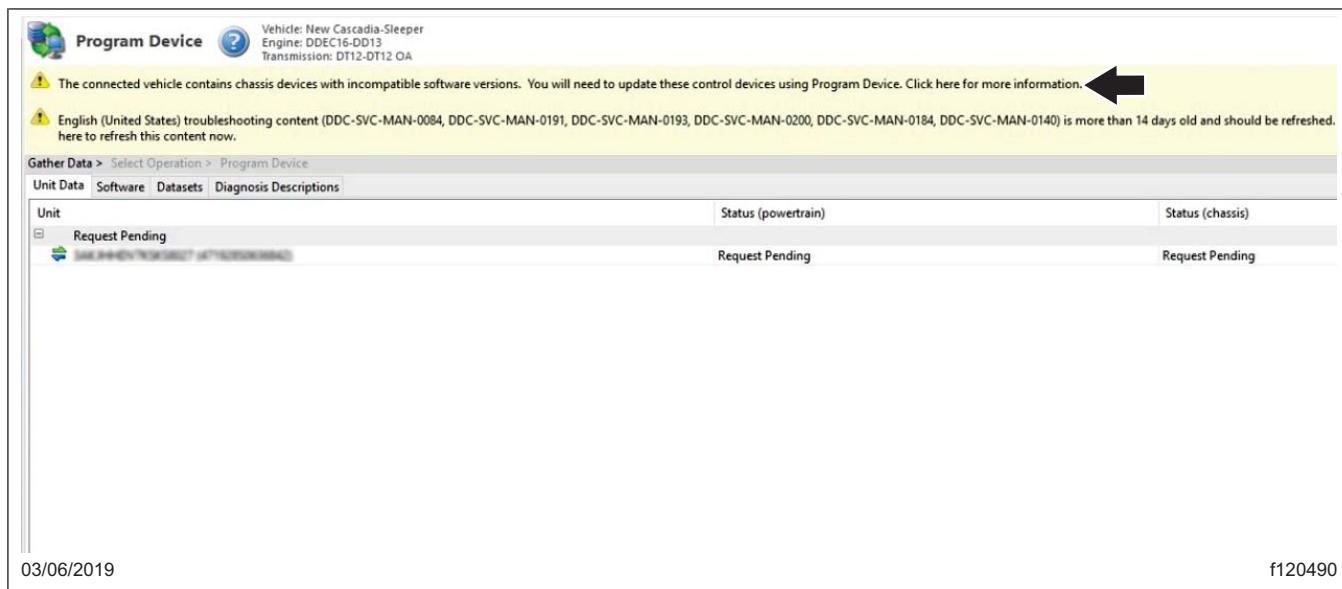
IMPORTANT: After programming is complete, the following message may appear in DiagnosticLink: "The connected vehicle contains chassis devices with incompatible software versions, you will need to update these control devices using Program Device. Click here for more information." If this message is shown, continue with the following substeps. Otherwise, go to the next step.

13.1 Click on the banner message. See [Fig. 12](#).

Fig. 12, Clicking on the Banner Message

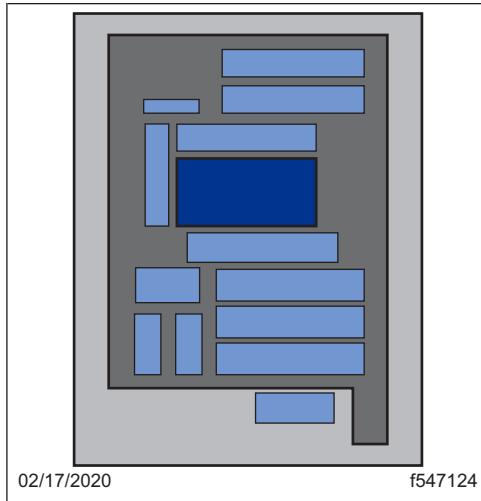
NOTE: The Connect 5 ECU (ICC5) is located below the XMC ECU. See [Fig. 14](#) and [Fig. 15](#).

Fig. 14, ICC5 Electronics Bay Location

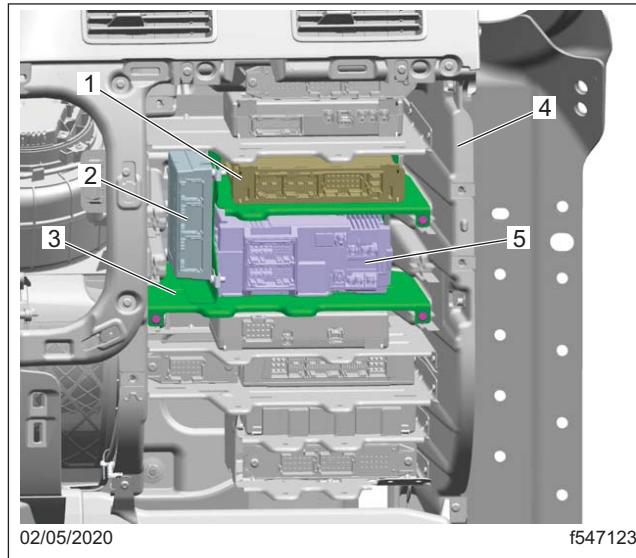
Fig. 15, Electronics Bay

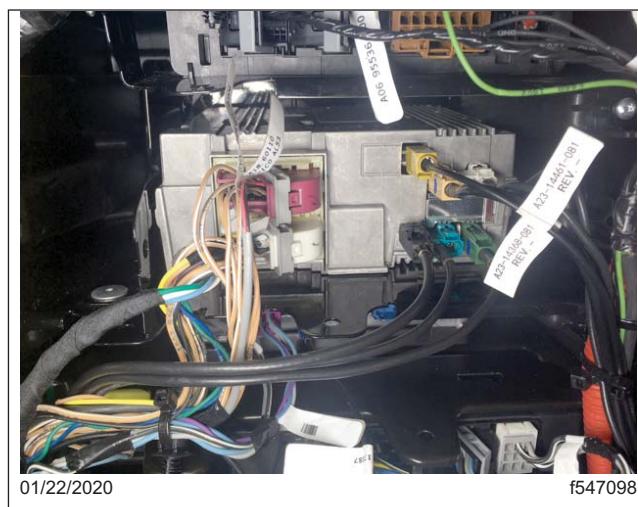
1. Disconnect the vehicle batteries.
2. Remove the electronics bay cover and the passenger-side lower dash cover. Refer to Section 60.06 in the *New Cascadia Workshop Manual* for instructions.
3. Remove the four fasteners that secure the Vehicle Power Distribution Module (VPDM) to the front of the electronics bay, and carefully lay it on the floor. Refer to [Section 54.08, Subject 100](#) in the *New Cascadia Workshop Manual* for instructions.
4. Identify and disconnect the connectors from the Connect 5 ECU (ICC5). See [Fig. 16](#).

Fig. 16, Connectors of Connect 5 ECU

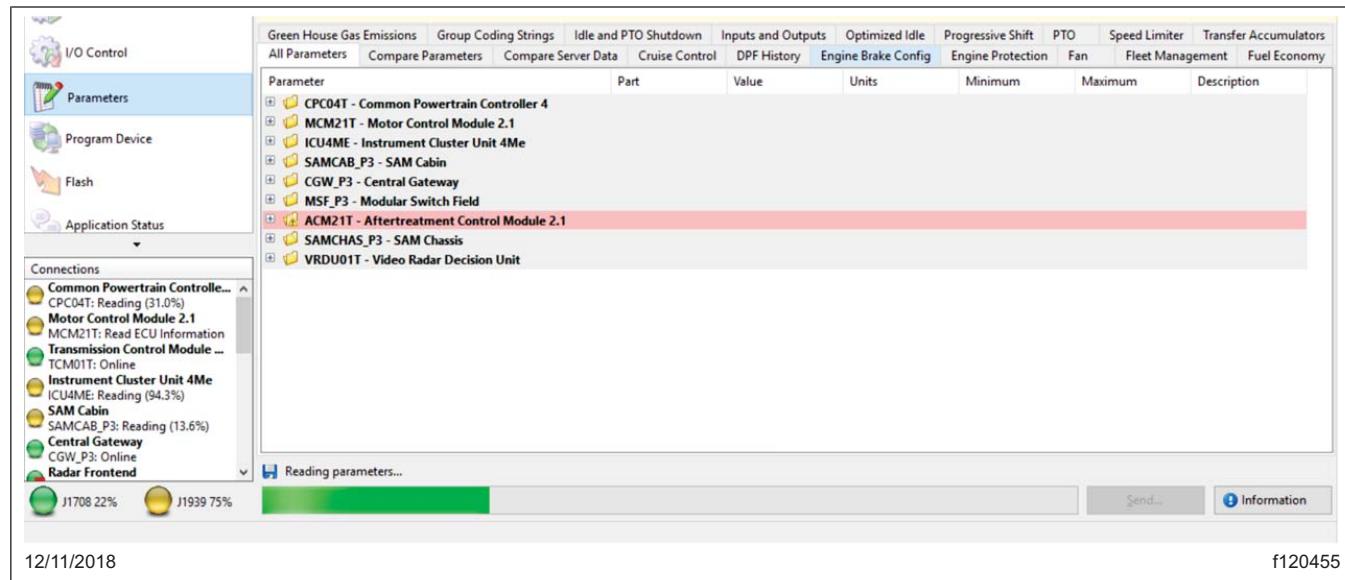
Fig. 17, Reading Vehicle Parameters on DiagnosticLink

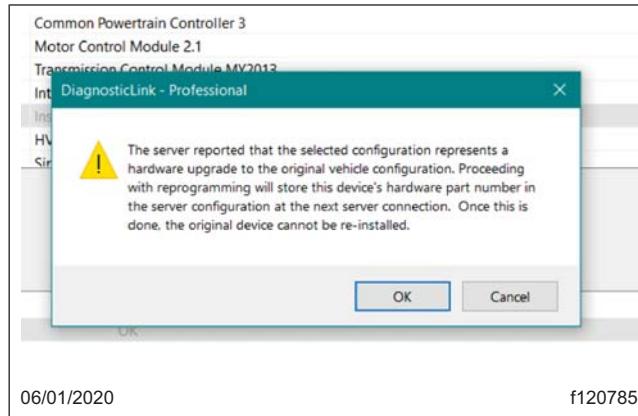
At this point, a warning may appear. See [Fig. 18](#). Click "OK" and continue.

Fig. 18, New Connect 5 ECU (ICC5) Warning

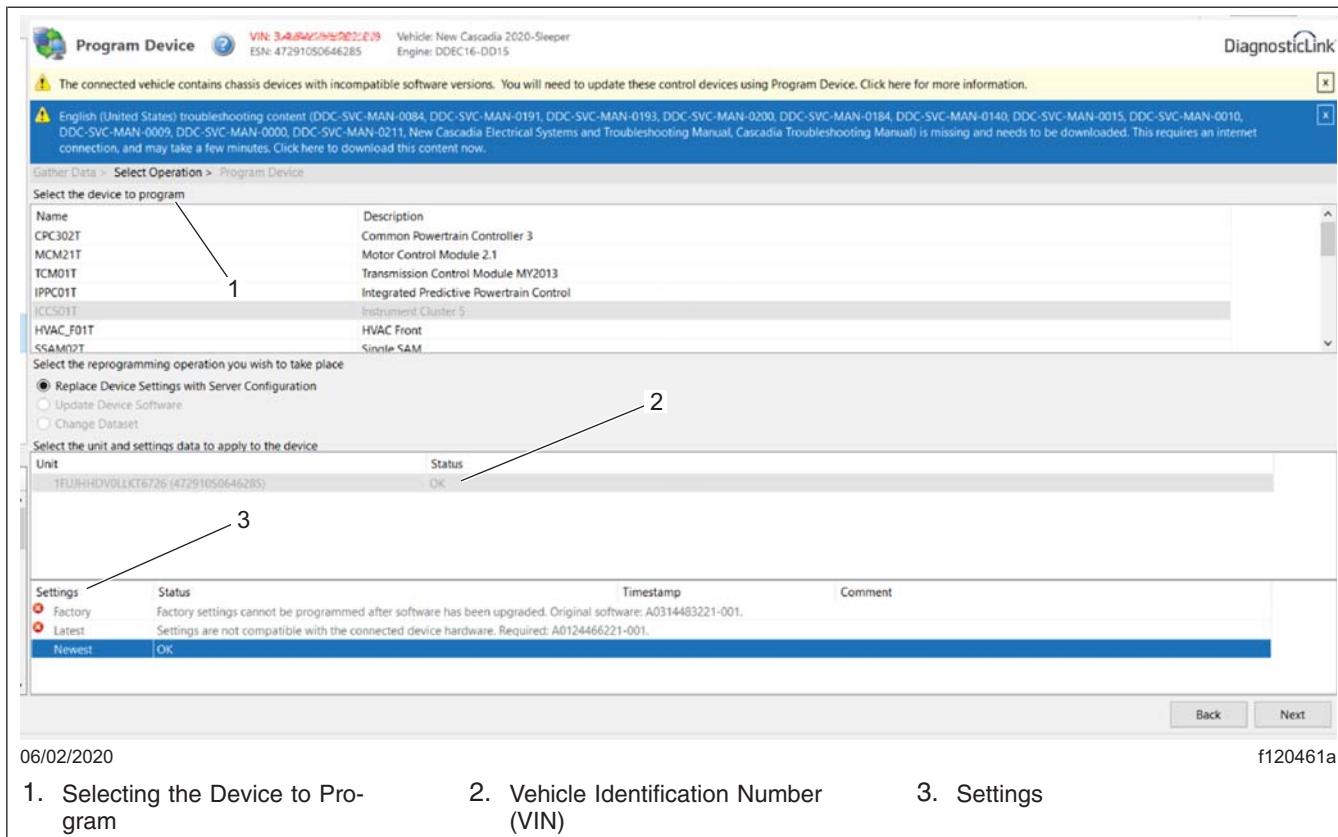
10. Select the CGW to program and select the VIN. Then, if a "Newest" record exists, select "Newest." If only a "Latest" record exists, then select "Latest." Click "Next." See [Fig. 19](#).
11. Review and verify the VIN and hardware part number. Click "Start" to program the controller. The software will be flashed and the new parameter set will be written to the controller on the vehicle. See [Fig. 20](#).

Fig. 19, Selecting "Latest" or "Newest" Software

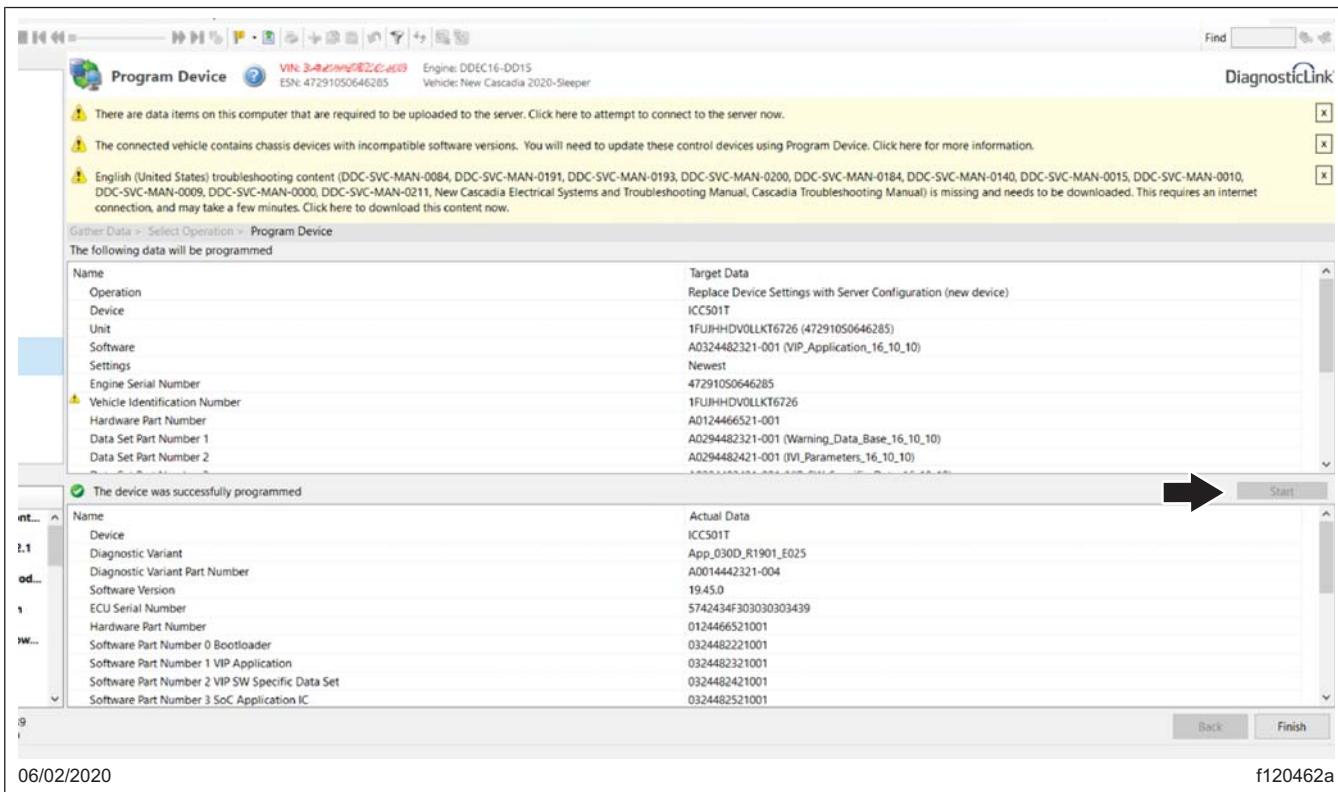
Fig. 20, Programming the ICC5

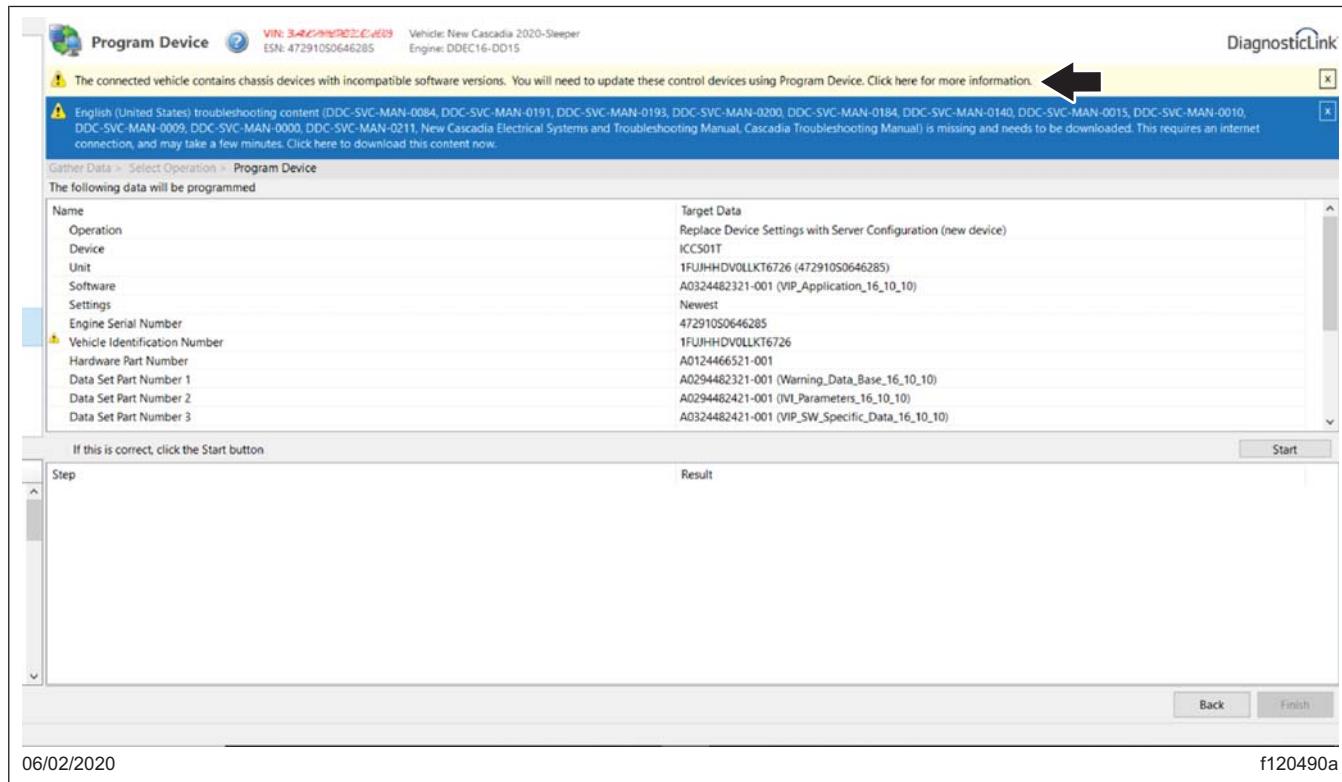
IMPORTANT: After programming is complete, the following message may appear in DiagnosticLink: "The connected vehicle contains chassis devices with incompatible software versions, you will need to update these control devices using Program Device. Click here for more information." If this message is shown, continue with the next step. Otherwise, go to step 15.

- Click on the banner message. See **Fig. 21**.

Fig. 21, Clicking on the Banner Message
