**Subject: GHG17 Detroit™ DD5 Software Reprogramming for Model Year 2020 Thomas Built Bus Applications**

**Models Affected: GHG17 DD5 Engines in C2 School Buses Built from November 2019 to April 2020**

Daimler Trucks North America LLC, on behalf of its DETROIT™ Powertrain Division, is initiating Field Service Campaign D20M7 to modify the vehicles mentioned above.

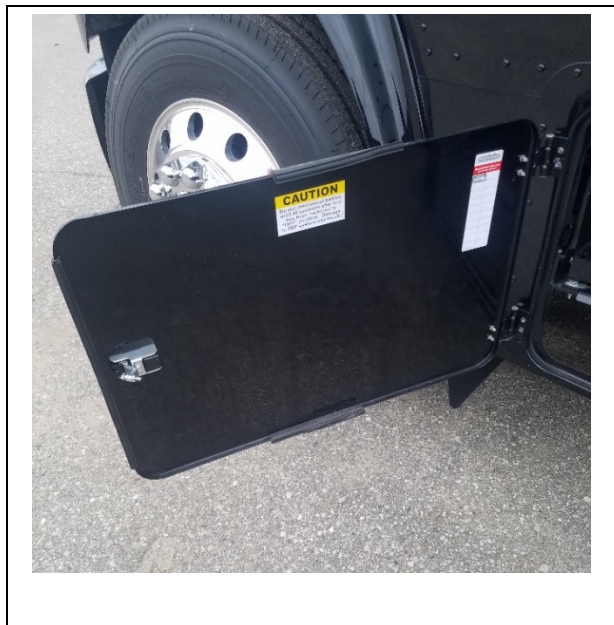
Fig. 1, Completion Sticker Location

Please refer to the attached work instructions. Prior to performing the campaign, check the vehicle for a completion sticker (Form WAR261). In this application the base label is usually located on the inside of the battery compartment door. If Field Service Campaign D20M7 has been completed, no further work is needed. If base label is not located on the inside of the battery compartment door, please affix the label (Form WAR259). Refer to figures 1 and 2.

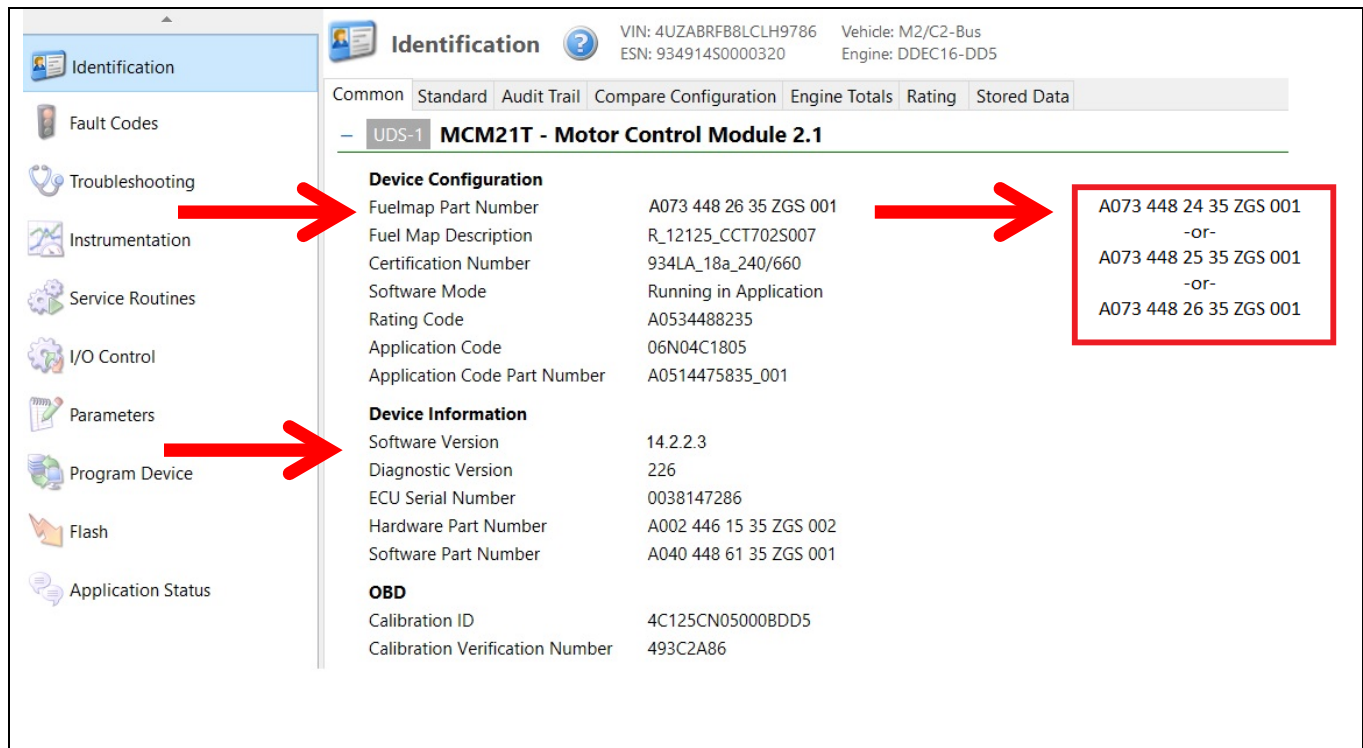
Fig. 3, DiagnosticLink® Identification Screen

4. On the Identification screen, check the current MCM software level. Listed below are the software levels and fuel map part numbers required. See Figure 3 for an example of the Identification screen.
  - a. MCM software **14.2.2.3** with fuel map part number:
    - 200 hp rating A0734482435 ZGS 001
    - 220 hp rating A0734482535 ZGS 001
    - 240 hp rating A0734482635 ZGS 001

5. Is the **Fuelmap Part Number** for the **MCM** equal to the requirements listed in step 4?
  - a. If Yes, no programming is necessary. Proceed to step 11.
  - b. If No, proceed to step 6 for programming instructions.
6. Select the "Program Device" option along the left side of the DiagnosticLink® screen.

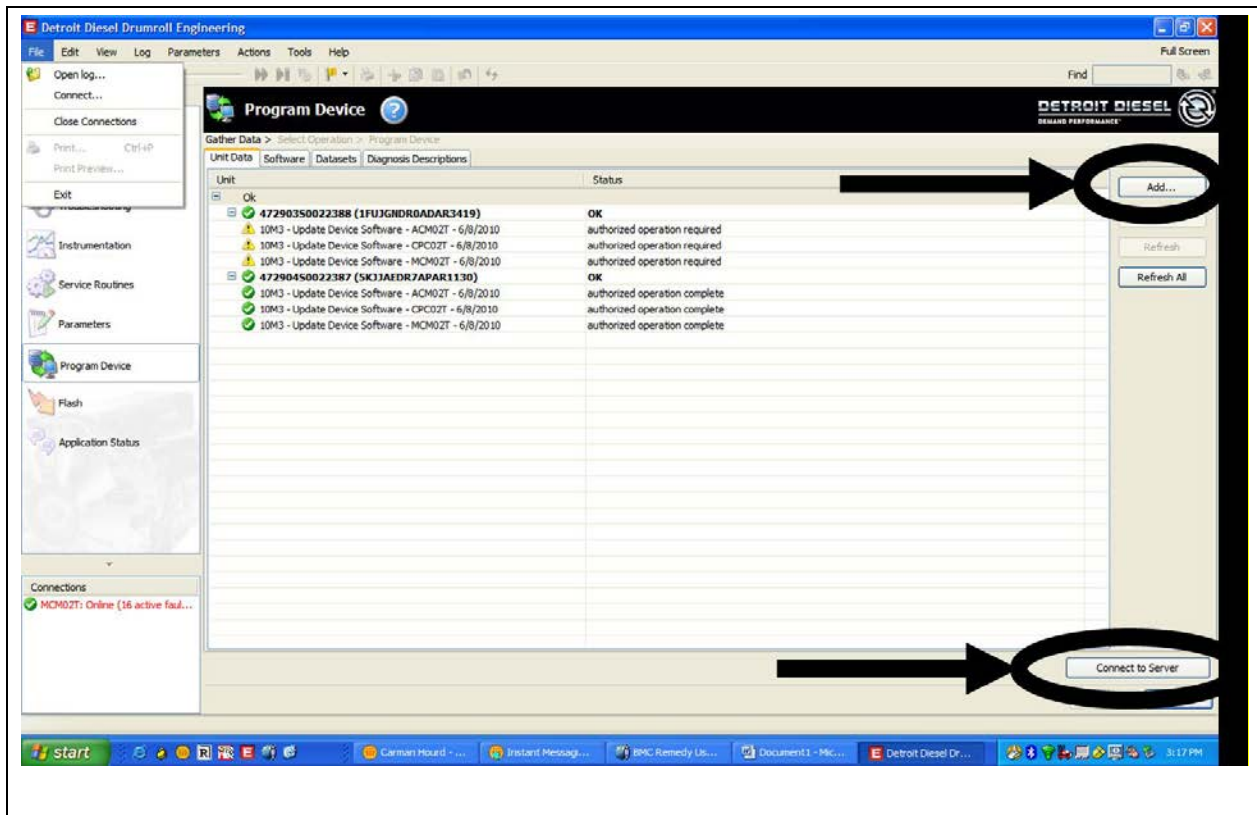
Fig. 4, Adding Engine Serial Number and Connecting to Server

7. Select the “Add” button in the upper right corner of the DiagnosticLink® screen and enter the engine serial number. Then click the “Connect to Server” button in the bottom right corner of the DiagnosticLink® screen. See Figure 4.

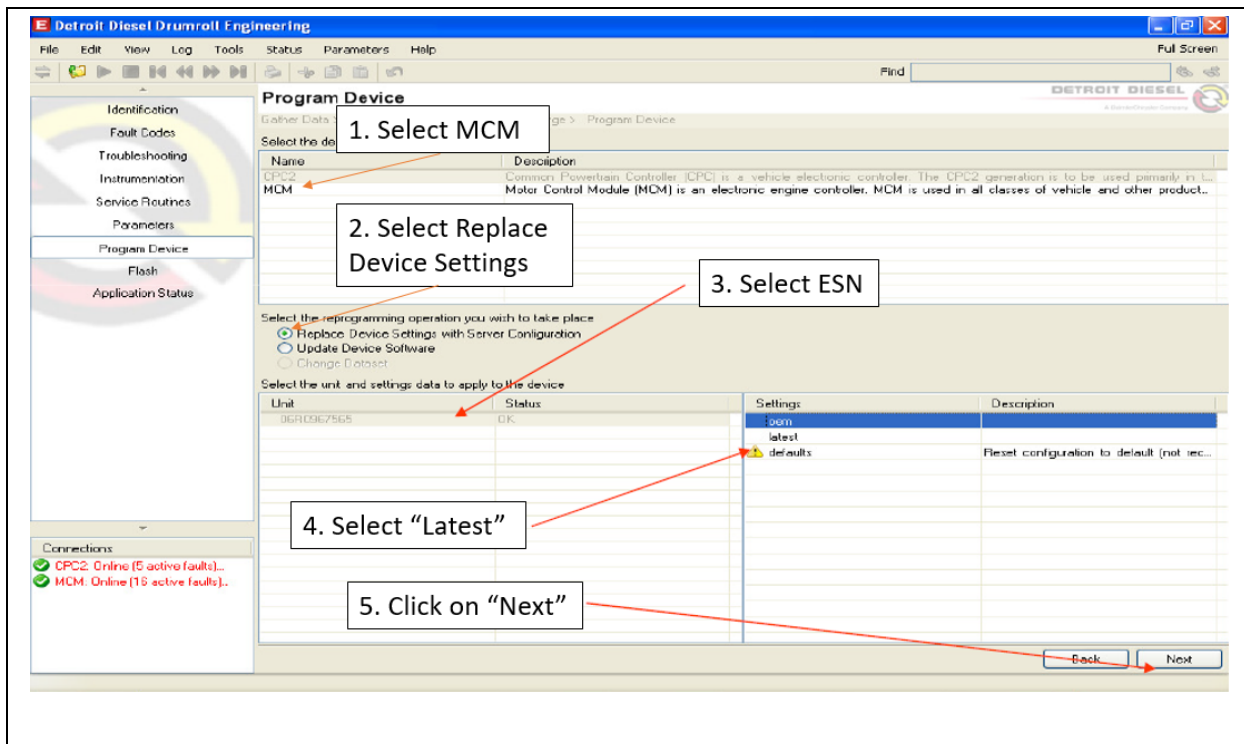
Fig. 5, Replace Device Settings

9. Replace Device Settings with **Latest** server settings on the **MCM** and verify that the fuel map part number meets the requirements listed in step 4.

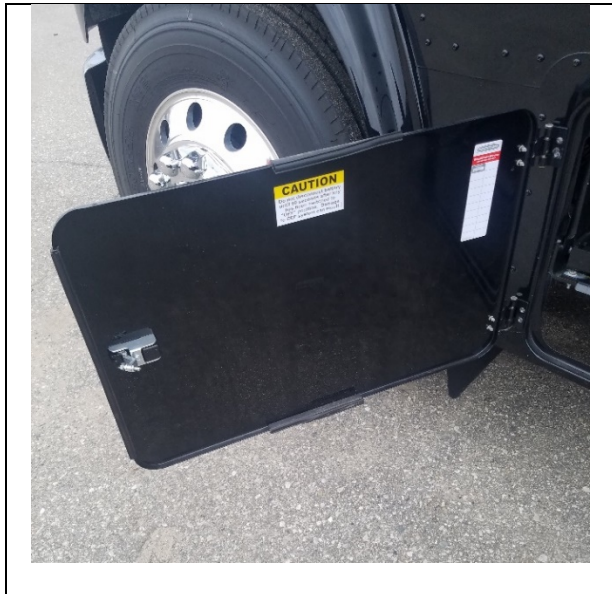
Fig. 7, Completion Sticker Location

- Upon completion of Field Service Campaign D20M7, clean a spot on the base label (Form WAR259), write the Field Service Campaign Number D20M7 on a blank, completion sticker (Form WAR261).
- Label ordering info: [DTNACconnect](#) > Services and Reference > Publications & Warranty Supplies > Warranty
