NUMBER
PI1803Y/Z (Rev 2, 06/09/2020)

PRODUCT IMPROVEMENT CAMPAIGN

**SUBJECT: ENGINE REPLACEMENT INSTRUCTIONS
FOR DTC P1326 (PI1803Y/Z)**

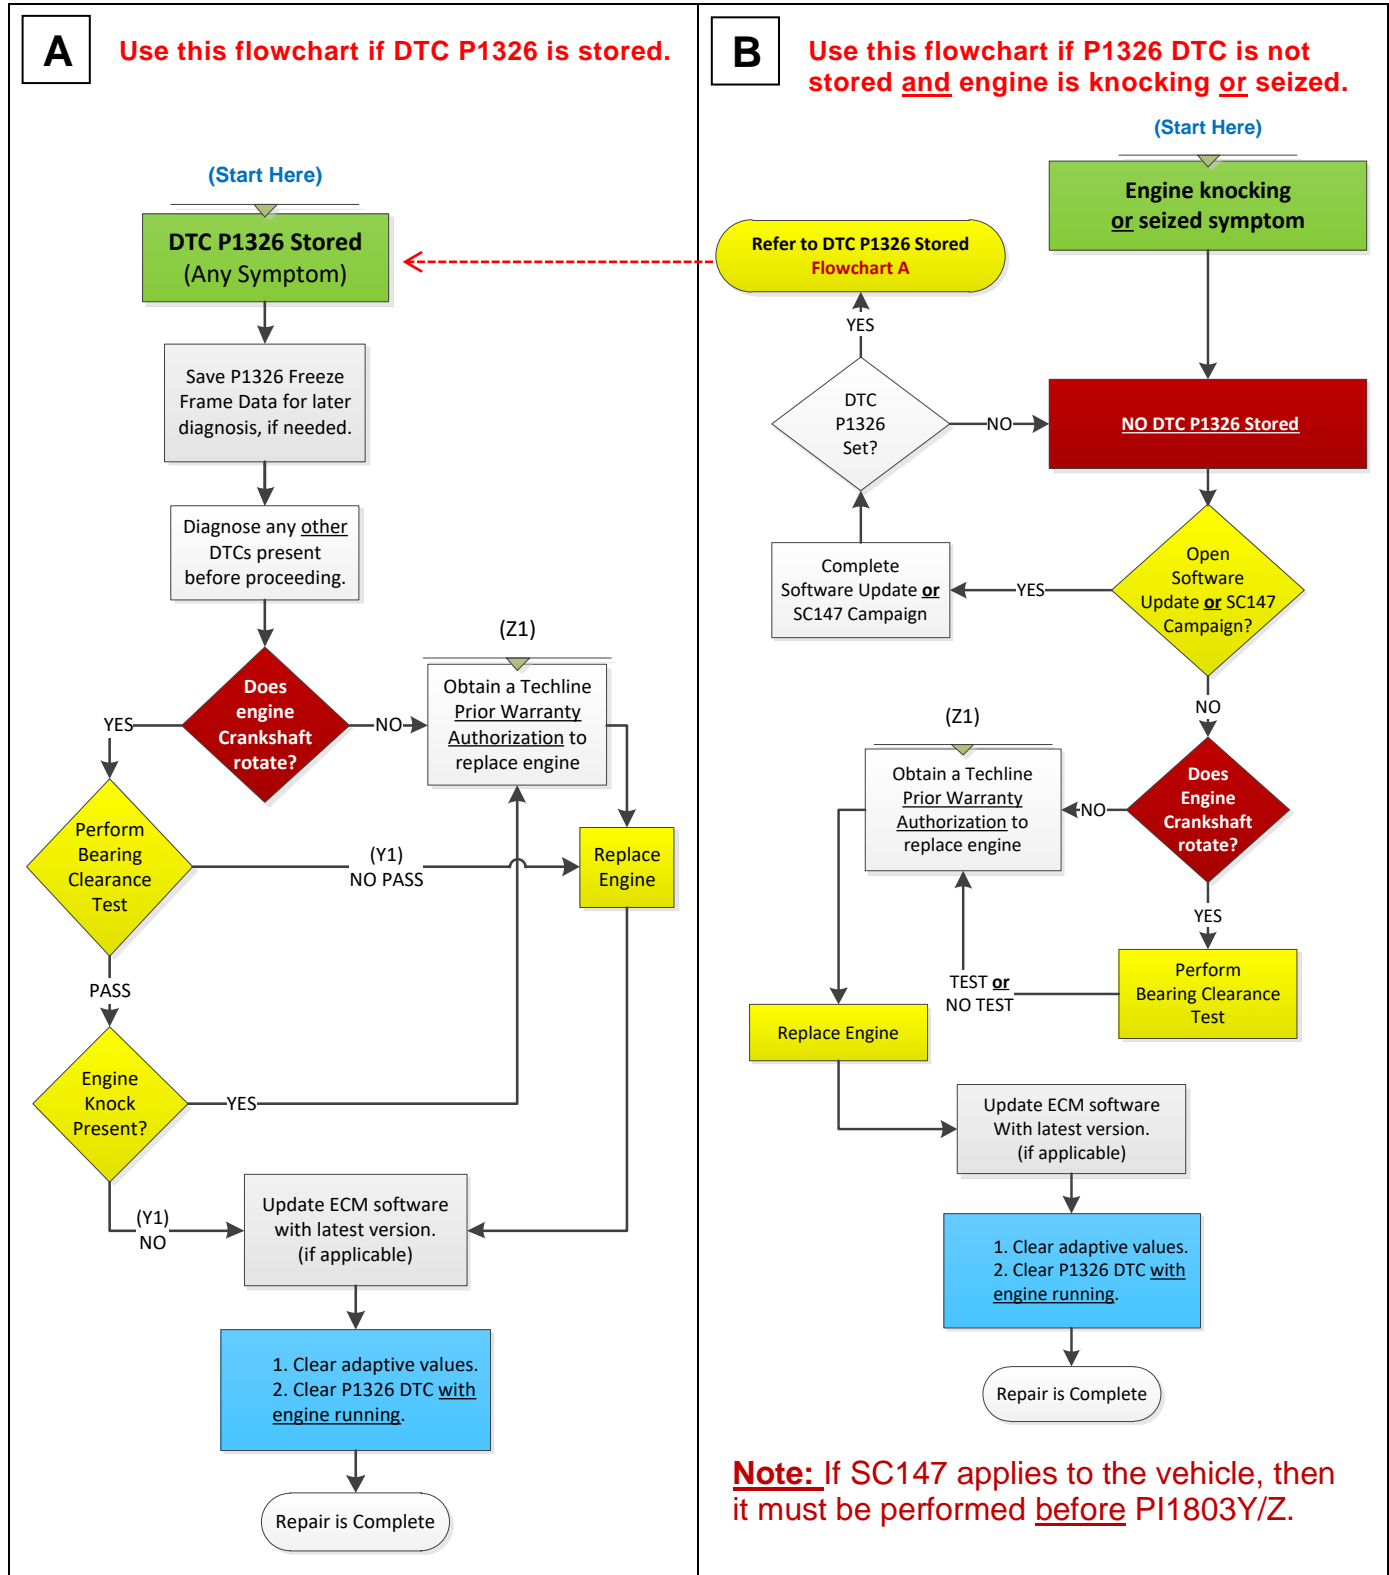
Flowcharts:

Choose the applicable flowchart based on the initial inspection and required DTC scan with VDN record:

- **Scenario 1** – Vehicle is in with DTC P1326 stored (A).
- **Scenario 2** – Vehicles is in with no DTC P1326 stored but engine is knocking or seized (B).
- **Scenario 3** – Vehicle is in with DTC P1326 stored and also engine is making noise or seized (A).

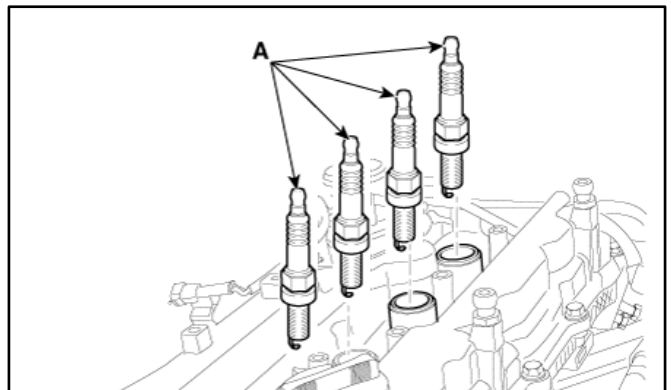
2. Remove the four (4) spark plugs (A) by referring to the “Maintenance → Power Train → Spark Plug → Repair procedures (Replacement)” in the applicable Shop Manual on KGIS.

Tightening torque for Spark Plugs:
10.9 – 18.0 lb.ft (14.7 – 24.5 N.m,
1.5 – 2.5 kgf.m)

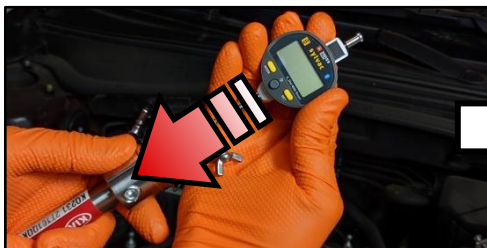
- 7. Install the Dial Gauge fully into the Probe Rod and secure together by hand tightening the locking wingnut.

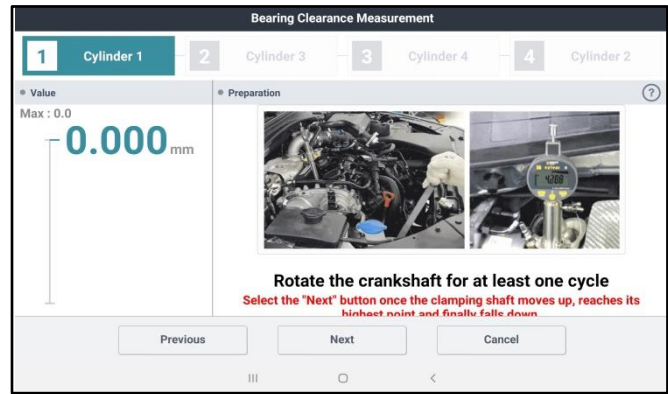
13. Insert the SST Crankshaft Rotator and turn the crankshaft clockwise as instructed on the KDS screen.

Removal of inner wheel liner and the use of general tools may be required to access and rotate the crank bolt on some 2.0L T-GDI engine models.

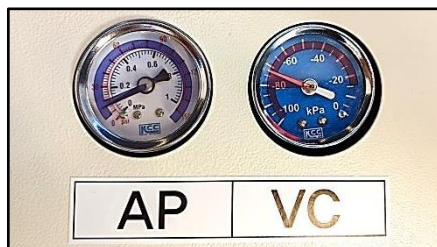
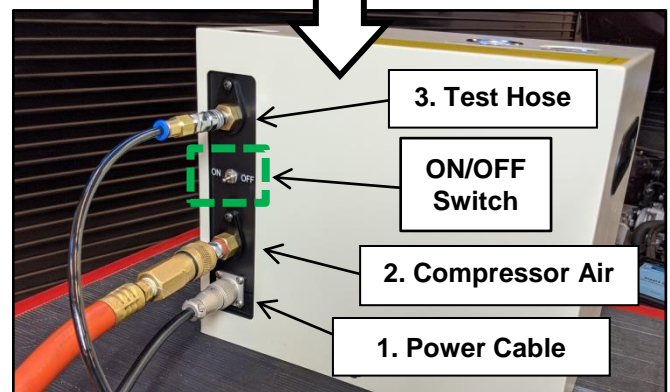
18. Turn the Bearing Clearance Tester power switch to the 'ON' position. Gauges should read as follow:

AP (Pressure) Gauge: (0.1 ~ .011MPa)
VC (Vacuum) Gauge: (-73 ~ -83kPa)

If the gauges do not read within specification, calibration of the SST box is required. Refer to [TSB SST067](#) for details.

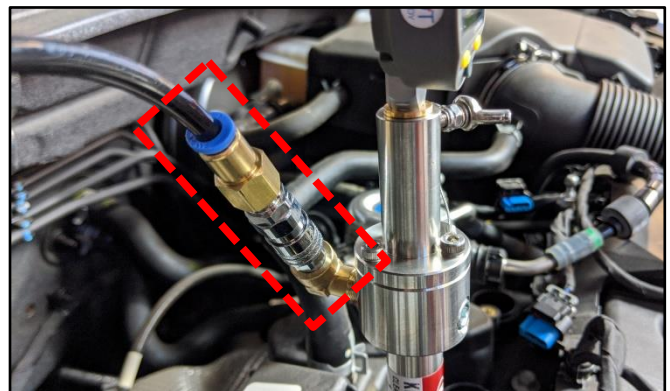
19. Carefully, insert and connect the other end of the Test Hose to the Probe Rod fitting.

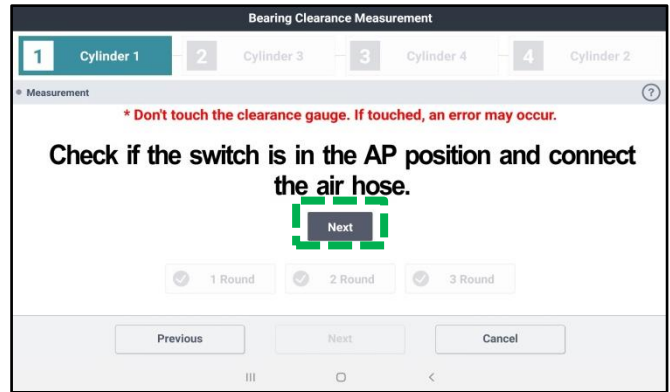
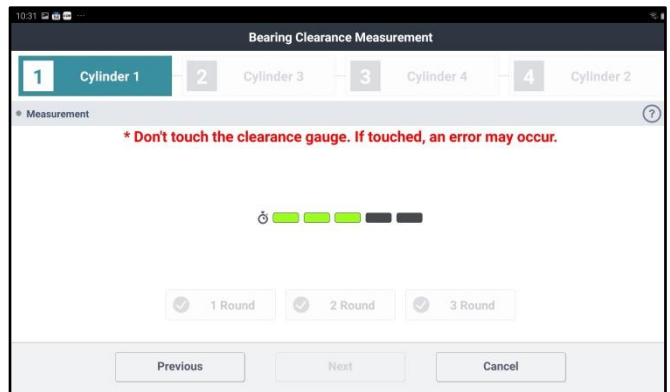
21. Locate the 'AP/VC' switch on top of the Bearing Clearance Tester Box and switch it to the 'AP' position. Select 'Next' to begin **Cylinder 1** bearing clearance test.

*** NOTICE**
 The toggle switch has a 3-way operation. The center is neutral. Always toggle past neutral.

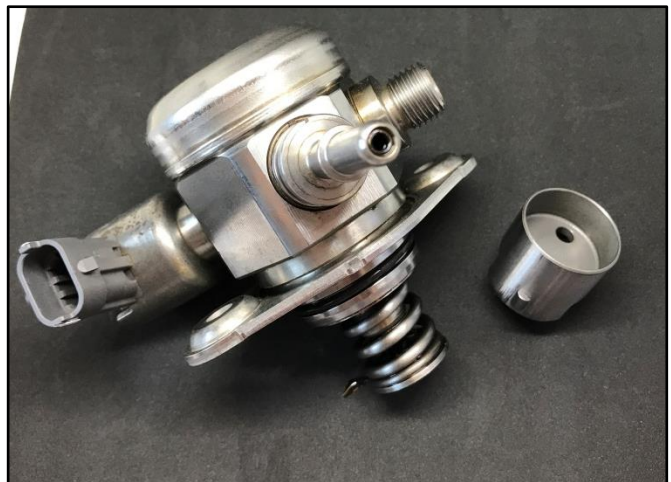
High Pressure Pump & Roller Tappet:

Tightening torques of pump bolts:
9.4 – 10.9 lb.ft (12.8 – 14.7 N.m,
1.3 – 1.5 kgf.m)

Tightening torques of pipe flare nut:
19.5 – 23.9 lb.ft (26.5 – 32.4 N.m,
2.7 – 3.3 kgf.m)

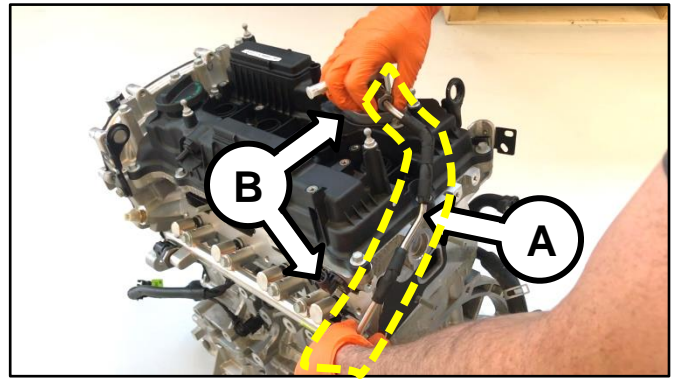
High Pressure Fuel Pipe:

1. Properly position the new fuel pipe (A) and then hand-tighten both flare nuts (B).

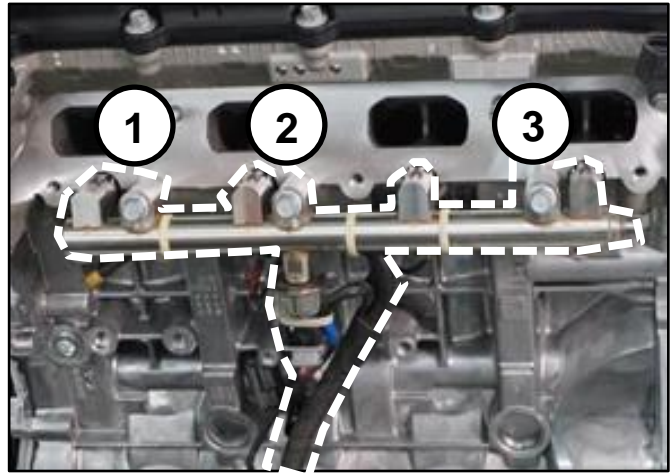
Delivery Pipe:

- Refer to [TSB ENG083](#) for special attention and handling procedures of GDI-specific components.
- Prior to installing the delivery pipe, be sure to replace all of the injector O-rings and injector retainers.
- Prior to installing the delivery pipe, apply engine oil to the injector O-rings.
- When installing the delivery pipe, use caution not to damage the tip of the injector.
- Be sure to replace the delivery pipe retaining bolts and torque them in the sequence shown.

**Tightening torque of bolts:**

**13.7 – 17.4 lb.ft (18.6 – 23.5 N.m,
1.9 – 2.4 kgf.m)**

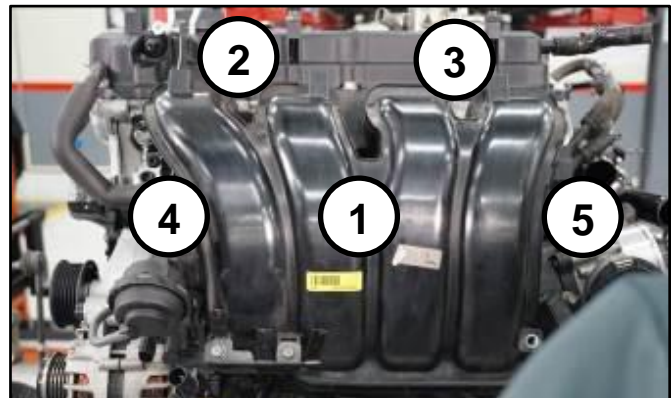
- Prior to installation, replace the intake manifold gaskets.
- Torque bolts in the sequence shown.

Tightening torque of bolts:

**13.7 – 17.4 lb.ft (18.6 – 23.5 N.m,
1.9 – 2.4 kgf.m)**

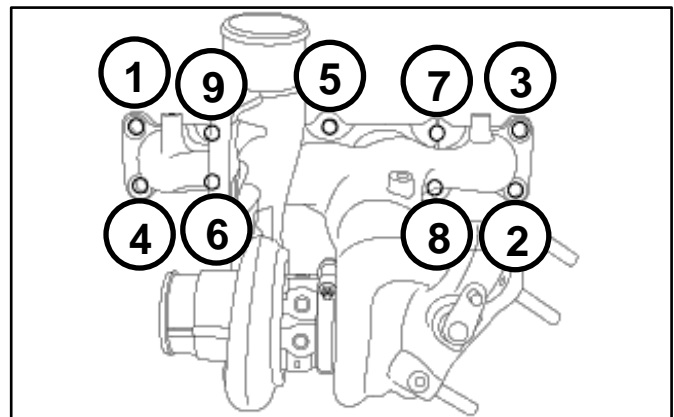
- Torque exhaust manifold nuts in the sequence shown.

Tightening torque of nuts:
 36.2 – 39.7 lb.ft (49.0 – 53.9 N.m,
 5.0 – 5.5 kgf.m)

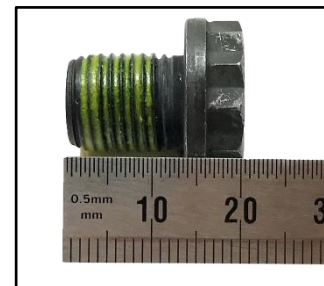
- Replace all seven (7) drive plate (AT) bolts.

Tightening torque of nuts:

**86.8 – 93.9 lb.ft (117.7 – 125.5 N.m,
12.0 – 13.0 kgf.m)**

Drive Plate Bolt (A/T)

Torque Converter
