| | | GROUP<br>BODY ELECTRICAL | NUMBER<br>20-BE-008H | |
| | <b>HYUNDAI</b><br>ical Service Bulletin | June 2020 | MODEL(S)<br>SONATA (LF), GENESIS<br>(DH), TUCSON (TL),<br>ELANTRA GT (GD),<br>SANTA FE SPORT (AN),<br>SANTA FE (NC), AZERA<br>(HG), VELOSTER (FS),<br>SONATA HYBRID (LF<br>HEV), SONATA PLUG-IN<br>HYBRID (LF PHEV) | |
| SUBJECT: | APPLE CARPLAY & ANDROID AUTO SOFTWARE UPDATE | | | |

**DESCRIPTION:** This bulletin provides information for new software to update the Navigation and Display Audio system to include the Apple CarPlay and Android Auto feature.

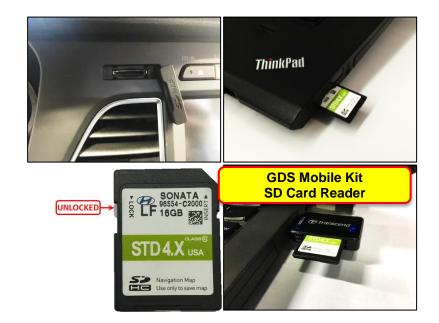
Ensure the SD card is unlocked (not write-protected). The lock slider should be in the up position.

Delete all content in the SD Map card. 3.

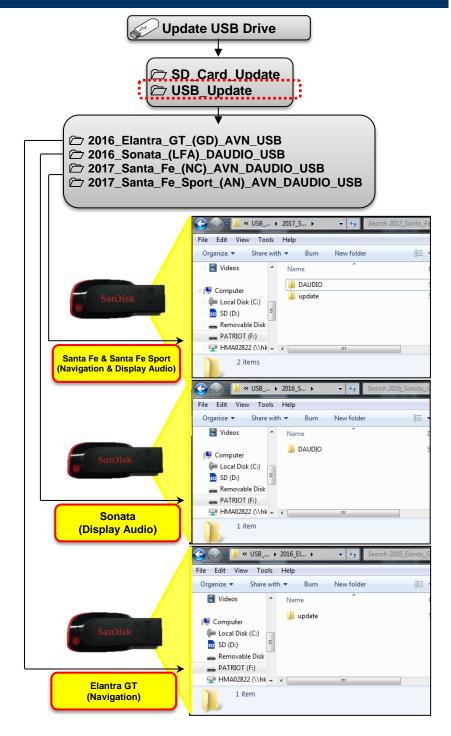
- 8. In the Update USB Drive, open the USB\_Update folder.
- 9. In the USB\_Update folder, open the appropriate ModelYear\_Model\_HeadUnitType folder.
- 10. Copy and paste the file(s) into the root directory of the empty 4GB USB Drive as shown for the respective model.

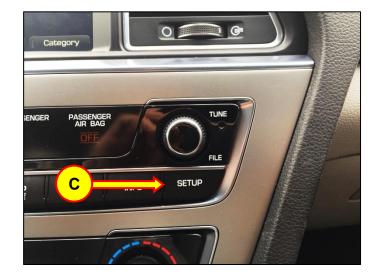
3. Press the Setup (C) button to enter the Setup menu.

The below pop-up messages may appear if the SD card was updated. Continue through steps 3-6 to initiate the software update.

- 'Navigation is currently unavailable. Please check the SD card.' Or
- 'Failed to authenticate navigation.' pop-up message may appear if the SD card was updated.

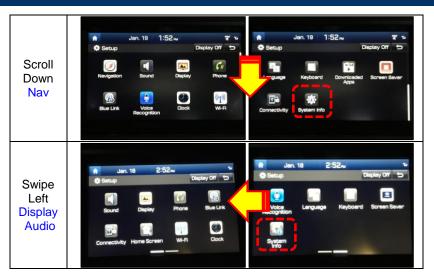
4. Scroll down or swipe left in the Setup menu then touch the "System Info" icon.

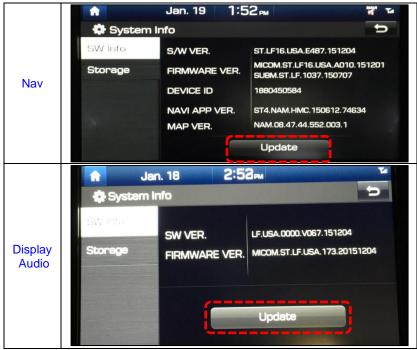
5. Touch the "Update" icon at the bottom of the screen to proceed with the software update.

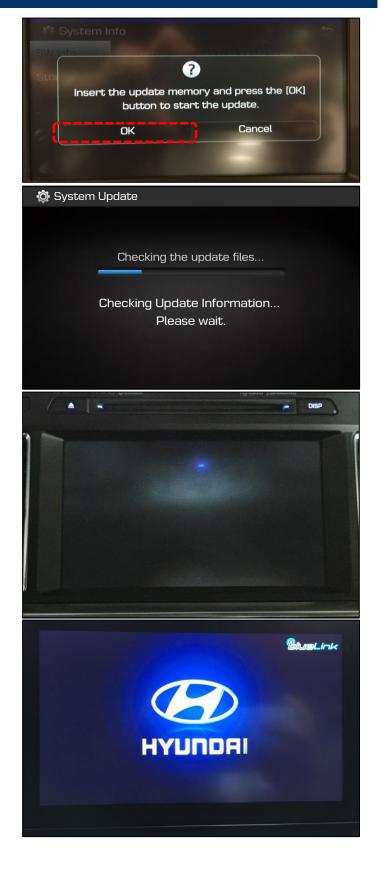
6. Touch the "OK" icon.

The software will automatically update through 6 steps:

It will take approximately 20-40 minutes to complete the update process.

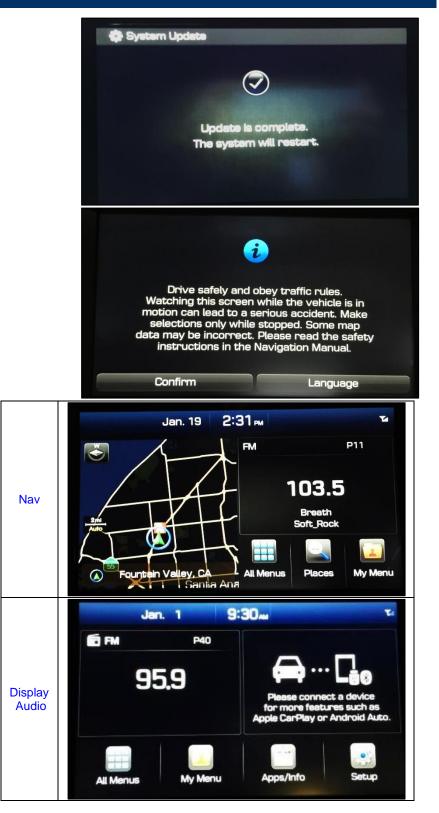
7. The system will reboot automatically after the "Update is complete" message appears.

The software update is completed after the system reboots and the Disclaimer or the Home screen is displayed.

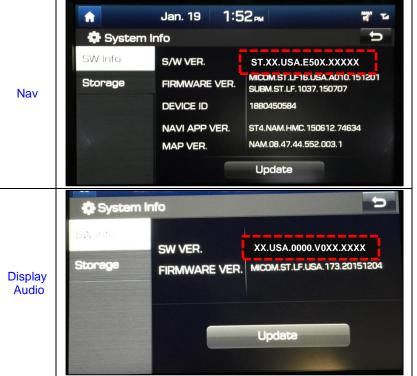
8. Confirm the software version for the model using steps 3-4 and the table listed below.

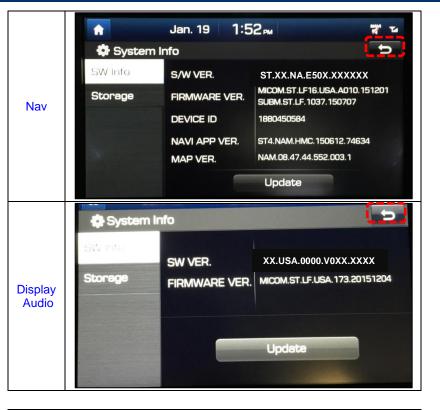
9. Touch the '⊃' (Back) icon at the upper right corner of the screen to access the Connectivity settings screen.

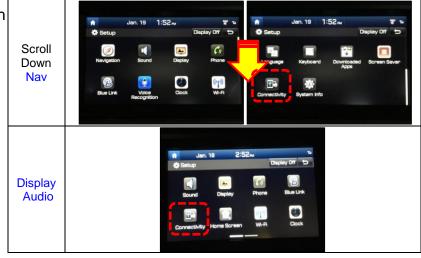
Confirm the Connectivity settings for both Android Auto and Apple CarPlay (iOS) are set to ON (Enabled).
