# AfterSales TSO – Circular Letter

## MAS002199

## New ETM Software Volta 6 – Troubleshooting guides

**MODELS: Levante, Quattroporte and Ghibli Model Years 17, 18, 19 and 20**

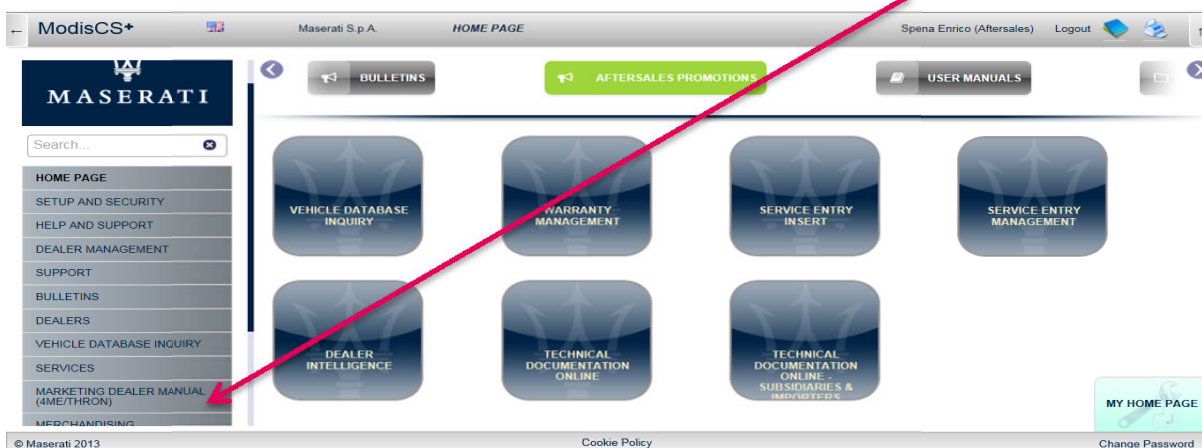
**A.1.** In ModisCS+ Select MARKETING DEALER MANUAL (4ME/THRON).

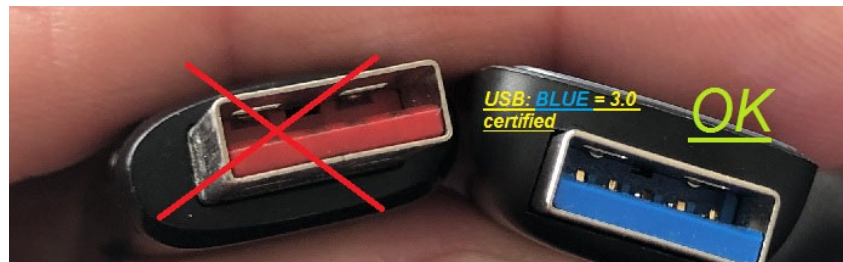
**A.6.** Copy the file to a NEW Folder on your Desktop then from the NEW Folder to a USB memory stick formatted with an NTFS file system.

- Use only Sandisk, Verbatim, Kingston or Transcend “3.0 **Certified**” USB PEN Drive. (Blue contact plate)

- Use at least an 8 Gb or larger USB with the NTFS format.
- Follow the instructions contained in MAS001272 about the USB memory stick features.

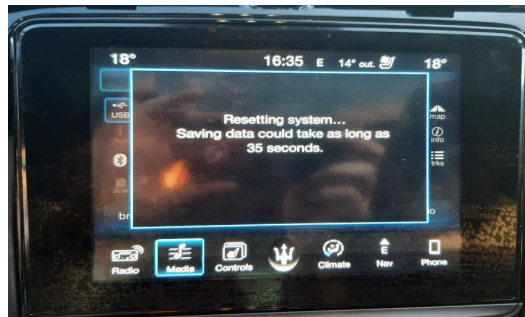
- B.1.** BRIDGE software installation (ETM update). Follow the table in this bulletin (MY 17 Sedans) for the vehicles requiring this s/w..
- B.2.** Download the software from the MARKETING DEALER MANUAL (4ME-THRON) (Follow Section A)
- B.3.** Extract all the files in an empty USB stick with the following specifications (as per Bulletin MAS001272):
- USB 3.0
  - At least 8GB or higher
- B.4.** Insert the USB stick in the USB port inside the vehicle.
- B.5.** Follow the on screen prompts.
- Please keep the vehicle in Key ON state (with a battery charger connected to the vehicle) and leave the USB stick inserted for the entire duration of the update.
  - Removal of the USB stick during the update will result in a non-functional head unit.
  - The time may depend on the market, the s/w version and the speed of the USB memory stick. The installation could take up to 1 hour.
