DCM Firmware Update (LG)

Service Category Audio/Visual/Telematics

Section Cellular Communication

YEAR(S)	MODEL(S)	ADDITIONAL INFORMATION
2020	ES300H, ES350, UX200, UX250H

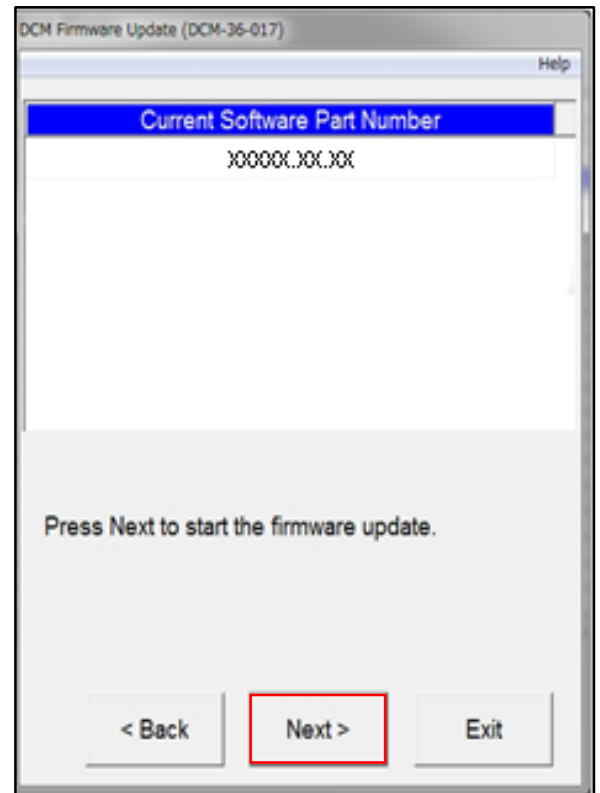
Figure 5.

- Click on Next when the current software part number screen appears.

If the screen in Figure 5 does NOT appear and an error message displays, begin the Firmware Update Procedure again from step 4. The battery reset MUST be performed again.

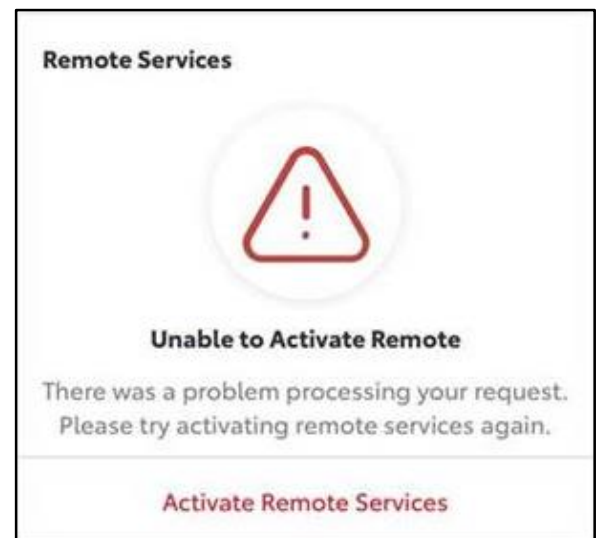
Figure 8.

- Using Techstream, perform a Health Check and clear ALL DTCs that may have occurred during the update process.
- In the customer’s Lexus app, perform steps 17 – 19 for customers with the “Unable to Activate Remote” message.

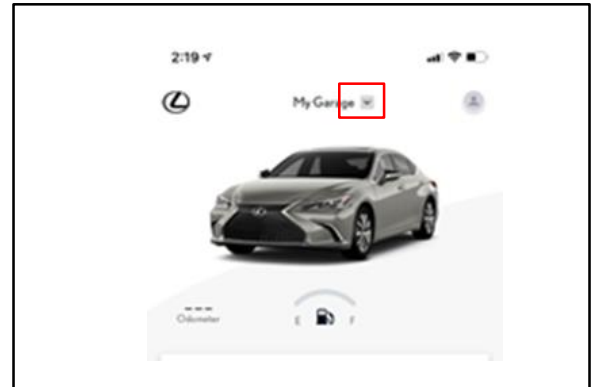
Figure 9.

17. Click on the arrow by the vehicle name/nickname.

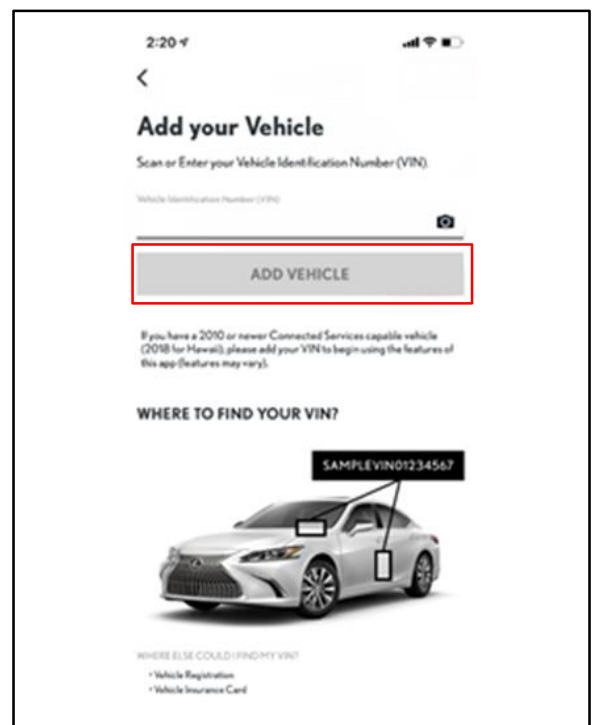
Figure 11.

19. Click on Add Vehicle to perform the enrollment again.
