June 2020
SF606A

Subject: Agility 8.0L Engine Calibration Updates

Models Affected: Specific model years 2012-2018 Freightliner Custom Chassis B2 school bus chassis and S2 shuttle bus and pick up and delivery chassis, manufactured January 27, 2012, through April 6, 2018.

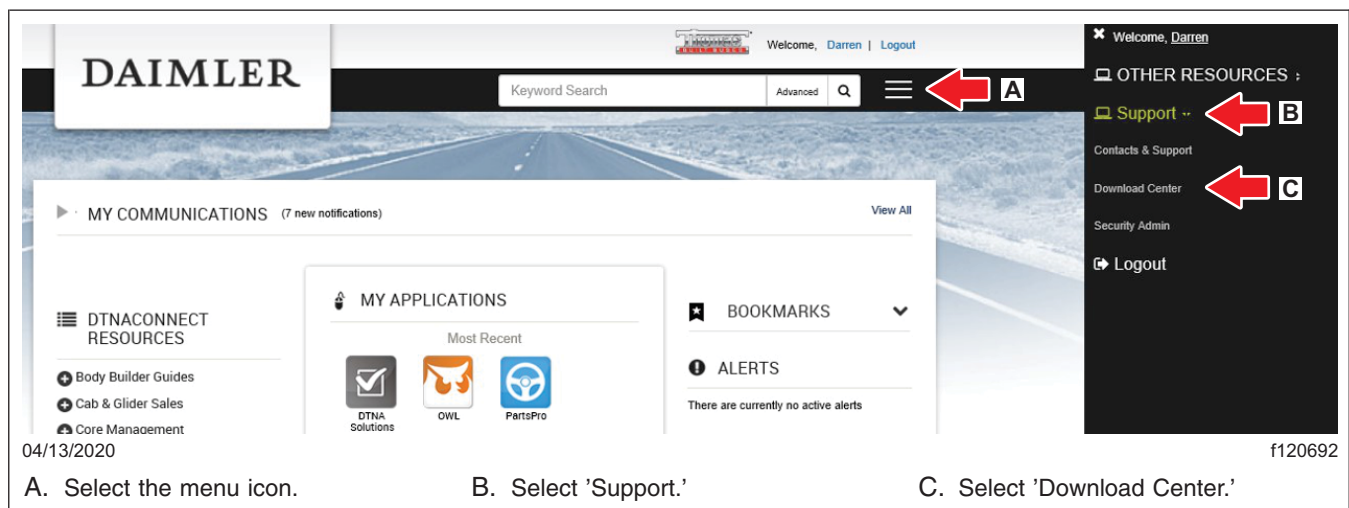
Fig. 1, DTNACconnect Screen

3. Go to www.DTNACconnect.com
4. In the upper right-hand corner, select the menu icon. See [Fig. 1](#), ref. A.

5. Select 'Support,' then select 'Download Center.' See [Fig. 1](#) ref. B and ref. C.

- Go back to www.DTNACoconnect.com and select 'Support,' then select 'Download Center.' See [Fig. 1](#) ref. B and ref. C. Select '8.0L LPG Engine Calibration Update' then select the engine calibration link, shown in [Fig. 15](#).

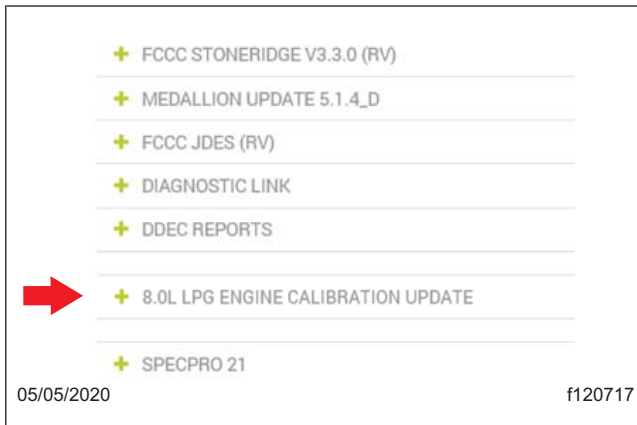
Fig. 2, Selecting 8.0L LPG Engine Calibration Update

6. A list will appear on the screen. Select '8.0L LPG Engine Calibration Update.' See [Fig. 2](#).
7. Select the Agility Service Link shown in [Fig. 3](#). Select 'Run' to install in the program software. See [Fig. 4](#).

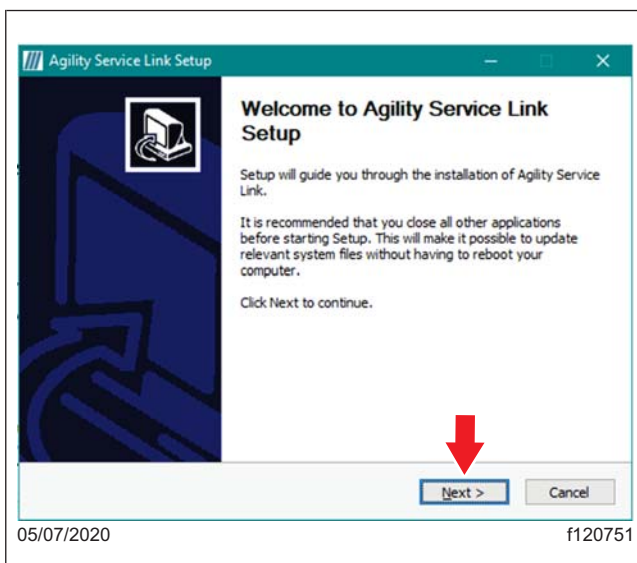
Fig. 5, Agility Service Link Setup Window

8. An 'Agility Service Link Setup' window will appear. Select 'Next' as shown in [Fig. 5](#).
9. A license agreement window will open. Read the license agreement, then select the 'I Agree' box. See [Fig. 6](#).

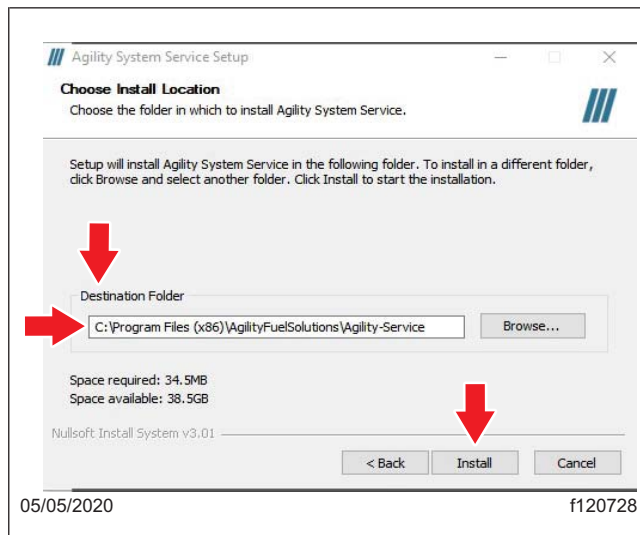
Fig. 7, Installation Location Window

10. A window will appear to choose the install location for the program software. The program software installation will default to C:\Program Files(x86). It is recommended that you allow it to install in the default directory. If another directory is used, make sure to note the location where the program is installed. Select 'Install.' See [Fig. 7](#).
11. A window will appear to complete the Agility Service Link setup. Select 'Finish,' as shown in [Fig. 8](#).

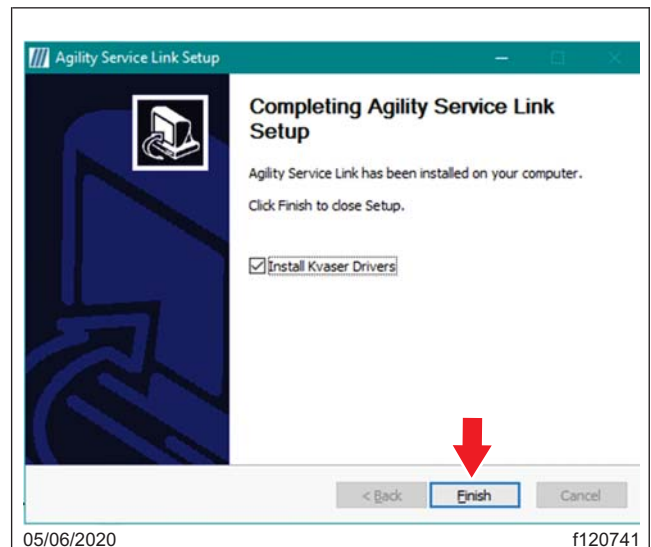
Fig. 8, Completing Agility Service Link Setup Window

The box to 'Install Kvaser Drivers' will automatically be checked; select 'Finish.'

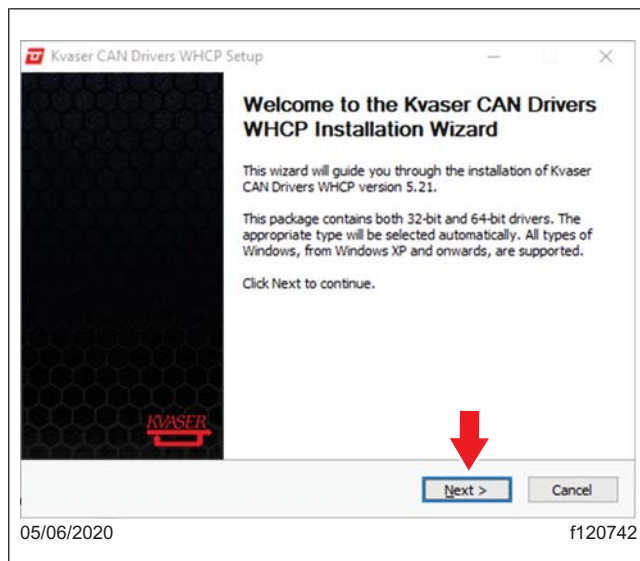
Fig. 9, Kvaser CAN Drivers WHCP Setup Window

12. The Kvaser drivers will now be installed. Select 'Next' in the Kvaser CAN Drivers WHCP Setup window. See [Fig. 9](#).
13. The 'Release Notes' window will appear. Select 'Next' as shown in [Fig. 10](#).

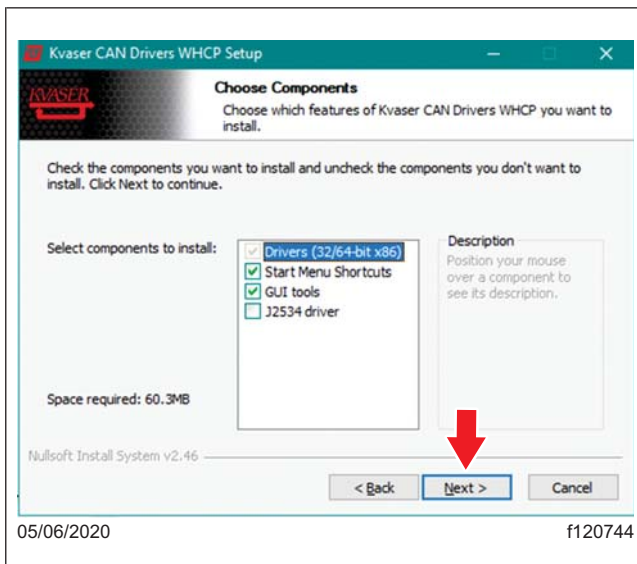
Fig. 11, Choose Components Window

- The 'Choose Components' window appears next. All of the components are automatically selected. If there are components you do not want to install, remove the check mark beside the component(s) and select 'Next' as shown in [Fig. 11](#).
- A window will open to choose the install location. Allow it to install in the default directory or the application may not work correctly. Select 'Install.' See [Fig. 12](#).

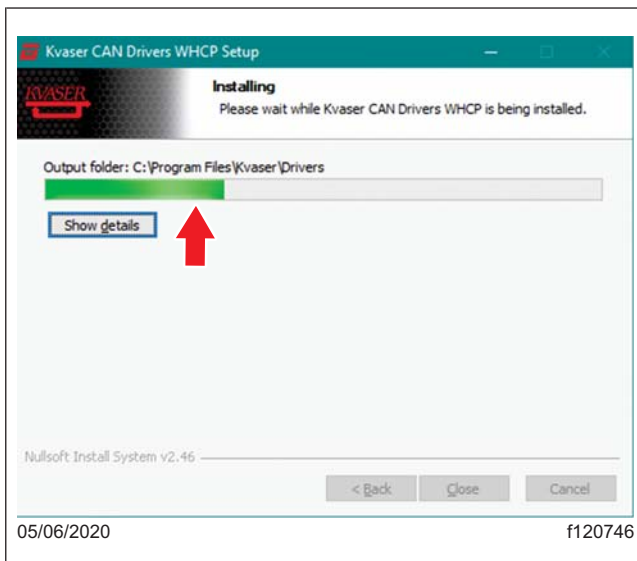
Fig. 13, Kvaser Installation Progress Bar

- A bar shows the progress of the Kvaser installation. See [Fig. 13](#).
- A window will appear when the installation is complete. Select 'Close.' See [Fig. 14](#).

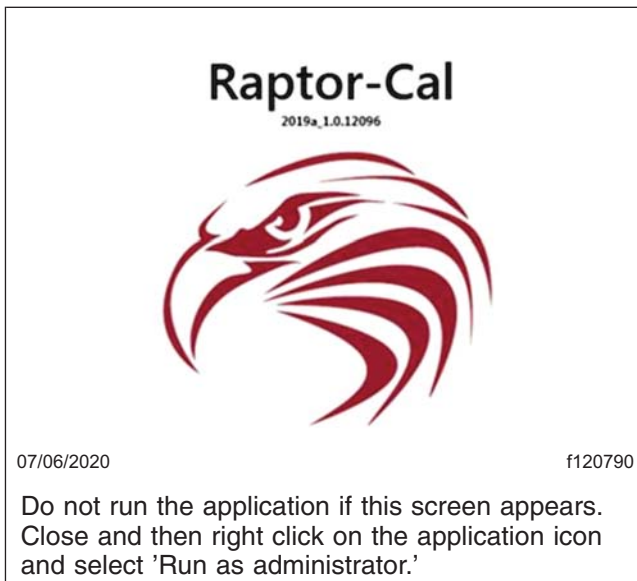
Fig. 20, Raptor Screen

IMPORTANT: If the raptor screen, shown in [Fig. 20](#) appears, **do not run the application.** Close and then right click on the application icon and select 'Run as administrator.' See [Fig. 21](#). The technician may need help from their IT department to use administrator rights.

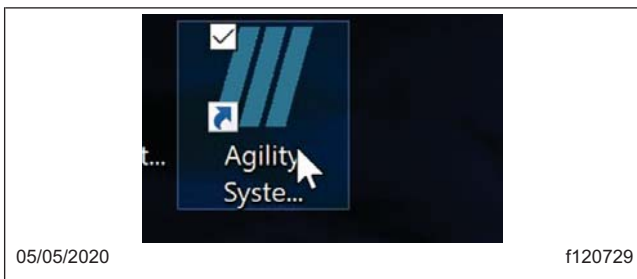
Fig. 22, Agility Icon on the Desktop

1. Double click the Agility icon on the desktop. See [Fig. 22](#).

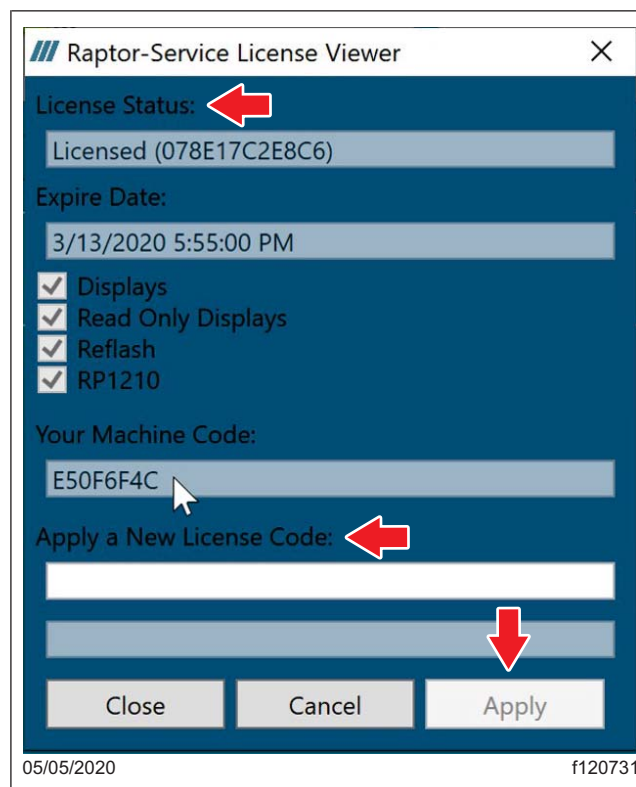
Fig. 24, Raptor-Service License Viewer Window

NOTE: A unique machine code was automatically created when the program was installed. Write down the machine code for the next step. You will have to provide this code when contacting agility. See [Fig. 24](#).

3. The 'License Viewer' window will open. See [Fig. 24](#). You will need to contact Agility at 1-949-207-5364 between 8 A.M. to 5 P.M. eastern standard time and provide the machine code noted earlier, and then ask for the license code. Any phone call after this time will go to voicemail.

4. Once the license code is created by Agility, enter it in the 'Apply a New License Code' section shown in [Fig. 24](#), then select 'Apply' and close the window.

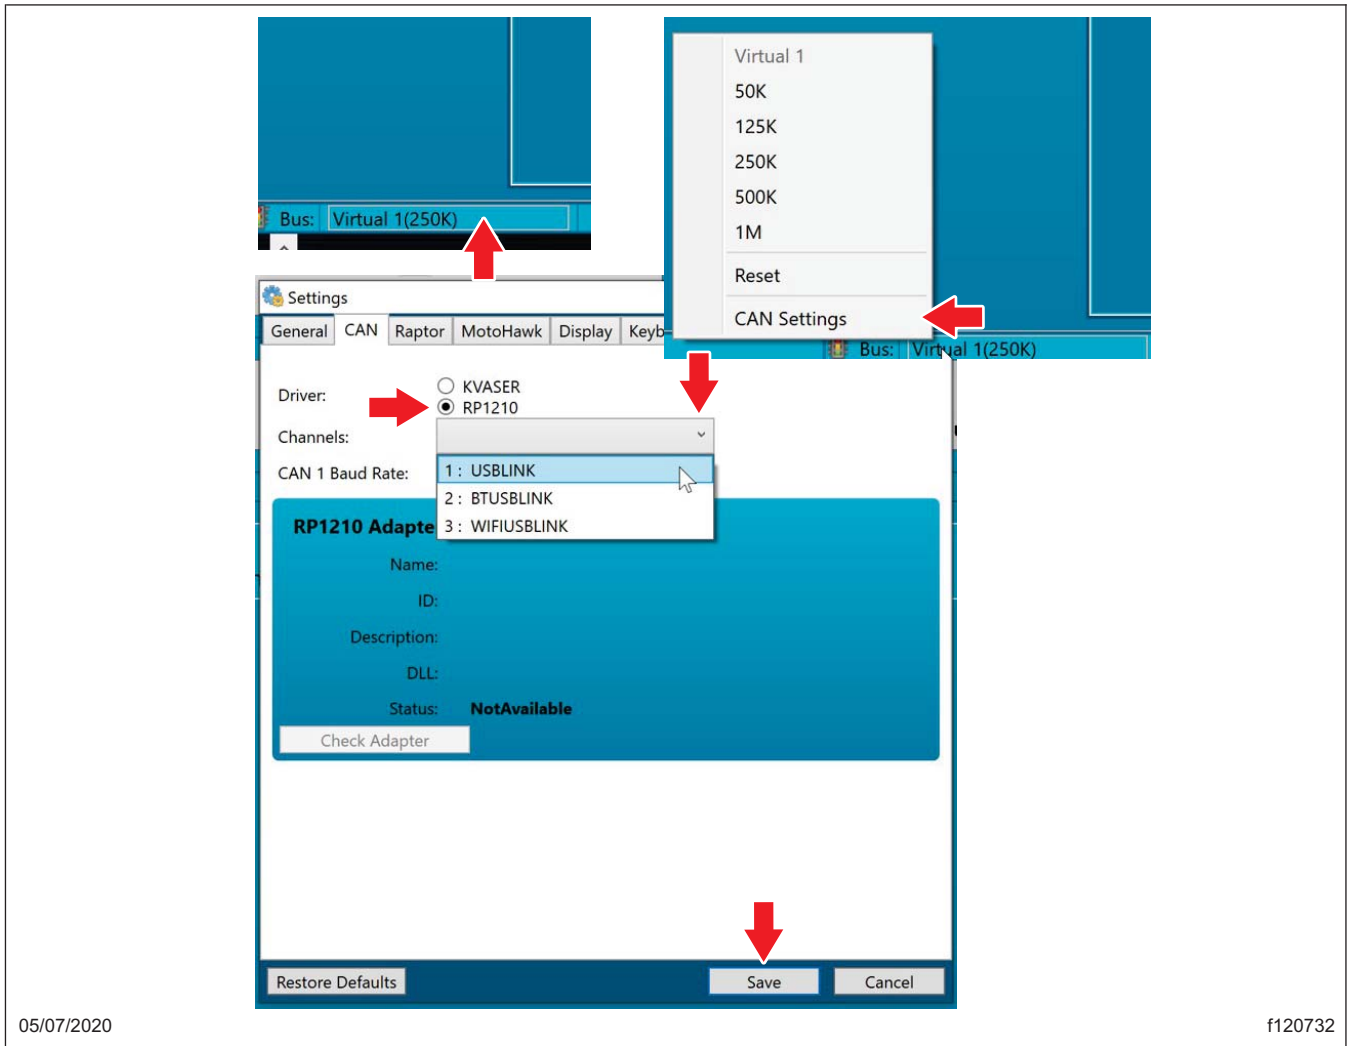
Fig. 25, Virtual 1(250k) Window

3. Right click the 'Virtual 1(250k)' box, then select 'CAN Settings.' See [Fig. 25](#).
4. Select 'RP1210' or 'Kvaser' from the 'Driver' options as applicable, shown in [Fig. 25](#).

5. Select the 'Channels' drop-down list, then select the interface being used and select 'Save.' See [Fig. 25](#).

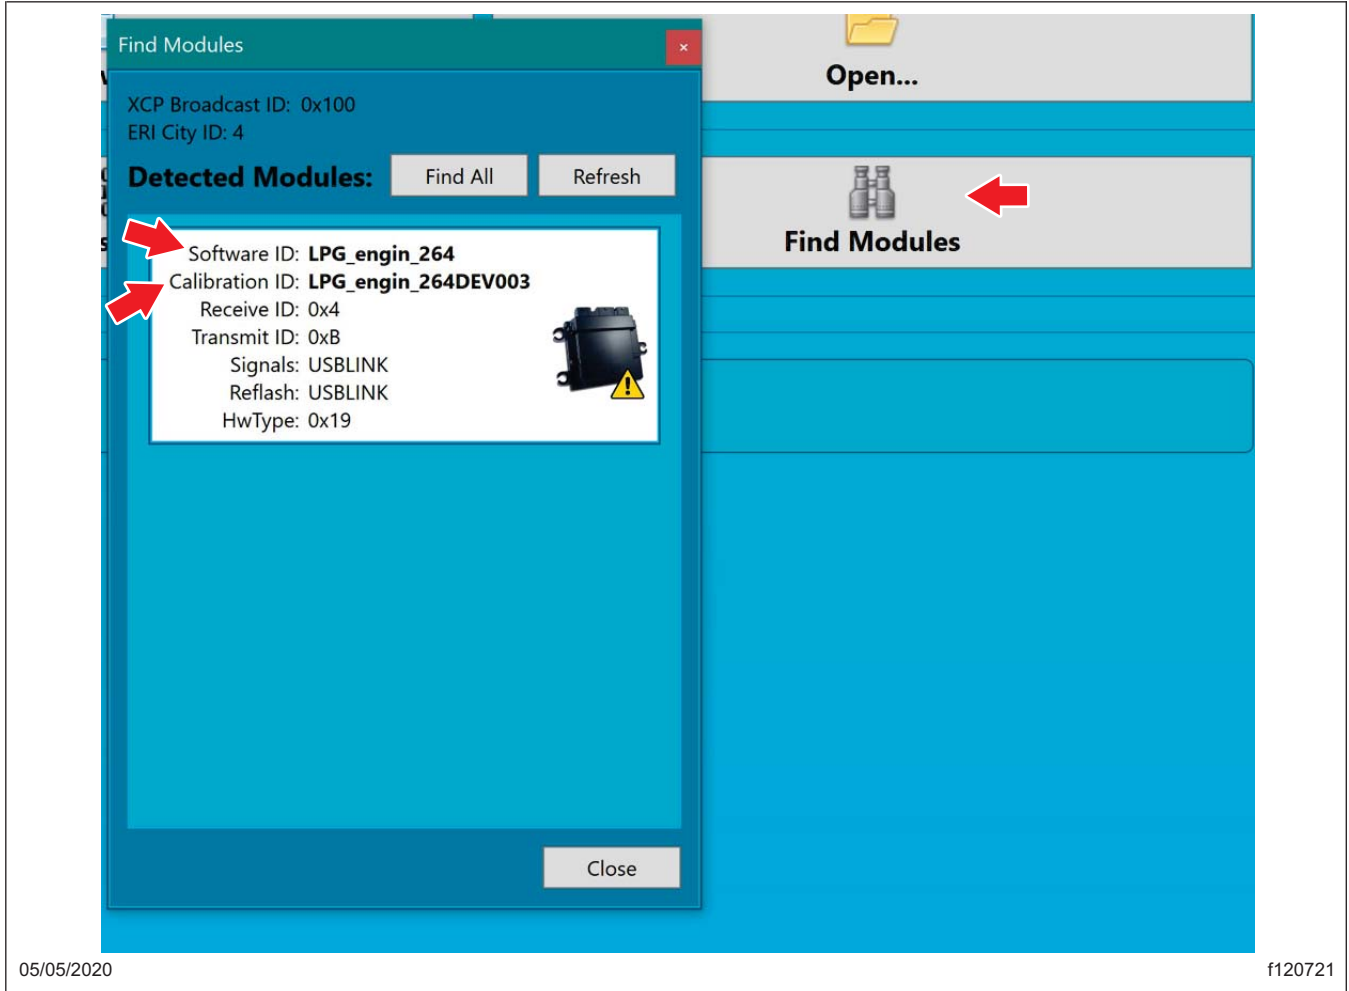
Fig. 26, Find Modules Window

3. Select 'Find Modules'; all of the available modules appear in the window. See [Fig. 26](#).

4. Write down the 'Software ID and Calibration ID' (near the ECU image). See [Fig. 26](#).

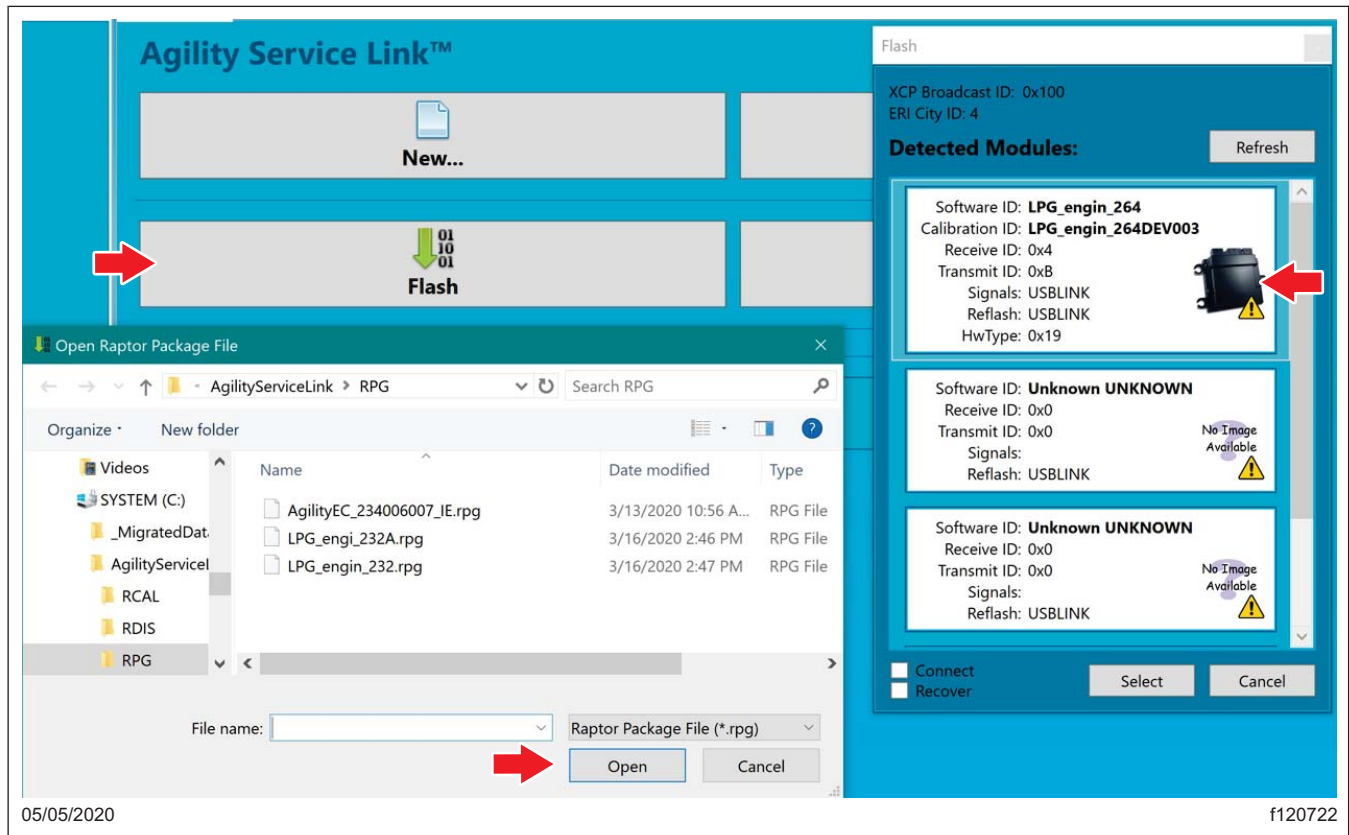
Fig. 27, Selecting Flash and the Module to be Flashed

5. Select 'Flash,' then double click the module you want to flash (it has the ECU image beside it). See Fig. 27.

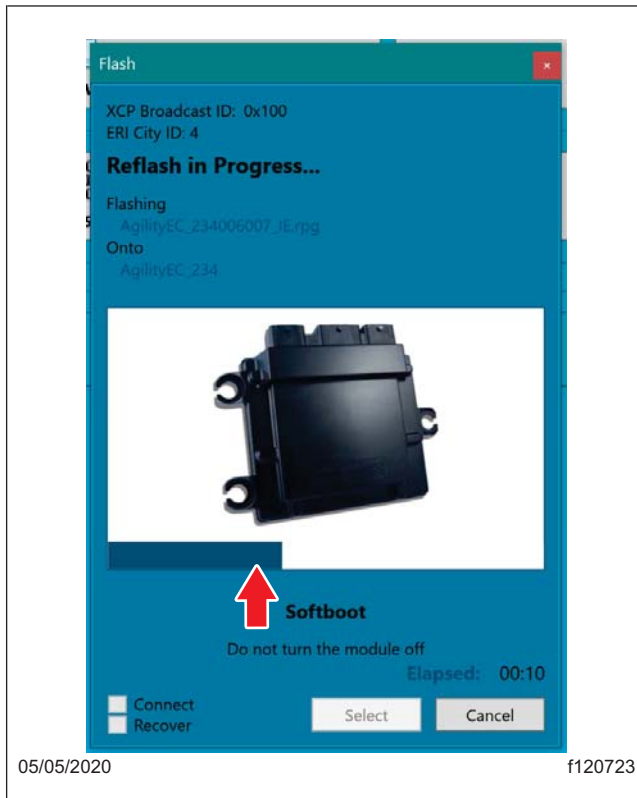
Fig. 28, Progress Bar Window

8. A bar shows the progress of the ECU as it is reprogrammed. See [Fig. 28](#).

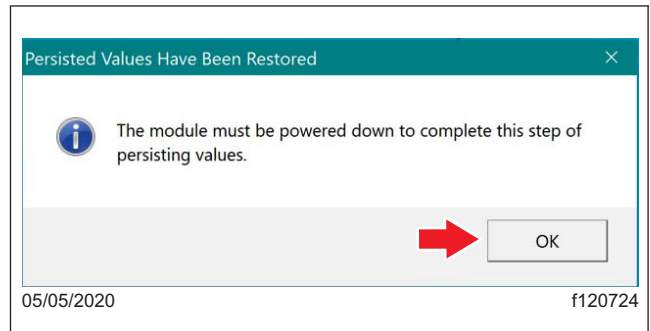
Fig. 29, Persisted Values Have Been Restored Window

10. The 'Persisted Values Have Been Restored' window appears. Select 'OK'. See [Fig. 29](#).

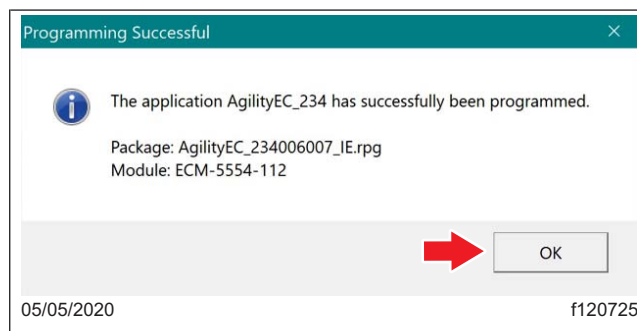
Fig. 30, Programming Successful Window

11. The 'Programming Successful' window will appear. Select 'OK.' See [Fig. 30](#).
