NUMBER
PI1802Y/Z (Rev 3, 07/01/2020)

PRODUCT IMPROVEMENT CAMPAIGN

**SUBJECT: ENGINE REPLACEMENT INSTRUCTIONS
FOR DTC P1326 (PI1802Y/Z)**

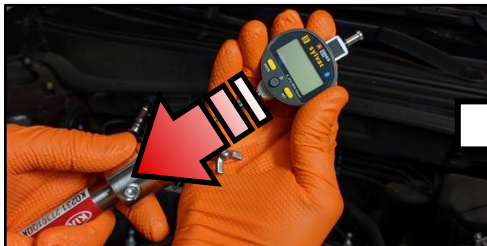
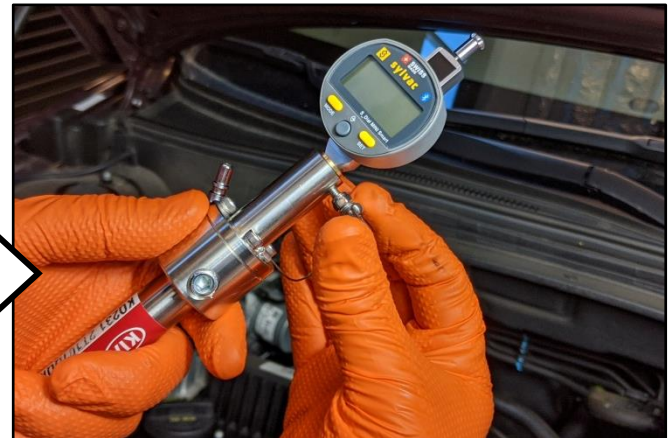
7. Install the Dial Gauge fully into the Probe Rod and secure together by hand tightening the locking wingnut.

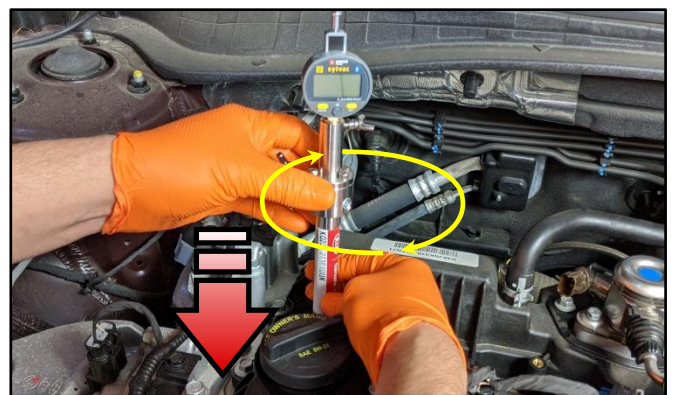
8. **Carefully**, insert the assembled SST Probe Rod and Dial Gauge into the Cylinder 1 spark plug hole and **carefully** turn the SST Crankshaft Rotator **by hand** clockwise until hand tight.

Damage to cylinder head can occur if spark plug hole is cross-threaded. DO NOT use a wrench to tighten the SST rod.
