SERVICE BULLETIN

NUMBER: 15-245-19R

SUBJECT: FOTA (Firmware Over-The-Air) Reprogramming
 Procedure to Optimize Harman Gen 3.0 Audio / Navigation Units

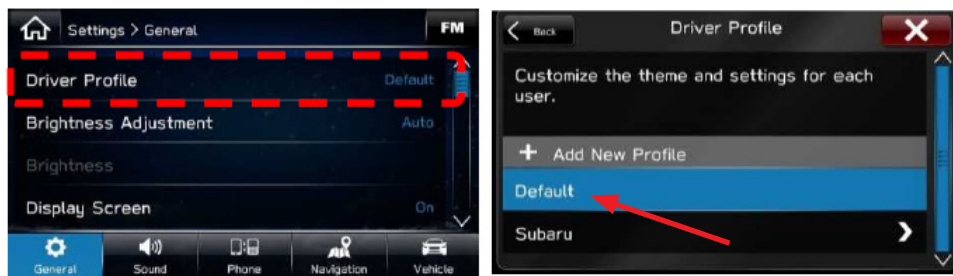
2-1-1) Confirm the driver profile (example shows “Default” as driver profile).

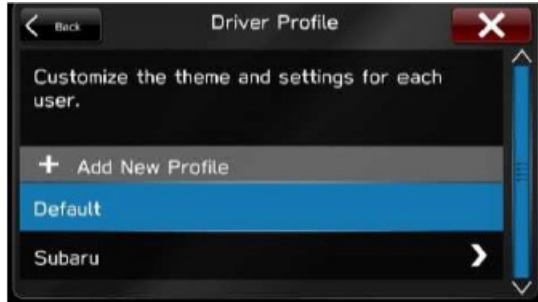
- 2-1-4) Change to next driver profile and repeat the actions above as necessary. (Example photo below shows other driver profiles. Be sure to note all the preset stations for each driver profile.)

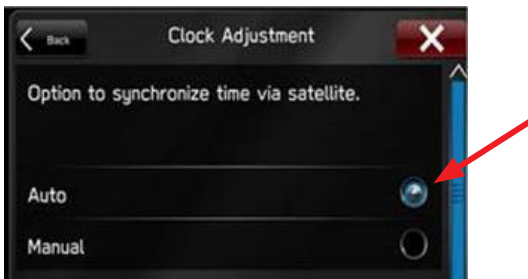
NOTE: The H/U clock **must** be set correctly in order to check for any available FOTA updates. Always confirm the Clock Adjustment mode is set to Auto.

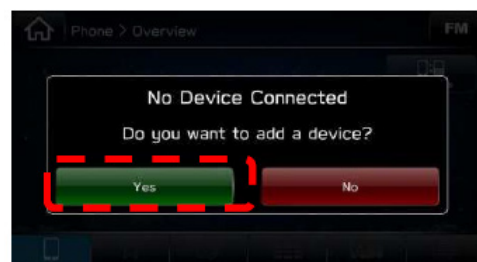
1.2.2) Select Yes on “No Device Connected” pop-up.

NOTE: If H/U display does not show the pop-up, please select “Add device” from the Phone Overview.

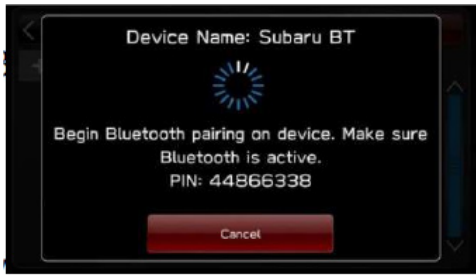
1.2.3) While the H/U displays the “waiting” screen shown below, operate the smartphone screens and select “Subaru BT” from the discoverable device list.

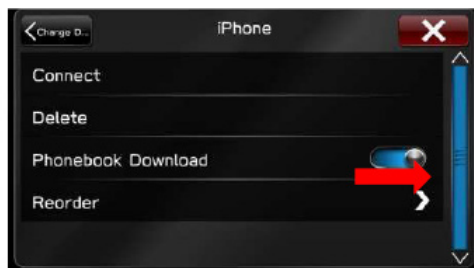
1.3.3) Turn “Phonebook Download” on.

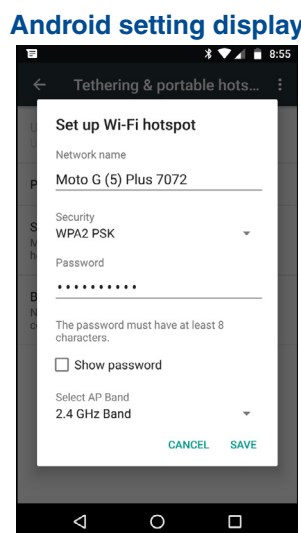
1.4.1) Prepare a Wi-Fi router device:

NOTE: Depending on the model (e.g. iOS or Android), these settings may need to be changed. Refer to the specific smartphone’s User Manual for more detailed information / instructions.

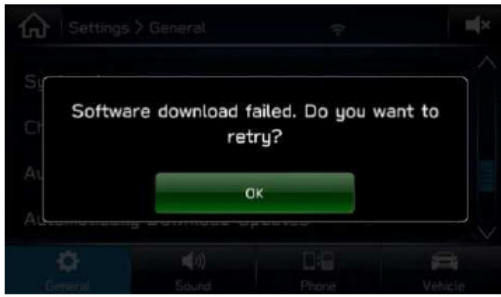
1.5.6) If the H/U display shows “Software download failed. Do you want to retry?”, there is possibility the H/U is not receiving the clock information correctly.

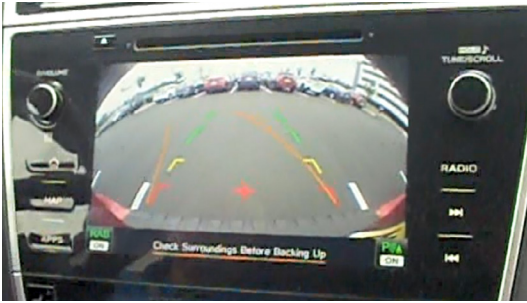
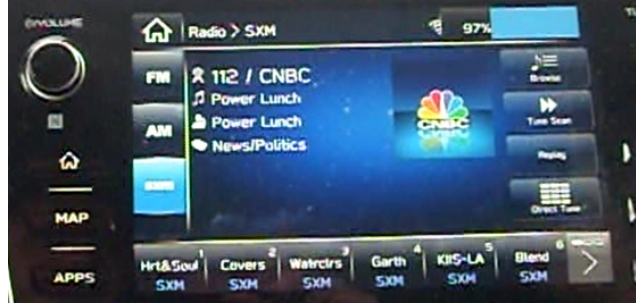
1.6.1) Wait until the download progress reaches 100%. During the software download, the H/U is fully functional. **NOTE:** It is normal for the progress to hang at some points for 1-2 minutes. This does not indicate a concern. **BE PATIENT.**

NOTE: When downloading via Wi-Fi, it may take anywhere from 5 to 20 minutes for the update to complete depending on the provider transfer rate signal strength.

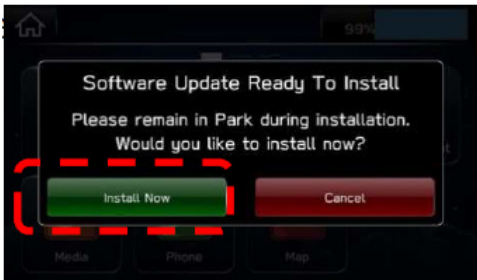
1.6.2) The image below shows the pop-up window which will appear once the download completes and the update is ready to install.

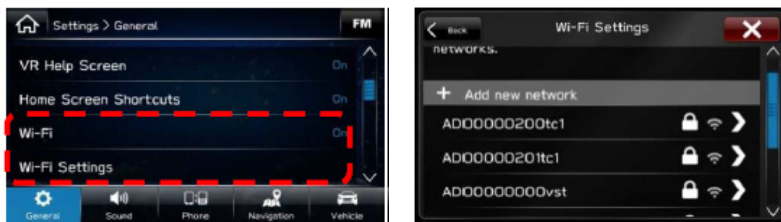
2.5) Select the desired Wi-Fi device from the “Wi-Fi Settings” list.

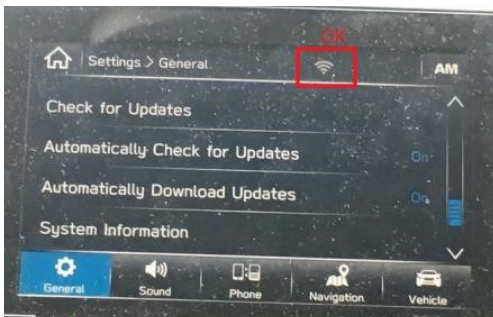
2.6) Select “Connect” and input the password of the Wi-Fi device to be used. When a connection is established, the screen will display a Wi-Fi icon on top bar.
