Technical Service Bulletin

REPEATED CLICK SOUND FROM HVAC SYSTEM - (AUTO A/C ONLY)

Bulletin No.: 07-003/20

2020 CX-30 vehicles equipped with Auto A/C 2019-2020 Mazda3 vehicles equipped with Auto A/C

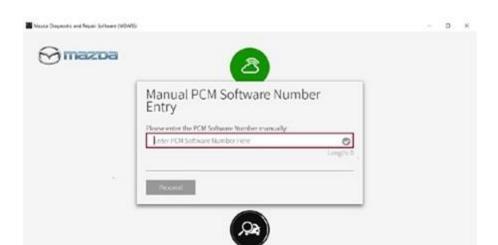
a. Look for the small sticker on the PCM that has the software number "**** 18 8K2*" printed on it.

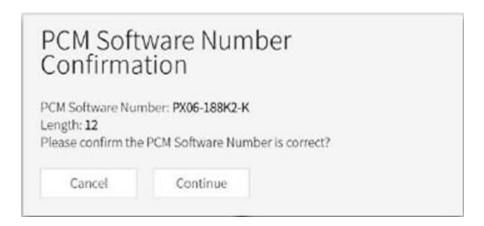
b. Enter the software number adding "-" instead of a space. **Example:** If "PX06 18 8K2H" is printed, enter "PX06-18-8K2H".

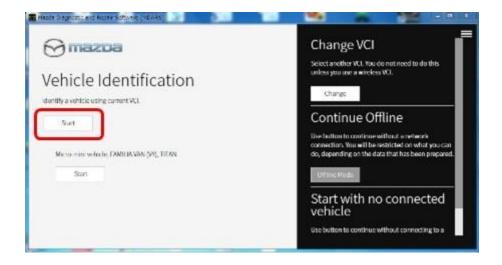
- 1. Connect the M-MDS to the vehicle.
- 2. Launch the Mazda Diagnostic And Repair Software (MDARS).
- 3. Turn the ignition on, then click "Start".

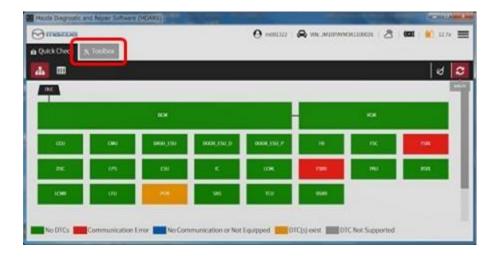
4. Select the "toolbox" tab.

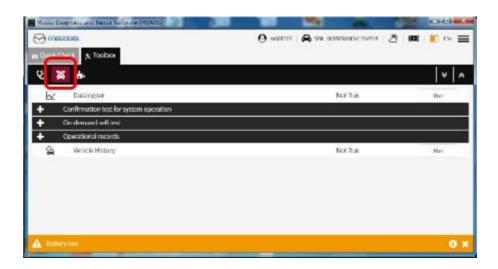
5. Select Work Support group.

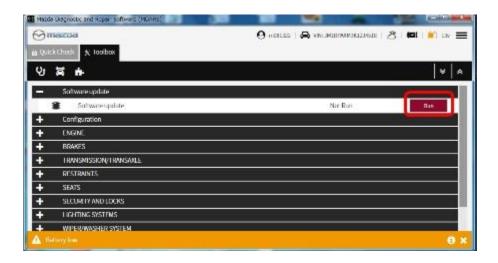
6. Select "Software update", then click "Run".

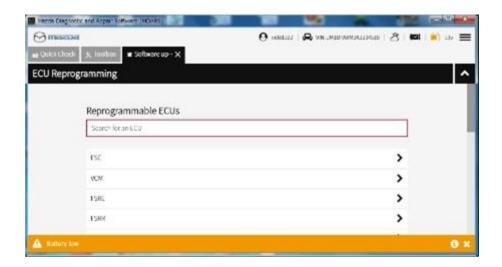
7. Select the ECU to be reprogrammed.

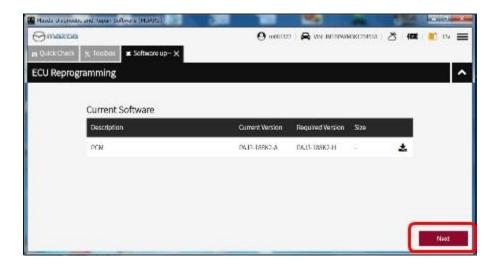
8. Confirm the current and new software versions, then click "Next".

NOTE: When reprogramming the BCM, two (2) softwares will be shown.

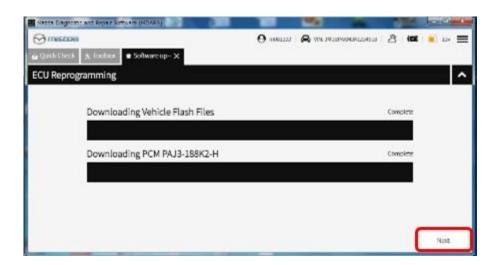
9. Wait for the download, then click "Next".

NOTE: When reprogramming the BCM, downloading will occur twice.

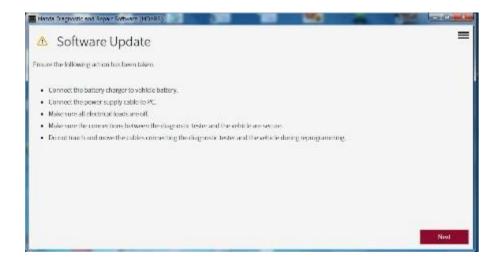
10. Read the screen instructions, then click "Next".

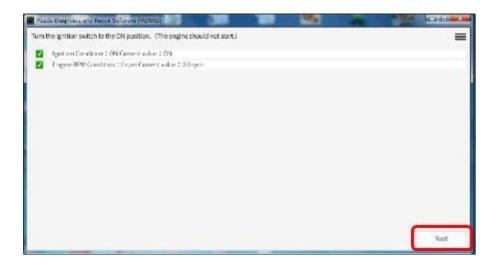
11. Follow the instructions on the screen, then click "Next".

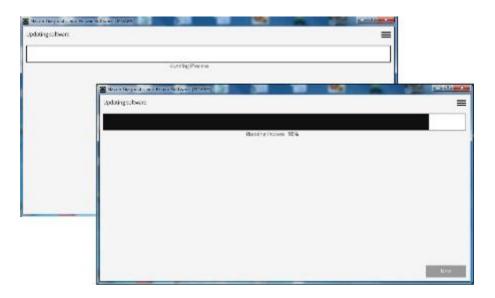
12. Wait for the reprogramming to complete.

- The progress bar will stay at 90% for 30 seconds. This is not a failure.
- When reprogramming the BCM, this process will occur twice.

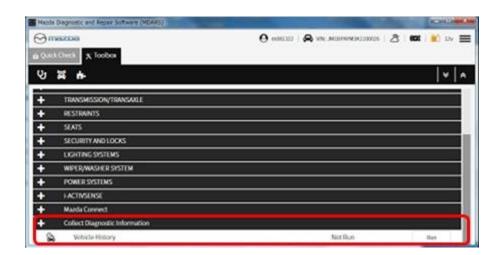
1. Select "Vehicle History" under "Collect Diagnostic Information", then click "Run".

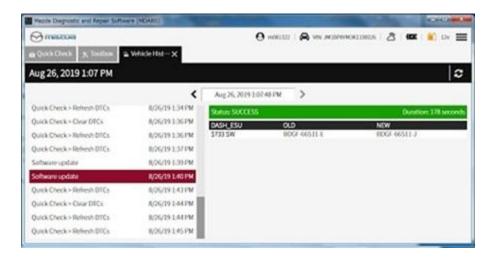
2. Confirm the reprogramming on screen and save the screen copy as a record.
