# Technical Service Bulletin

FIRST REMOTE CONTROL ATTEMPT FAILS USING MYMAZDA APP

**Bulletin No.:** 16-002/20

2020 CX-30 vehicles using Connected Service 2020 Mazda3 vehicles using Connected Service

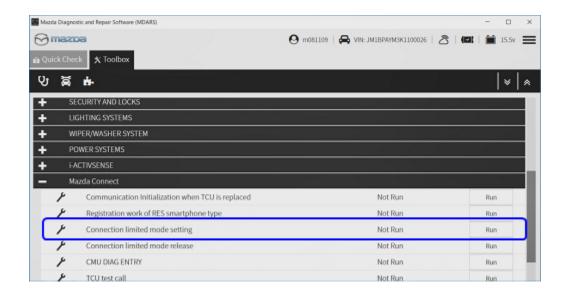
- a. Select "toolbox" tab and select Work Support group.
- b. Select to expand "Mazda Connect" group and select "Connection limited mode setting" and click "Run". Follow the instructions on the screen.

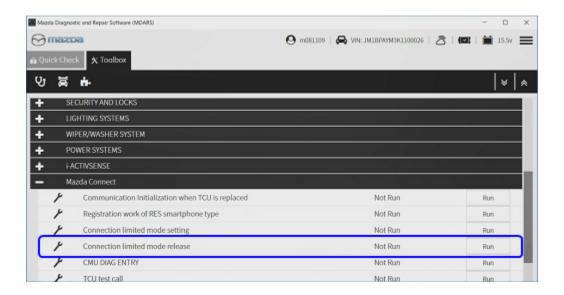
- 3. Release the connection limited mode.
  - a. Select "toolbox" tab and select Work Support group.
- b. Select to expand "Mazda Connect" group and select "Connection limited mode release" and click "Run". Follow the instructions on the screen.

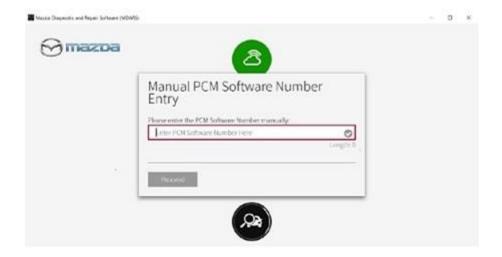
a. Look for the small sticker on the PCM that has the software number "\*\*\*\* 18 8K2\*" printed on it.

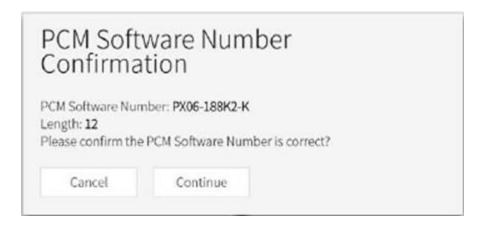
b. Enter the software number adding "-" instead of a space. **Example:** If "PX06 18 8K2H" is printed, enter "PX06-18-8K2H".

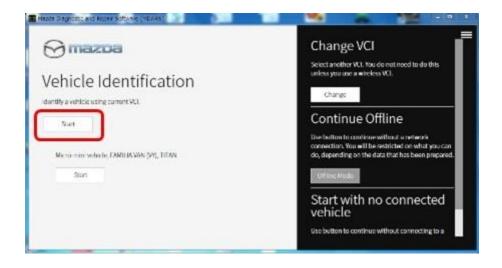
- 1. Connect the M-MDS to the vehicle.
- 2. Launch the Mazda Diagnostic And Repair Software (MDARS).
- 3. Turn the ignition on, then click "Start".

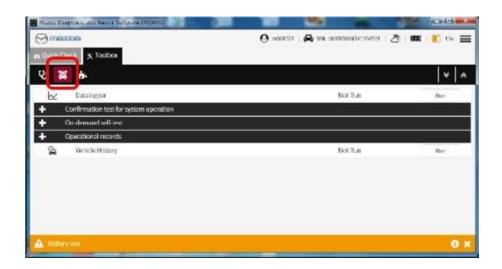
5. Select Work Support group.

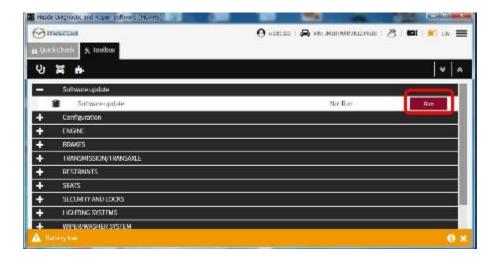
6. Select "Software update", then click "Run".

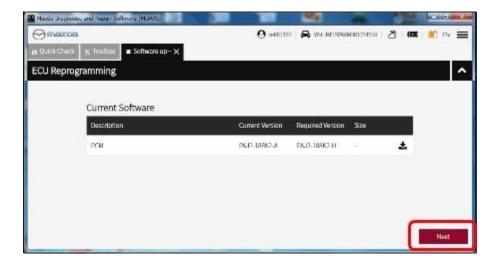
8. Confirm the current and new software versions, then click "Next".

NOTE: When reprogramming the BCM, two (2) softwares will be shown.

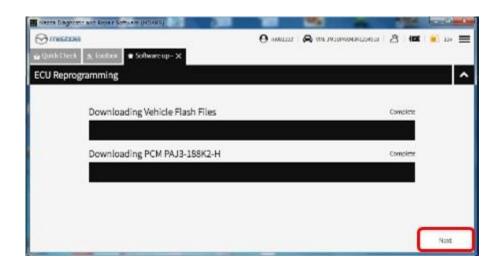
9. Wait for the download, then click "Next".

**NOTE:** When reprogramming the BCM, downloading will occur twice.

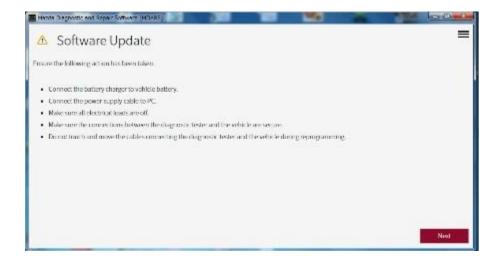
10. Read the screen instructions, then click "Next".

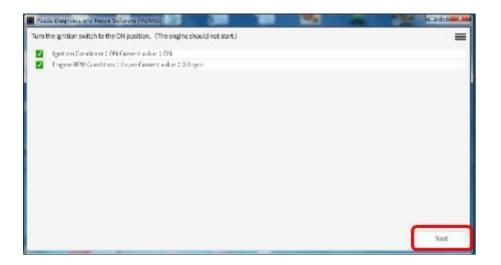
11. Follow the instructions on the screen, then click "Next".

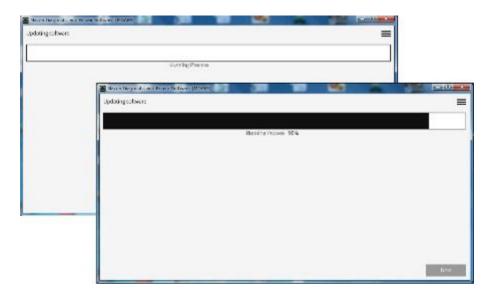
12. Wait for the reprogramming to complete.

- The progress bar will stay at 90% for 30 seconds. This is not a failure.
- When reprogramming the BCM, this process will occur twice.

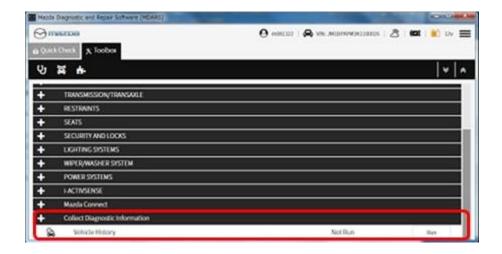
1. Select "Vehicle History" under "Collect Diagnostic Information", then click "Run".
