Title: Programming Procedure for Center Panel Switch Packs

Applies To: LT, RH, HV, MV, 2018+ LoneStar

Programming procedures for the center panel switch packs has changed. The modules will no longer be plug and play, you will need to program and assign the source address to the module for it to function properly. Review the scenarios below to determine which path to follow.

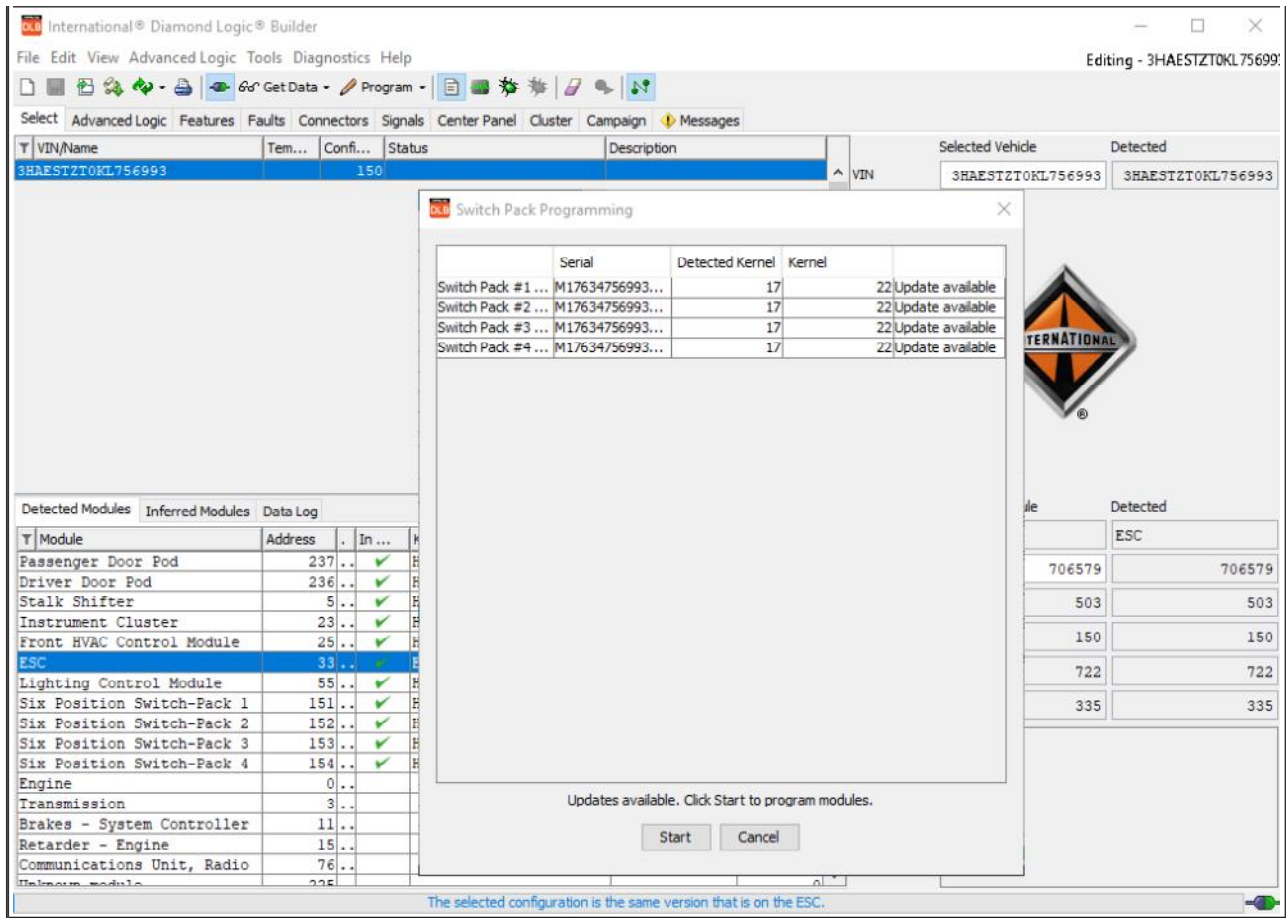
5. To initiate programming click start as shown in Figure 6.

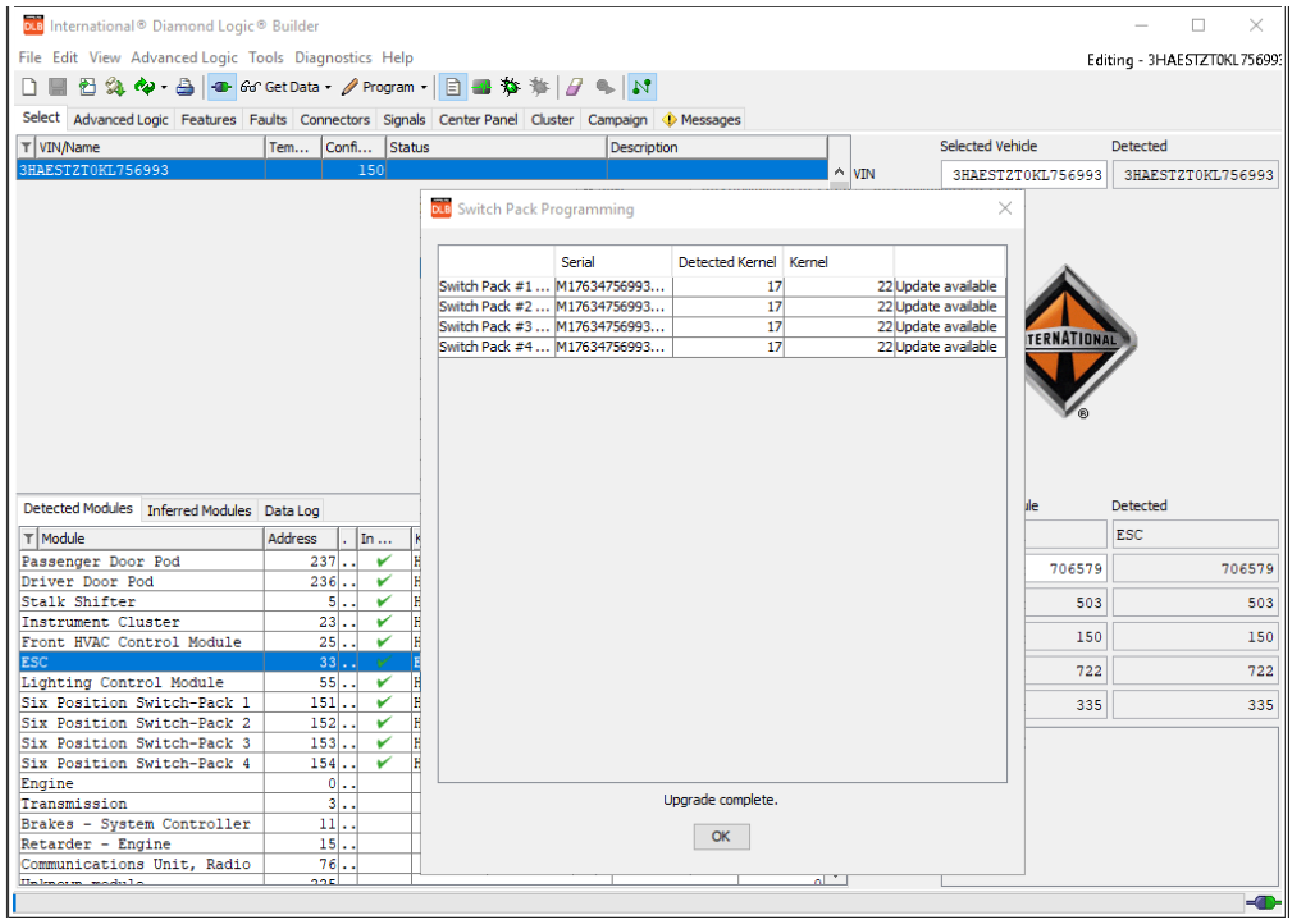
7. Once the update is complete you will be notified as shown in Figure 8.

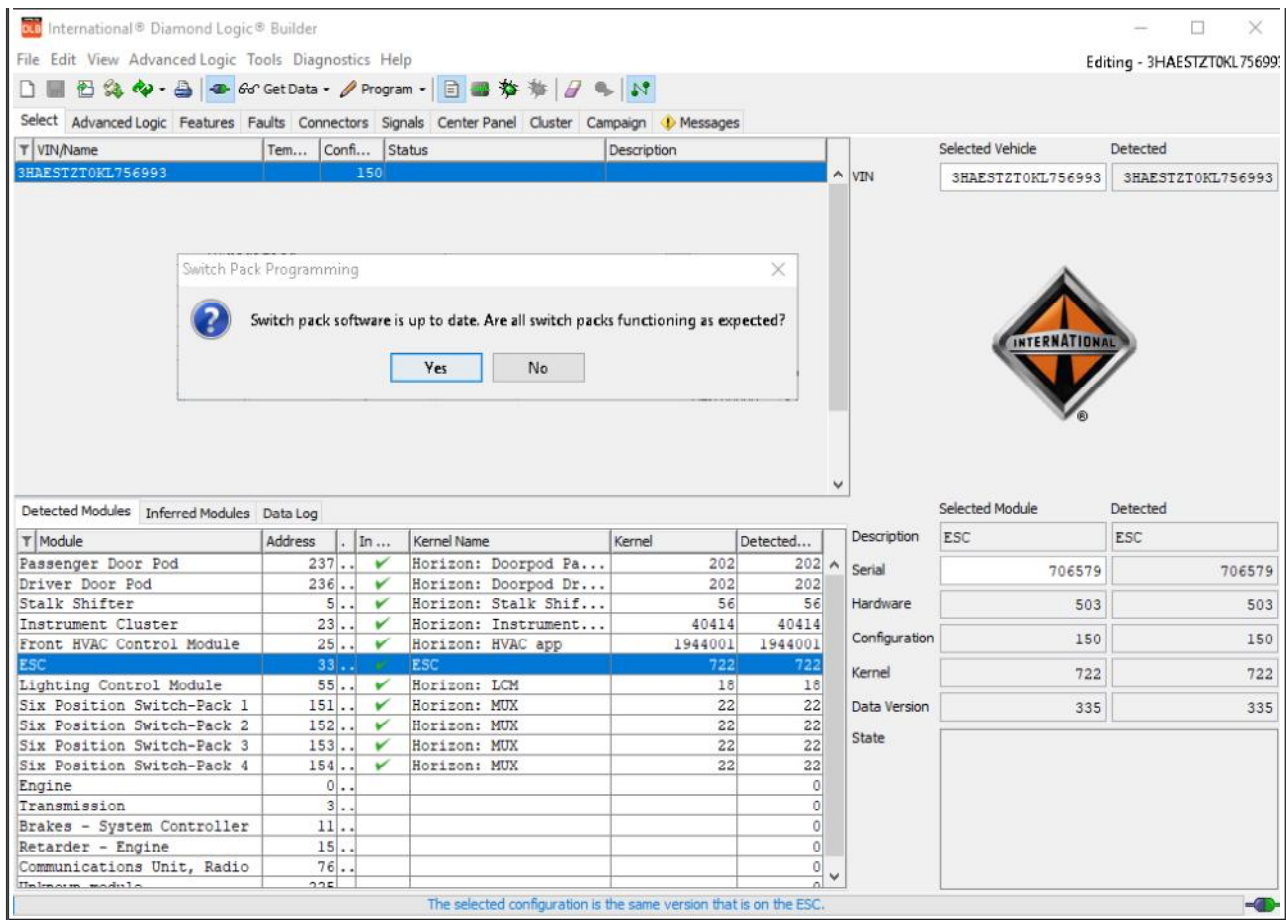
14. Navigate back to the tools menu and select "Switch Pack Programming".
15. You will receive the pop up message shown. Select NO. This will allow you to manually set the source addresses.

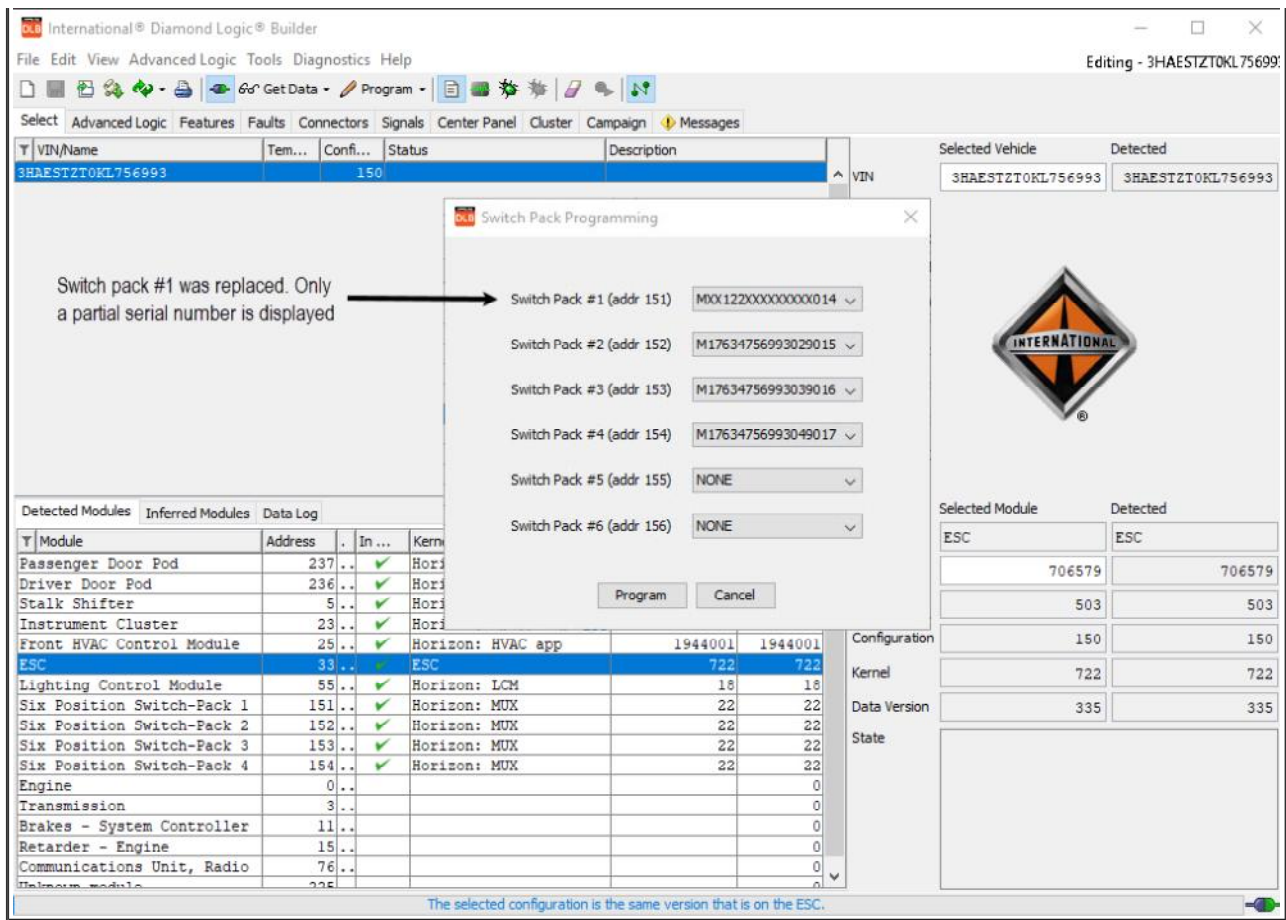
16. Set the switch pack source addresses based on their serial number and location in vehicle. Click Program.

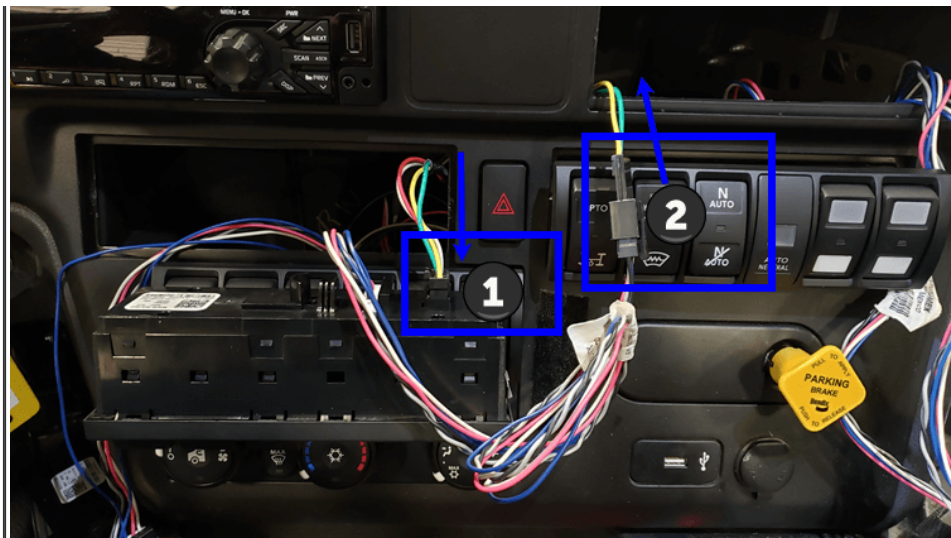
6. Plug the pigtail of the #1 switch pack into the connector going back to the IP harness
 - The replacement switch pack, in the #1 location is now the only switch pack plugged in.

- The in and out harness should be plugged in to the data link backbone is not broken.

1. Power ground and data link wiring coming in from the IP harness
2. Switch pack pigtail plugged into the data link going back to the IP harness
