WLG2 - Updating Software for Various Control Units (Workshop Campaign)

Model Line: Taycan (Y1A)

Subject: Software update (software release VR8.7)

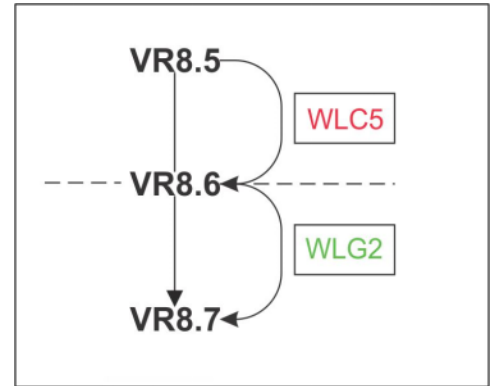
Evolution Taycan Software Updates

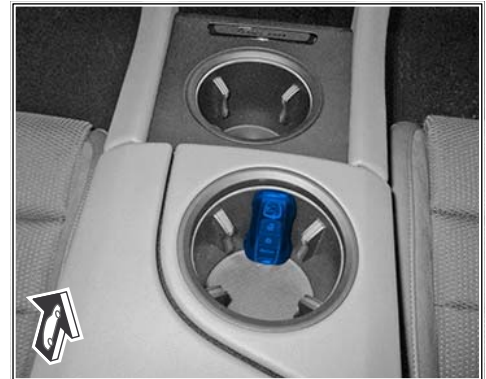
Emergency start tray

- Work Procedure: 1 Connect a suitable battery charger, e.g. **Battery charger 90A**, to the jump-start terminals in the luggage compartment and switch it on.
- 2 Position the **driver's key** with the back facing forward upright between the holding struts in the rear cupholder (**emergency start tray**) to guarantee a permanent radio link between the vehicle and remote control ⇒ *Emergency start tray*.
- 3 Connect the **9900 - PIWIS Tester 3** to the Vehicle Communication Module (VCI) via the **USB cable**. Then, connect the Communication Module to the vehicle and switch on the PIWIS Tester. Due to the long programming time, connect the **PIWIS Tester to the power supply during the operation**.

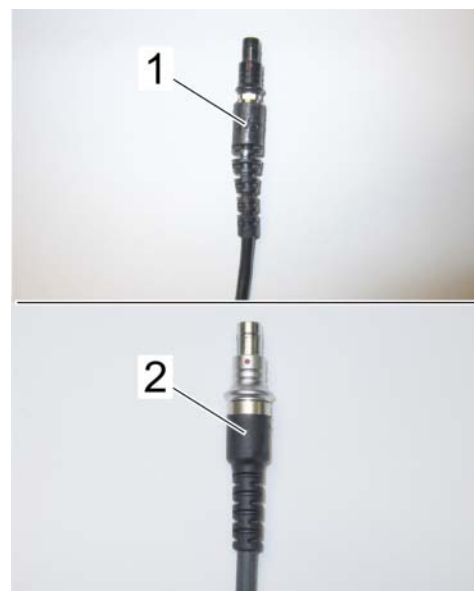
PIWIS Tester data cable

If the connection between the vehicle and PIWIS Tester is interrupted, check the data cable for the PIWIS Tester for signs of damage. If the data cable is damaged, it **must be replaced**. To do this, follow the instructions in the PPN for "Returning faulty USB cable caps" (PPN portal > Dr Ing. h.c. F. Porsche AG > Aftersales > Workshop > PIWIS > Documents).

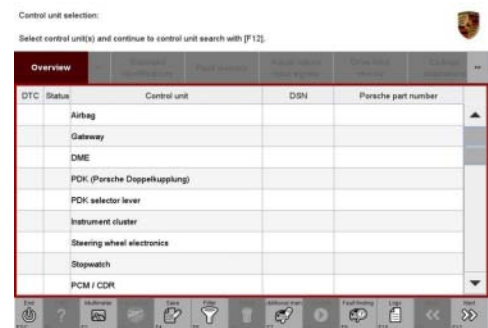
Control unit selection

- 1.6 Once you have erased the fault memories, select the **'Overview'** menu to return to the control unit selection screen ⇒ *Control unit selection*.
