# Technical product information

<b>Topic</b>	Interior trim - Creak and rattle - Noise identification
<b>Market area</b>	Bentley: worldwide (2WBE),Hongkong-Macau (5HK)
<b>Brand</b>	Bentley
<b>Transaction No.</b>	2056582/3
<b>Level</b>	EH
<b>Status</b>	Released for publishing
<b>Release date</b>	03-Jul-2020

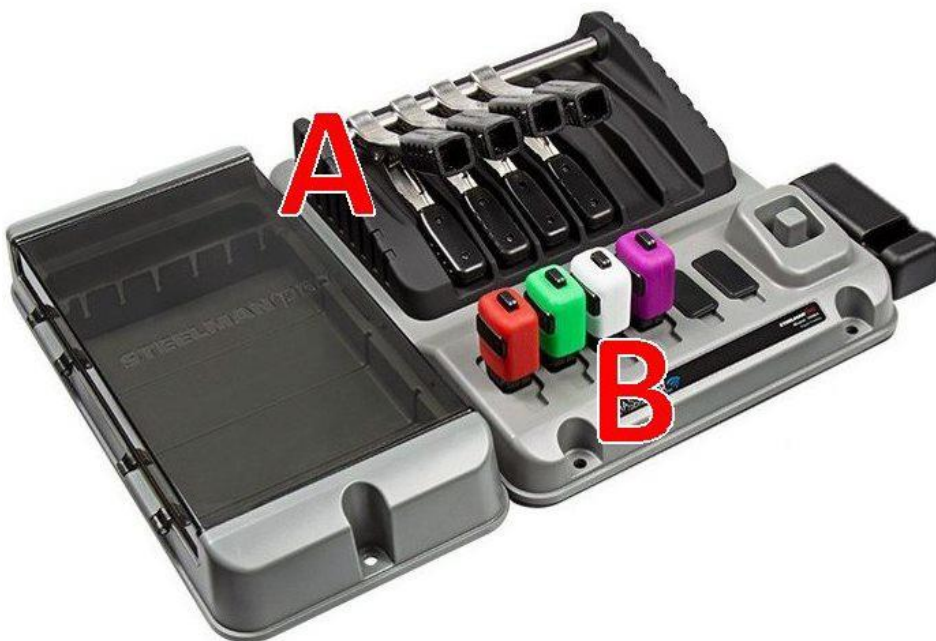
3) Referring to Figure 1 - Using the sensor clamp/s(Point A) and Bluetooth module/s(Point B) provided in the kit - Record the noise

TIP: In order to locate the noise it could be necessary to use multiple clamp and module assemblies, the operative must refer to the appropriate user instructions
