Service Bulletin

20-059

Product Update: 2018 Odyssey Front Control Box OTA Software Update

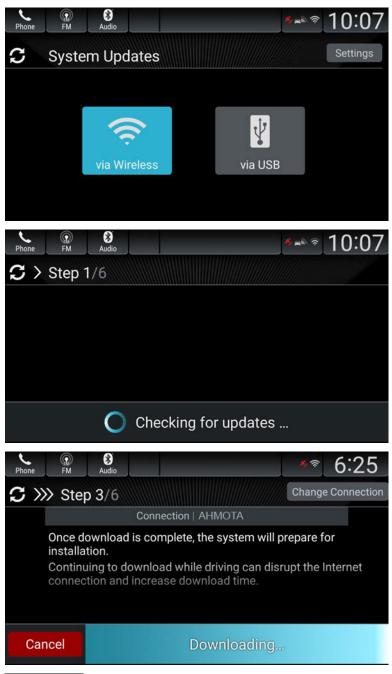
5. Once you have confirmed the vehicle is connected to AHMOTA, and the **Honda SW Version** reads lower than **B.1.3.4**, return to the Home screen. From there, select **System Updates**, then **via Wireless**.

- In some instances, you might not see the following screens on the display.
- If you see Code 6382, make sure your dealer AHMOTA network is properly set up.

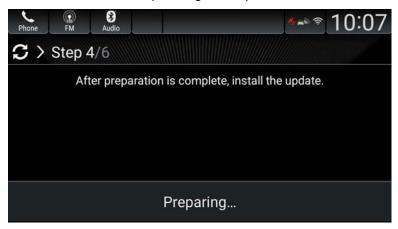
The download will only complete with the ignition turned to ON. If you turn the ignition to OFF before it is complete, or the Wi-Fi connection is lost, the download will resume once you turn the ignition to ON and the Wi-Fi connection is restored within 2 weeks. If it takes longer than 2 weeks, you must start the process again and it will reset to 0% complete.

• If the download completes, go to step 6.

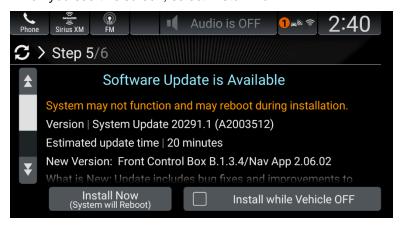
6. When you see this screen, select Install Now.

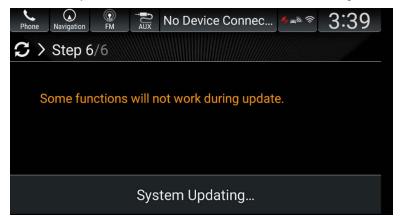
NOTES

- The system will reboot several times during the installation.
- You may see this screen twice if the vehicle has navigation.

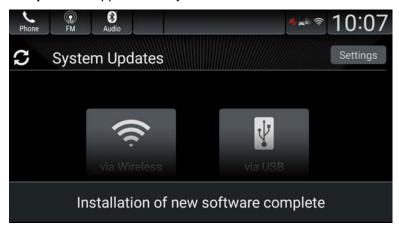
7. Once the installation is complete, you will see this screen. Keep in mind the message **Installation of new software complete** will appear for only **5 seconds**.

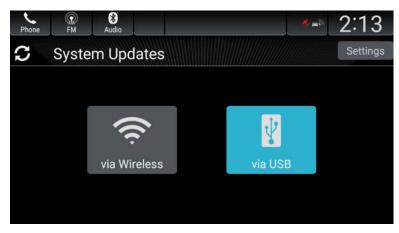
Once the file is on the flash drive, return to the vehicle. From the Home screen, select System Updates, then via USB.

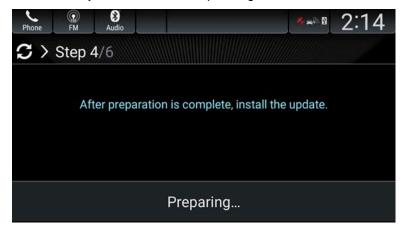
You will then see this screen telling you the system is automatically copying and preparing the update files. Keep in mind this may take some time depending on the file sizes.

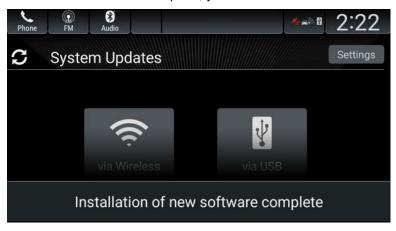
Once the installation is complete, you will see this screen.

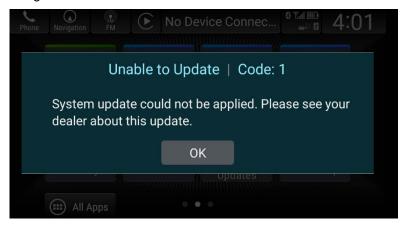
- The Installation of new software complete pop-up will only last 5 seconds.
- If you encounter a message **Unable to Update | Code: 1** after seeing the image above, press OK and cycle the ignition.
