Latest Vehicle Concern Fixes

BECM Setting P3049-A2 for BCCM Overstress	19/20MY I-PACE
<p>Customer Voice:</p> <ul style="list-style-type: none">Unable to charge vehicle- The indicator may flash red or continuously remain in the initializing phase <p>Technical Description:</p> <ul style="list-style-type: none">P3049-A2 is stored in the BECM for Hybrid/EV Battery Charger "A" - High Voltage Supply Circuit.This is caused by a diode failure inside the BCCM and an out sync time delayed with charging verses voltage stability <p>Status:</p> <ul style="list-style-type: none">If you suspect a vehicle with this concern please verify that the charge actuator lock deploys properlyVerify that the BCCM has a part number after J5D5-10C770-AF, if not raise a TA and follow LTS instructions.If no other root cause is found, Software is expected to be released at the end of July

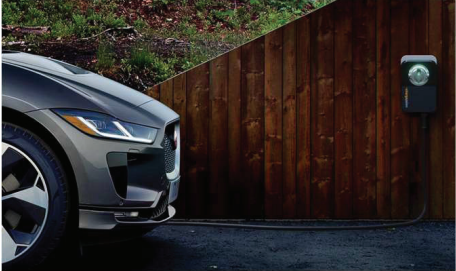
A photograph showing the front left corner of a silver Jaguar I-PACE electric vehicle parked next to a wooden wall. A charging station is mounted on the wall, and a charging cable is plugged into the vehicle's charging port.
