Technical product information

Topic	Mulsanne - No volume
Market area	Bentley: worldwide (2WBE),Hongkong-Macau (5HK)
Brand	Bentley
Transaction No.	2043897/2
Level	EH
Status	Approval
Release date

No volume/sound from the Infotainment system

Software update required to reinstall the functionality of the sound/volume

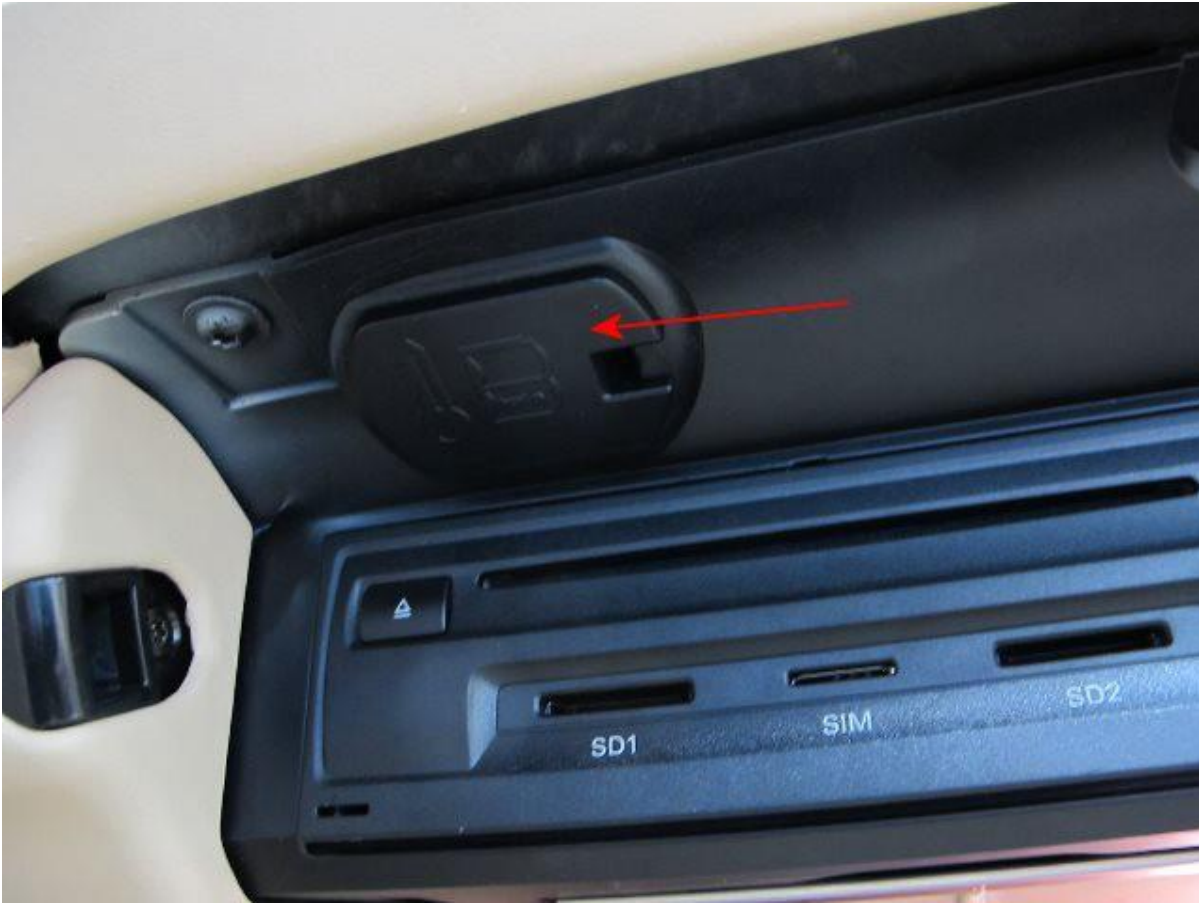
7. Locate the key reader situated within the glove compartment and remove the cover – Figure 3

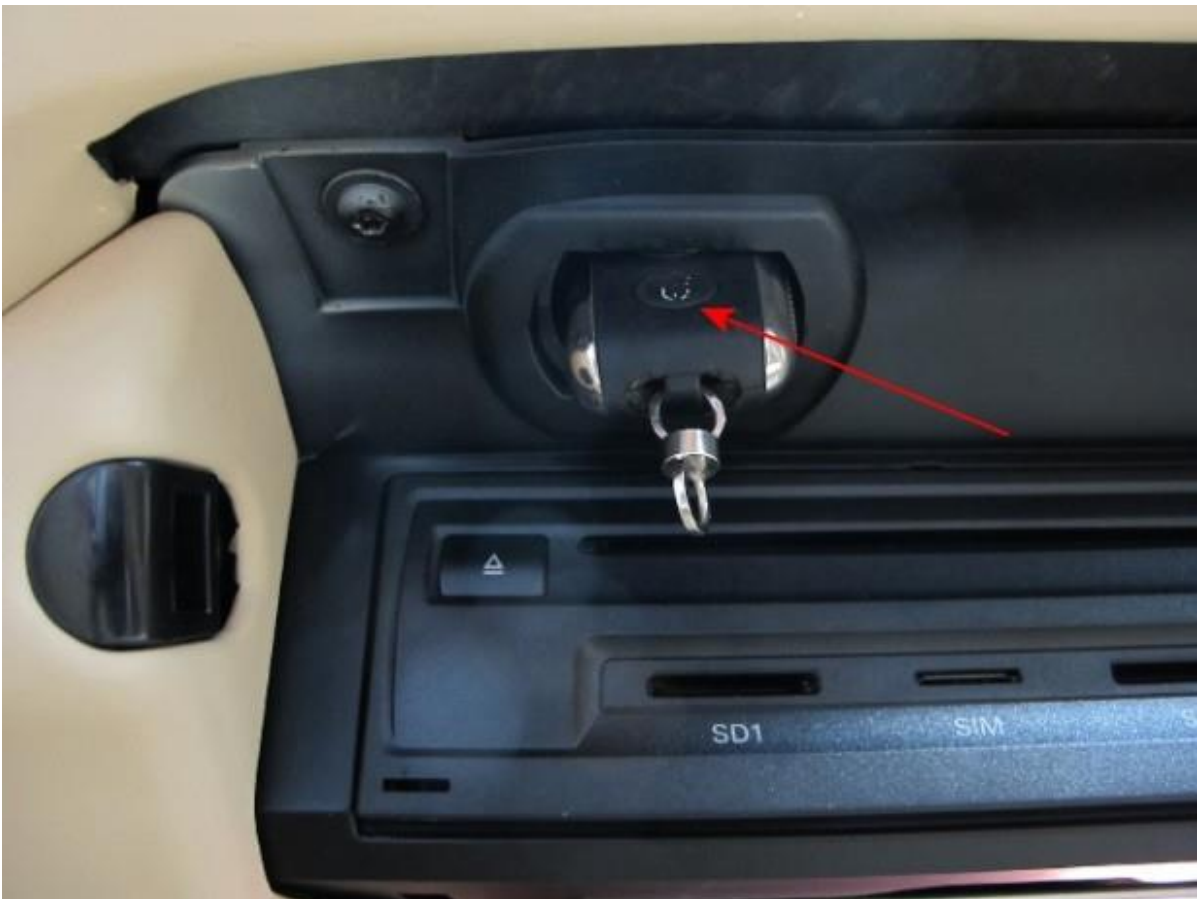
Figure 4

- Insert a single key into the key reader with the blade folded away until it “clicks” into place, make sure the key is securely located within the keyreader (Figure 4)

It is important that any additional keys or key rings are removed from the ignition key, the extra weight of a second key or key ring may cause the key to withdraw from the reader during the software update process.

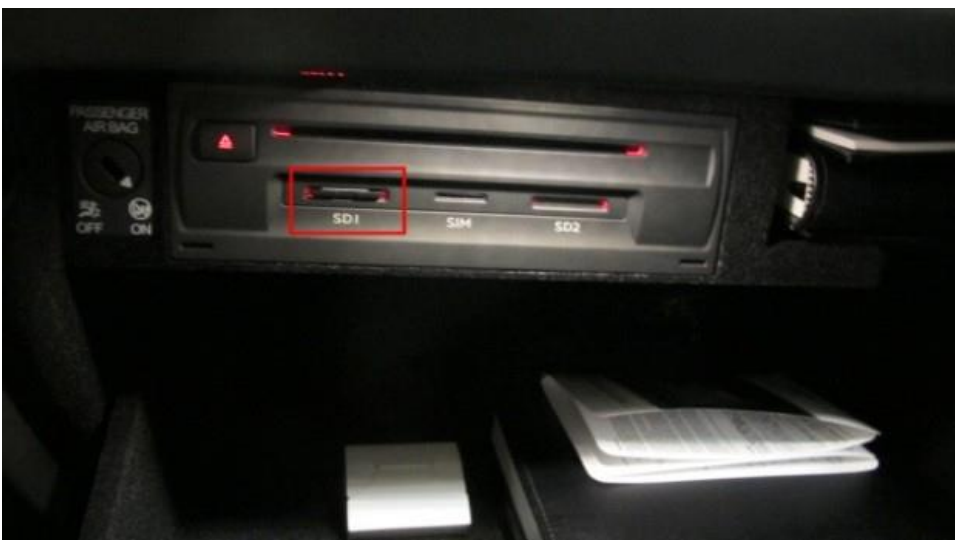
Figure 5

8. Fit the SD card in SD1 slot of the MIB, located in the glove box (Figure 5)

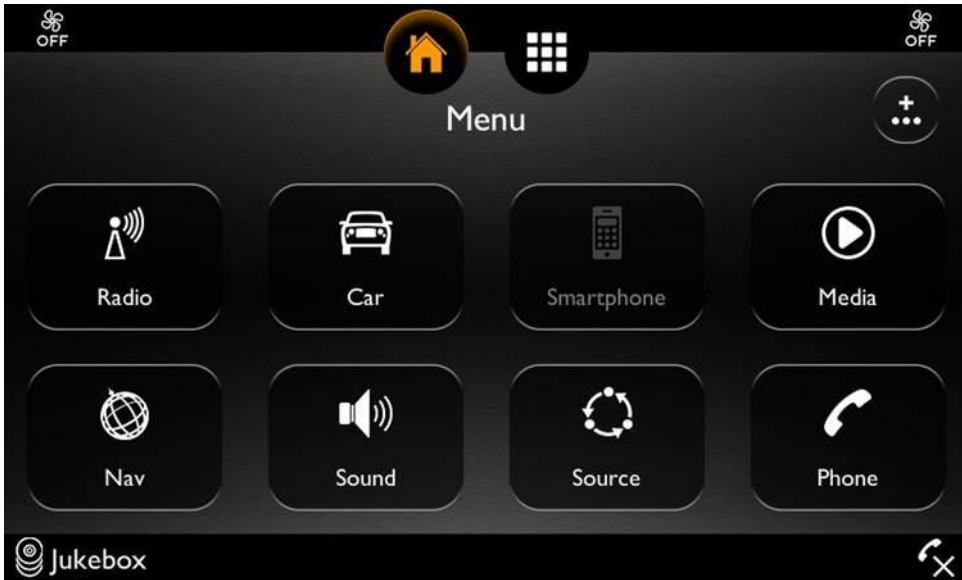
Figure 6

9. Navigate to the main menu screen (Figure 6) by pressing the home button.

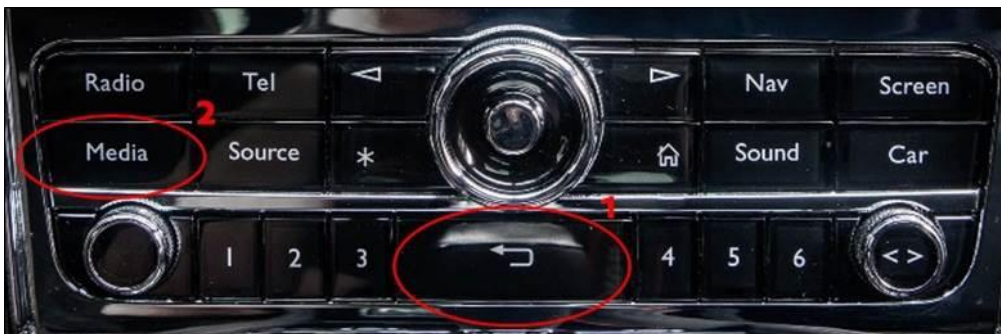
10. Referring to Figure 7 - Press and hold the Return button (1) first and then immediately press and hold the MEDIA button (2) on the infotainment unit - Keep both buttons pressed until the *Developer menu* (SWDL) screen is displayed (Figure 8).

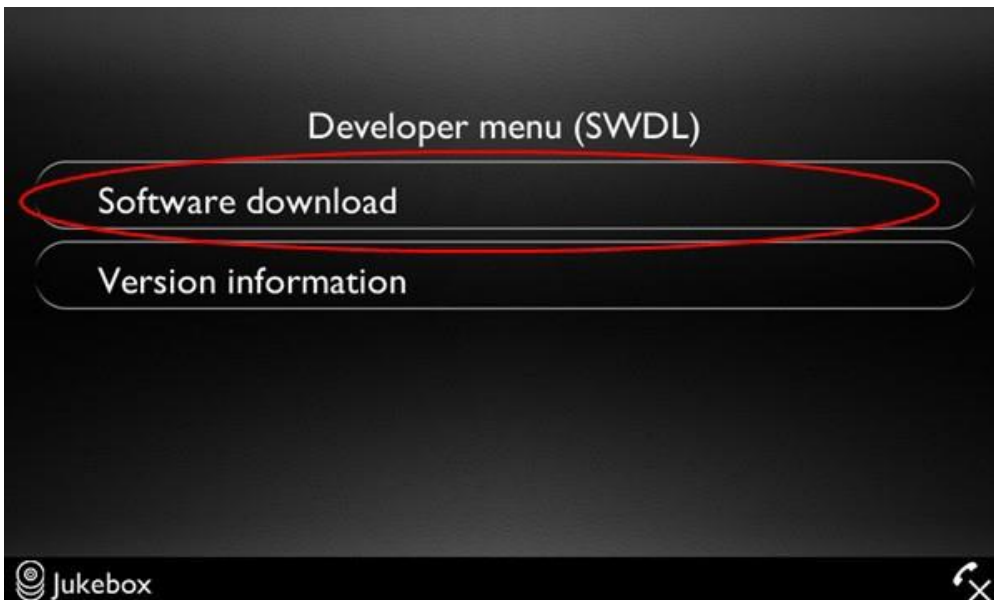
11. Referring to Figure 8 - Select - Software download

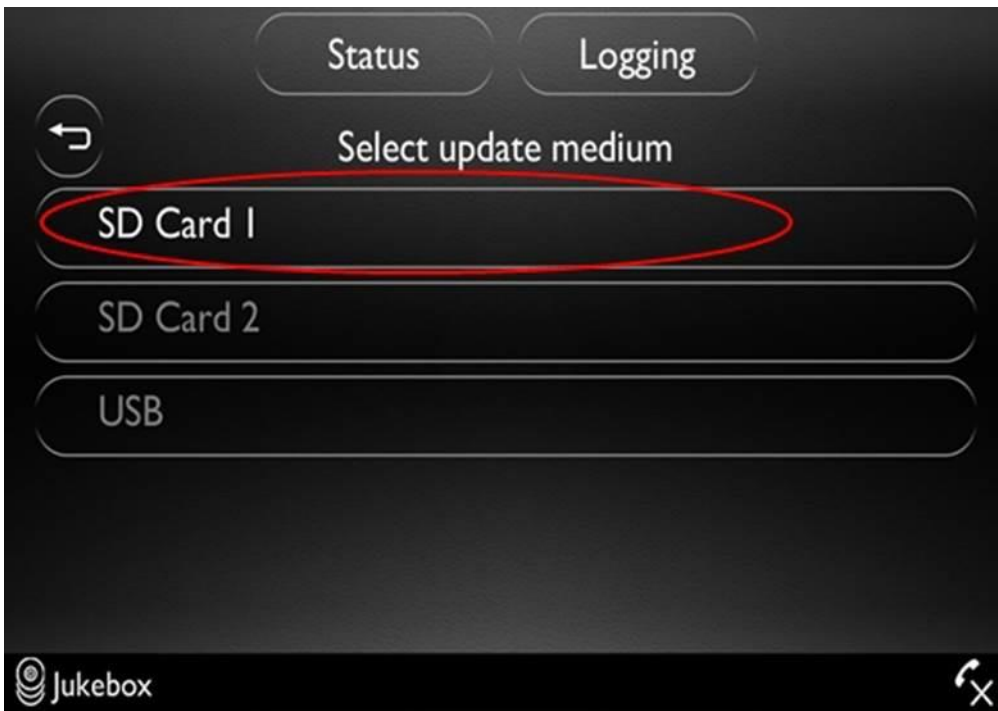
Figure 9

12. Select - SD Card 1 (Figure 9), the next screen will display the reading of the SD card data as shown in Figure 10 (Point A)

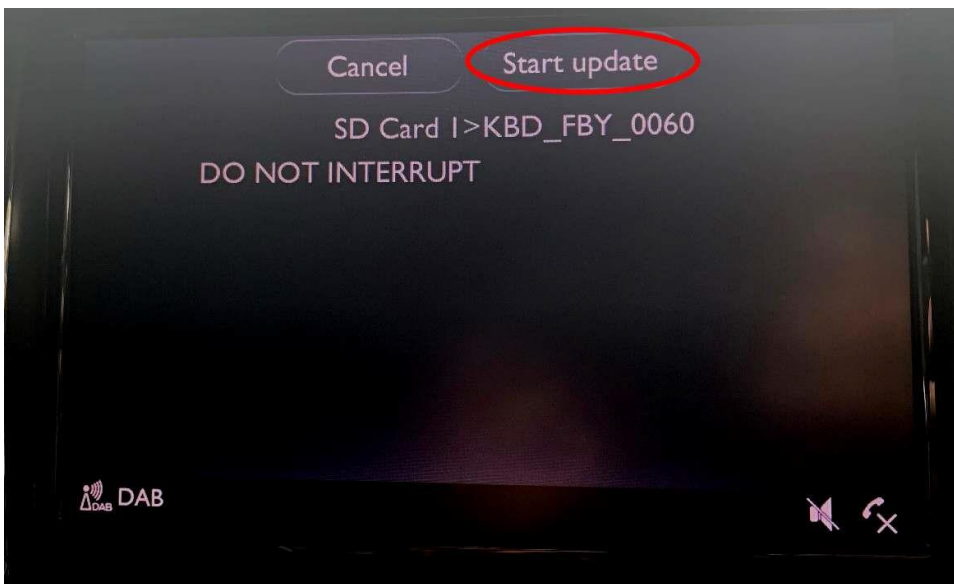
Figure 12

15. Select- Startupdate again on the following screen(Figure 12)
