Subject: GHG17 & GHG21 Detroit™ DD13, DD15, and DD16 ACM Software Reprogramming

Models Affected: GHG17 & GHG21 Detroit™ DD13 471.928, DD15 472.910, and DD16 473.910 vehicles built between January 2018 and July 2020

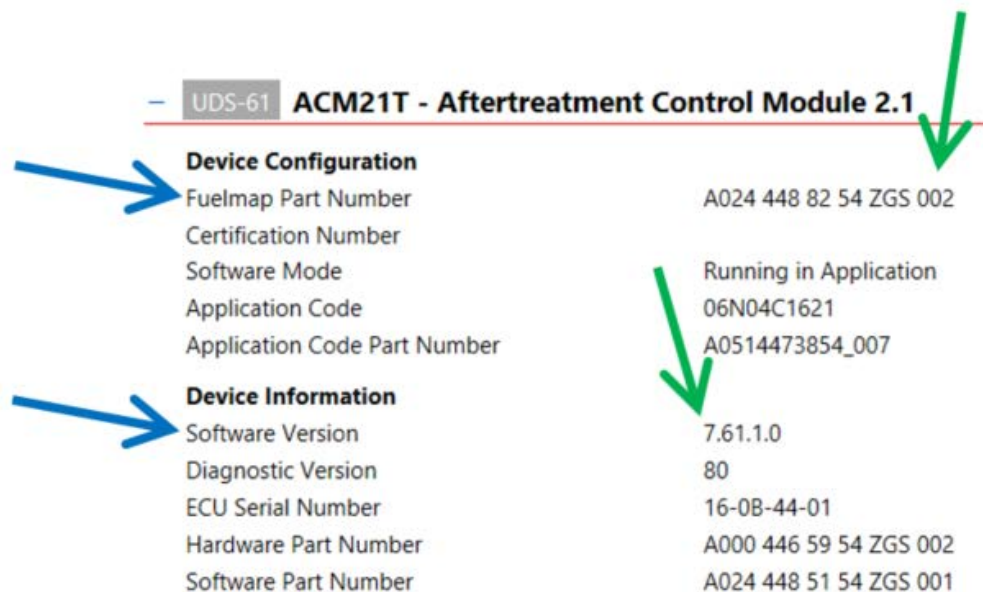
Figure 1 – MINIMUM MCM Software and Fuel Map ZGS levels

5. On the Identification screen, check the current ACM, MCM, CPC, and TCM (if equipped) software and fuel map levels. Listed in the table on page 1, are the **MINIMUM** levels required. See Figure 1 for an example of the Identification screen for the ACM.
 - a) ACM **software 7.61.1.0** and fuel map version **ZGS 002**

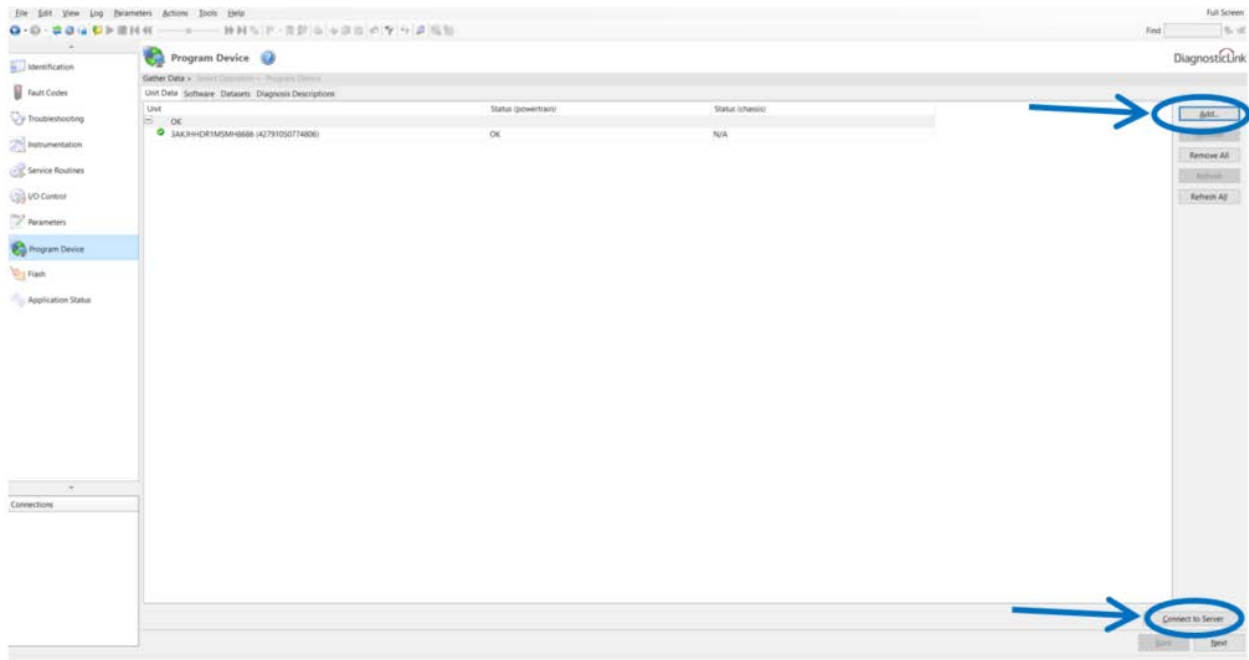
Figure 2 – Adding Engine Serial Number and Connecting To Server

7. Select the “Program Device” option along the left side of the DiagnosticLink® screen.
8. Select the “Add” button in the upper right corner of the DiagnosticLink® screen and enter the engine serial number. Then click the “Connect to Server” button in the bottom right corner of the DiagnosticLink® screen. See Figure 2.
