Entune Audio Head Unit Software Update (Pioneer)

Service Category Audio/Visual/Telematics

Section Navigation/Multi Info Display

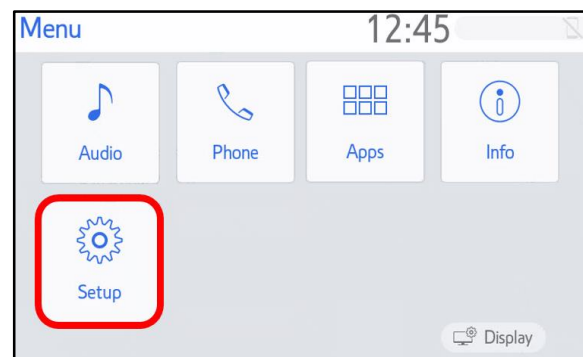
Figure 1.

1. Start the engine.
2. Press the Menu button on the radio faceplate, then select Setup.

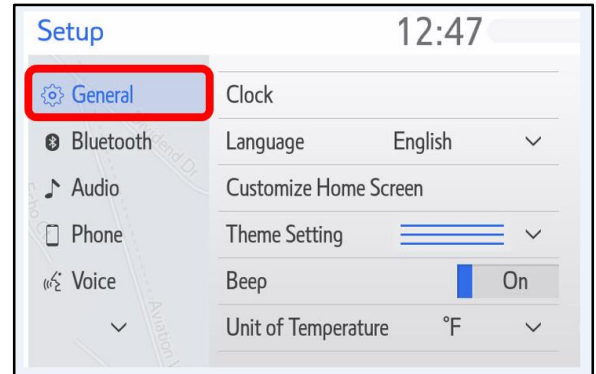
Figure 2.

3. Select General on the Setup screen.

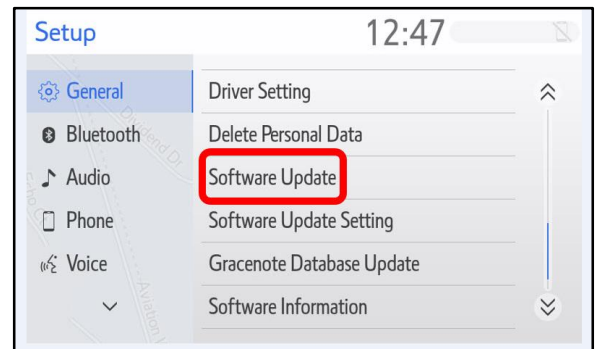
Figure 3.

4. Scroll down and select Software Update.

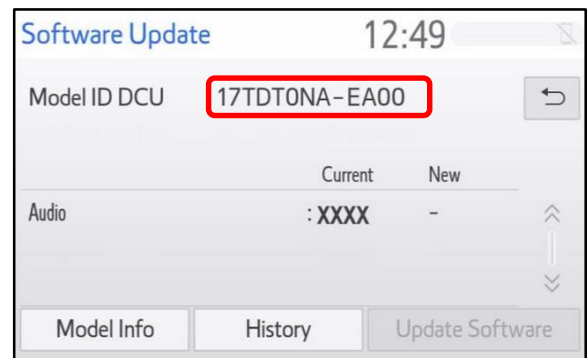
Figure 4.

5. Record the Model ID.
6. Match the Model ID to the software update file, then download the appropriate multimedia software update file from the Software Update Information section.

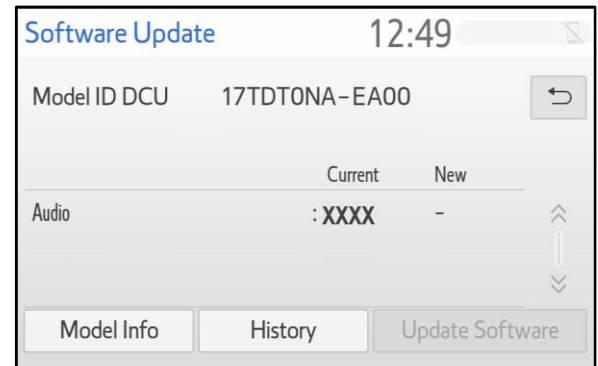
Figure 5.

7. Verify that the software version is the same or earlier than indicated in the Introduction.

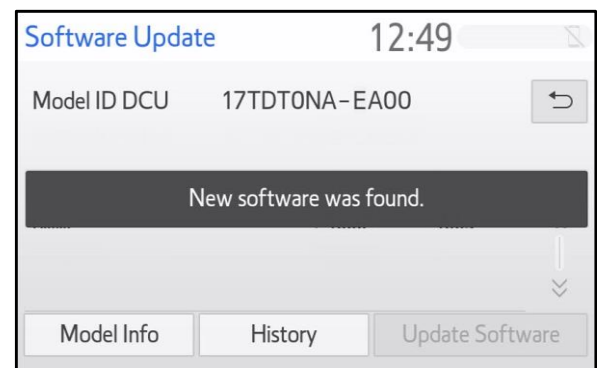
Figure 6.

9. Insert the prepared USB flash drive into the vehicle's USB port.

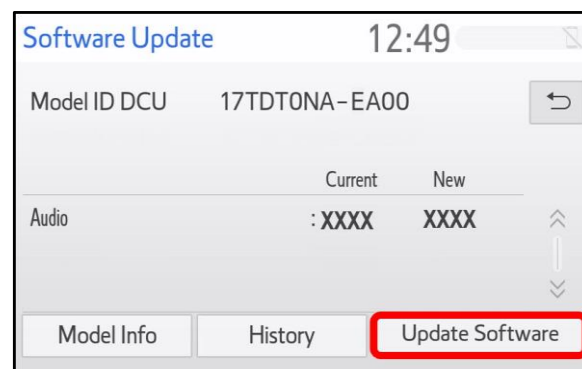
Figure 7.

- Select the Update Software button in the lower right corner.

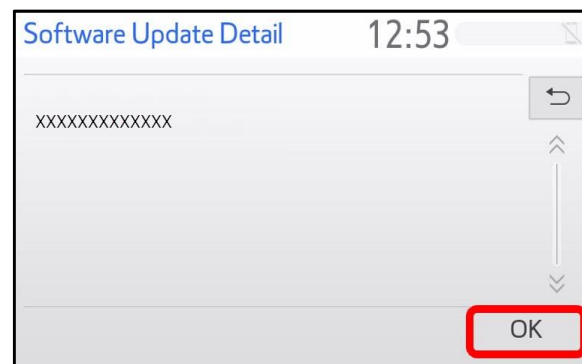
Figure 8.

- Select OK on the Software Update Detail screen.

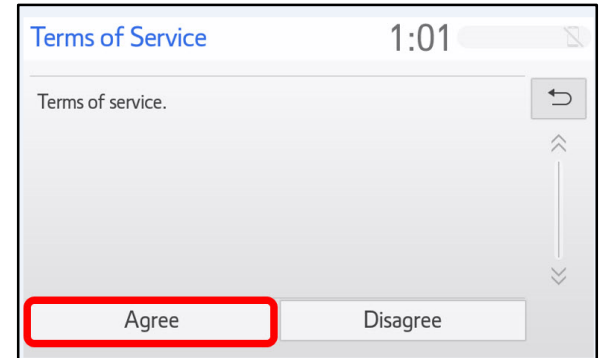
Figure 9.

13. Select Agree on the Terms of Service screen.

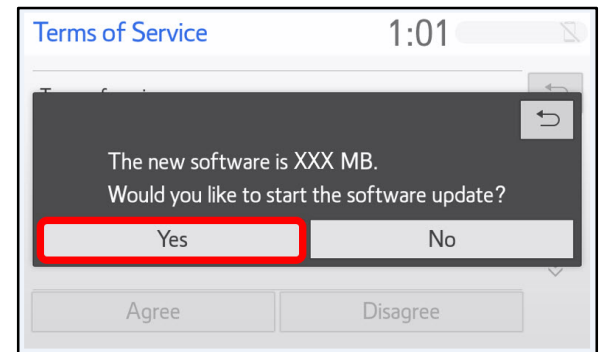
Figure 10.

14. Select Yes on the “Would you like to start the software update?” pop-up.

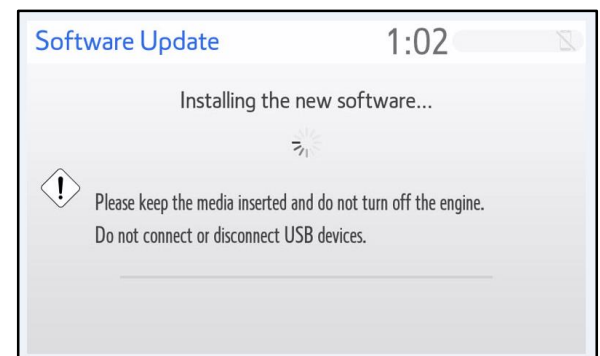
Figure 11.

15. Once the head unit begins installation, the update will take approximately 10 minutes.

- Do NOT turn off the engine or ACC before the software is ready for updating.
- Do NOT remove the USB flash drive until instructed in step 18.

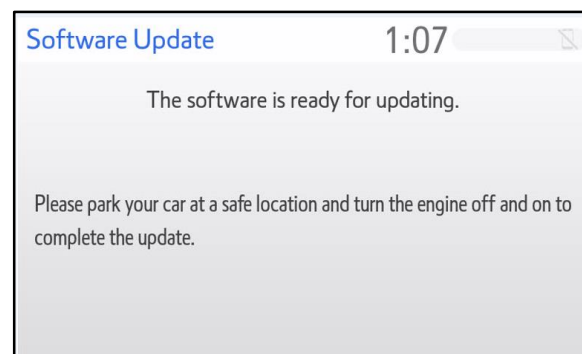
Figure 12.

16. When the “The software is ready for updating.” screen appears, turn OFF the vehicle.

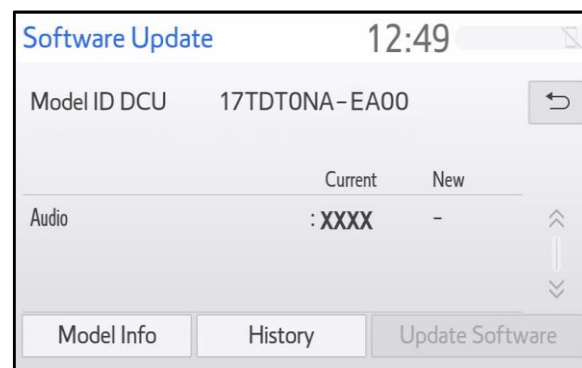
Figure 13.

19. Perform steps 1 – 4 to verify the software version matches the current software version information table below.
