# AfterSales TSO – Circular Letter

## MAS002199/A

## New ETM Software Volta 6 – Troubleshooting guides

**MODELS: Levante, Quattroporte and Ghibli Model Years 17, 18, 19 and 20**

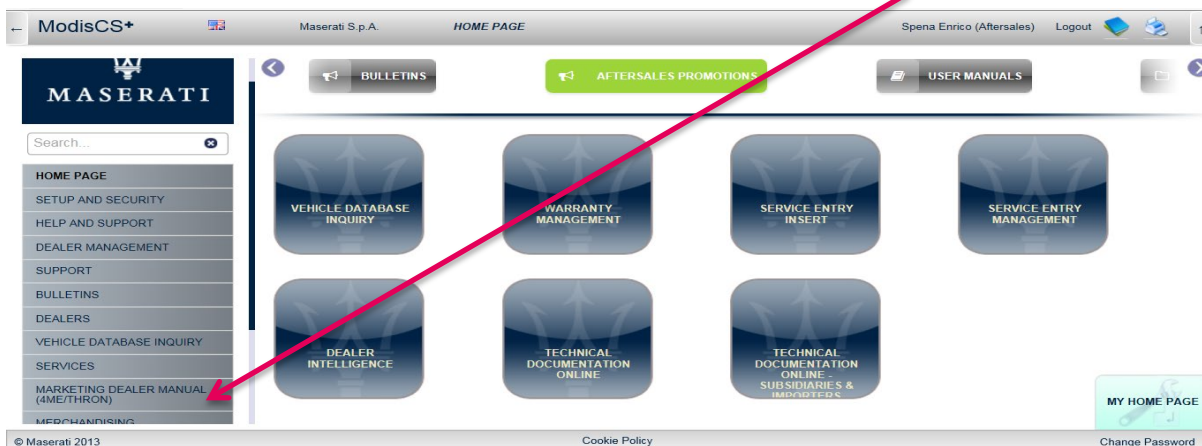
**A.1.** In ModisCS+ Select MARKETING DEALER MANUAL (4ME/THRON).

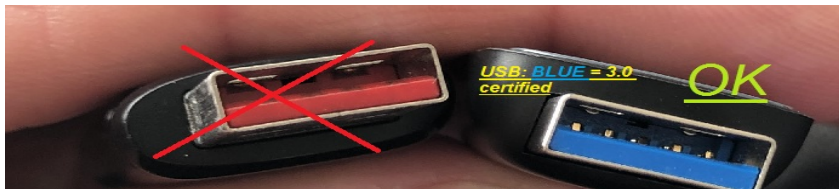
- A.6.** 1. Use only a 8GB or larger Sandisk, Verbatim, Kingston or Transcend “3.0 Certified” (Blue contact plate) USB PEN Drive with the NTFS format.

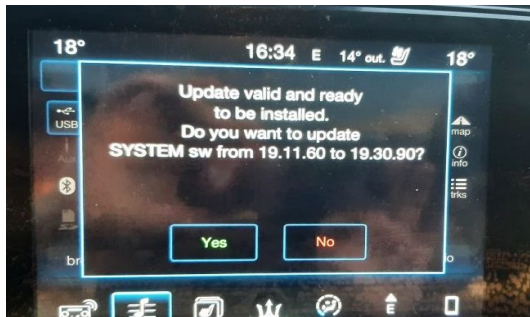
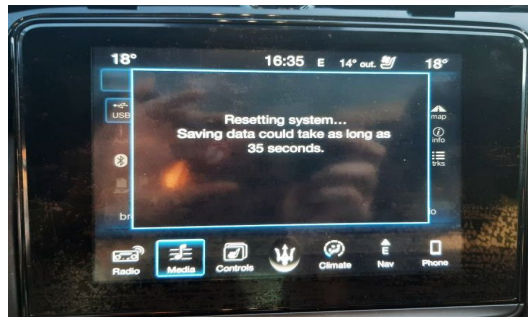
- B.1.** BRIDGE software installation (ETM update). Follow the table in this bulletin (MY 17 Sedans) for the vehicles requiring this s/w..
- B.2.** Download the software from the MARKETING DEALER MANUAL (4ME-THRON) (Follow Section A)
- B.3.** Extract all the files in an empty USB stick with the following specifications (as per Bulletin MAS001272):
- USB 3.0
  - At least 8GB or higher
- B.4.** Insert the USB stick in the USB port inside the vehicle.
- B.5.** Follow the on screen prompts.
- Please keep the vehicle in Key ON state (with a battery charger connected to the vehicle) and leave the USB stick inserted for the entire duration of the update.
  - Removal of the USB stick during the update will result in a non-functional head unit.
  - The time may depend on the market, the s/w version and the speed of the USB memory stick. The installation could take up to 1 hour.

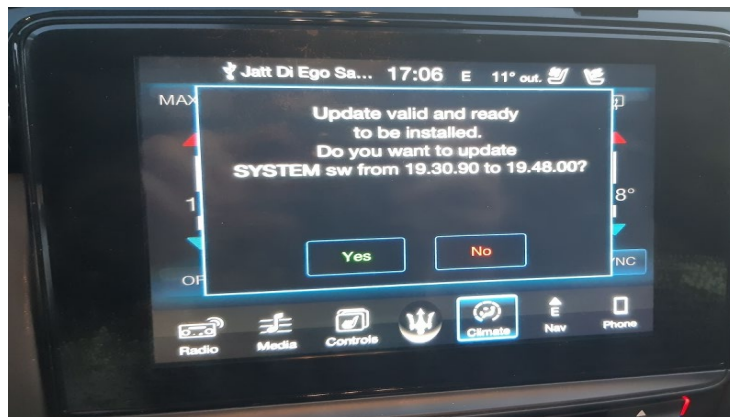
- C.1.** Download the software from the MARKETING DEALER MANUAL (4ME-THRON)  
(follow Section A)
- C.2.** Extract all the files in an empty USB stick with the following specifications:  
USB 3.0;  
At least 8GB or higher.
- C.3.** Insert the USB stick in the USB port inside the vehicle.
- C.4.** Follow the on screen prompts.
- Please keep the vehicle in Key ON state (with a battery charger connected to the vehicle) and leave the USB stick inserted for the entire duration of the update.
  - Removal of the USB stick during update will result in a non-functional head unit.
  - The time may depend on the market s/w version and the speed of the USB memory stick. The installation could take up to 1 hour.
