# MIL ON With DTC P0300 and/or Cold Start Misfire

YEAR(S)	MODEL(S)	ADDITIONAL INFORMATION
2017 - 2020	86

## MIL ON With DTC P0300 and/or Cold Start Misfire

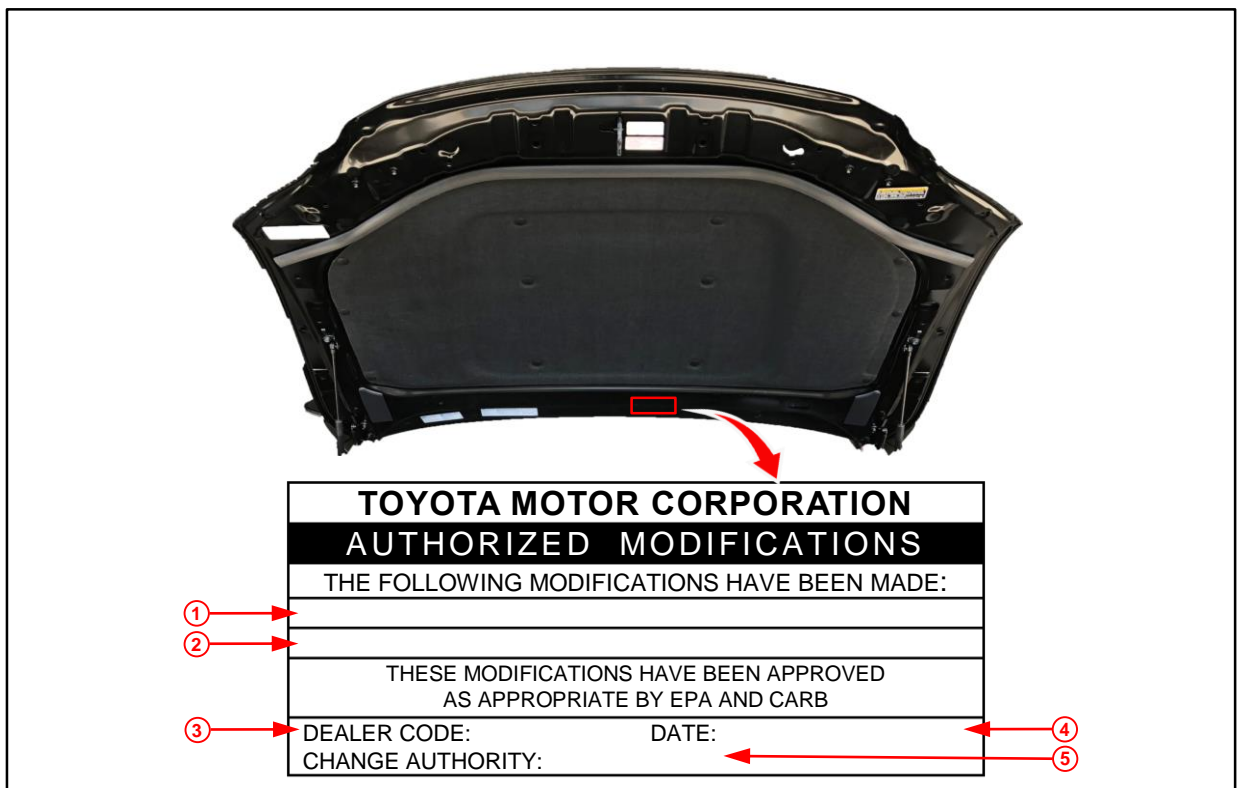
Figure 1. Location of Authorized Modifications Label on 2017 – 2020 86

<b>1</b>	Replacement ECM (PCM) Part Number (e.g., 22765AK041)
<b>2</b>	New Calibration ID (e.g., ZA1JK01D)
<b>3</b>	Dealer Code

<b>4</b>	Date Completed
<b>5</b>	This SB Number

4. Prepare and install the Authorized Modifications Label.
  - A. Using a permanent marker, enter the following information on the label:
    - Engine ECU part number [*Refer to the **Parts Information** section for the **NEW PART NUMBER***]
    - Calibration ID(s) [*Refer to the **Calibration Information** section for the **NEW CALIBRATION ID***]
    - Dealer Code
    - Repair Date
    - Change Authority [***This bulletin number***]
  - B. Affix the Authorized Modifications Label to the vehicle at the location shown in Figure 1. The Authorized Modifications Label is available through the MDC, P/N 00451-00001-LBL.
5. If possible, test-drive the vehicle from cold start at 50°F (10°C) to confirm the condition is no longer present.
