# Service Action

## Code: 90o8

Subject	MyAudi Software Update – USA ONLY																													
Release Date	August 20, 2020																													
Affected Vehicles

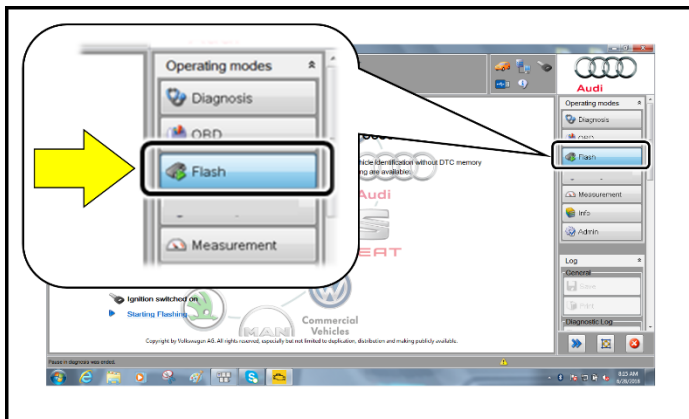
- Select “Yes” when prompted, “Do you really want to save?”
- Return to the home screen of the scan tool.
