WJ76 - Performing PCM Software Update (Workshop Campaign)

Model Line: Panamera (971)

Subject: Porsche Communication Management (PCM) 4.1

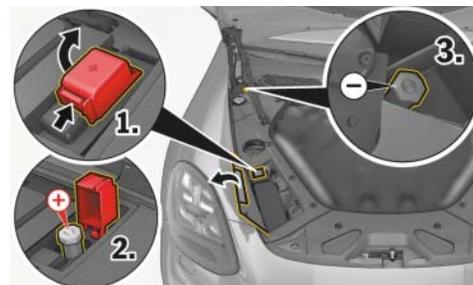
Jump-start terminals

Work Procedure: 1 Connect a battery charger with a current rating of **at least 90 A**, e.g. **Battery charger 90A** to the jump-start terminals in the engine compartment and switch it on ⇒ *Jump-start terminals*.

- Increased current draw during diagnosis or control unit programming can cause a drop in voltage, which can result in one or more fault entries and the abnormal termination of the programming process.
- ⇒ Before commencing work, connect a suitable battery charger with a charging current of at least 90 A to the jump-start terminals in the engine compartment.

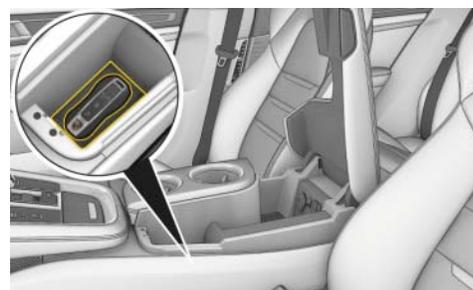
Driver's key in storage compartment

- 2 Place the driver's key with the back facing down into the front left storage compartment in the center console ⇒ *Driver's key in storage compartment*. This will guarantee an uninterrupted radio link between the vehicle and the driver's key.
- 3 Switch on the ignition.

- If the driver's key is not recognized in the vehicle, programming cannot be started or will be interrupted.
- ⇒ Place the driver's key with the back facing down into the front left storage compartment in the center console to guarantee a continuous radio link between the vehicle and the driver's key.

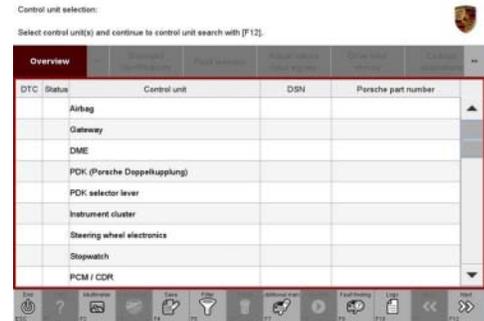
Control unit selection

- 1.1 In the control unit selection screen ('Overview' menu), press •F7" to call up the 'Additional menu' (⇒ *Control unit selection*).
- 1.2 Select the function "Read all fault memories and erase if required" and press •F12" ("Next") to confirm your selection ⇒ *Erasing fault memories*.

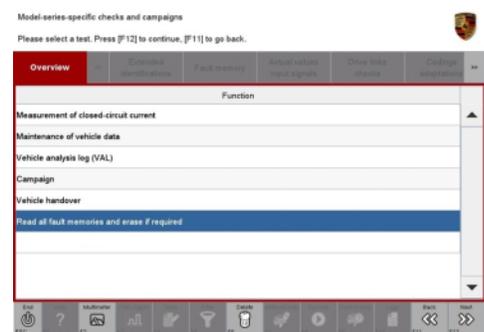
Erasing fault memories

- 1.4 Press •F8" to delete fault memory entries.
- 1.5 Press •F12" ("Yes") in response to the question as to whether you really want to delete all fault memory entries.

The faults stored in the fault memories of the various control units are deleted.
