WLG6 - Re-Programming High-Voltage Charger (OBC) Control Unit (Workshop Campaign)

Model Year: 2020

Model Line: Taycan (Y1A)

Subject: Control unit for high-voltage charger (OBC)

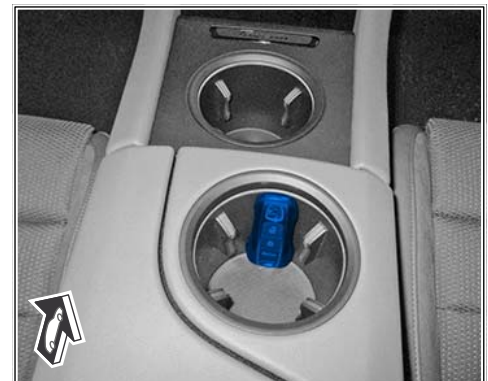
Emergency start tray

2 Position the **driver's key** with the back facing forward upright between the holding struts in the rear cupholder (**emergency start tray**) to guarantee a permanent radio link between the vehicle and remote control ⇒ *Emergency start tray*.

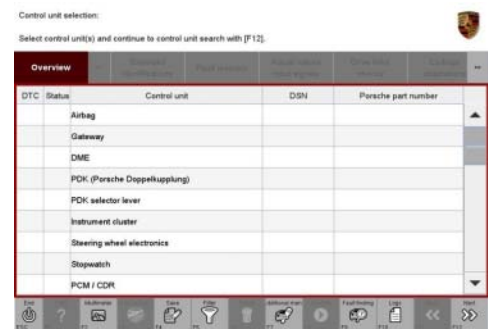
Control unit selection

- 1.1 Select the 'Seat adjustment on front passenger's side' control unit in the control unit selection screen ('Overview' menu) and press •F12" ('Next') to confirm your selection .
- 1.2 Once the seat adjustment on front passenger's side control unit has been found and is displayed in the overview, select the 'Maintenance/ repairs' menu.
- 1.3 Select the 'Standardize seatmotors' function and press •F12" ('Next') to confirm your selection.
- 1.4 Read the instructions and confirm by pressing •F12" ('Next').

- 1.5 Press •F8" to to run the procedure.
- 1.6 Once the seat motors on the passenger's side have been standardized, also teach the driver's side. To do this, select the 'Seat adjustment on front driver's side' control unit in the control unit selection screen ('Overview' menu) and repeat steps 1.2 to 1.6.
