WKH7 - Re-Programming DME Control Unit (Workshop Campaign)

Subject: **DME control unit**

Information: **Updated software is available for the DME control unit.**

Remedial Action: Re-program the DME control unit using the PIWIS Tester with test software version **39.600.020** (or higher) installed.

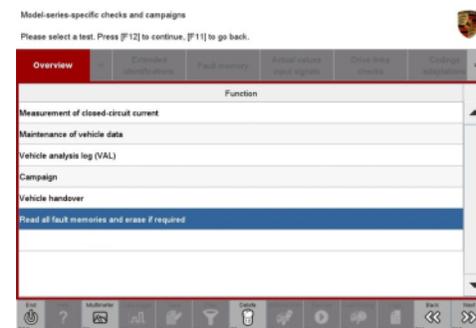
Erasing fault memories

1.4 Press •F8" to delete fault memory entries.

1.5 Press •F12" ('Yes') in response to the question as to whether you really want to delete all fault memory entries.

The faults stored in the fault memories of the various control units are deleted.
