**WLE8 - Re-programming DME control unit (Workshop Campaign)**

**Vehicle Type:** **Panamera Turbo (971)/Panamera Turbo S E-Hybrid (971)**  
**Panamera Turbo Executive (971)/Panamera Turbo S E-Hybrid Executive (971)**  
**Panamera Turbo Sport Turismo (971)/Panamera Turbo S E-Hybrid Sport Turismo (971)**

**Subject:** **DME control unit**

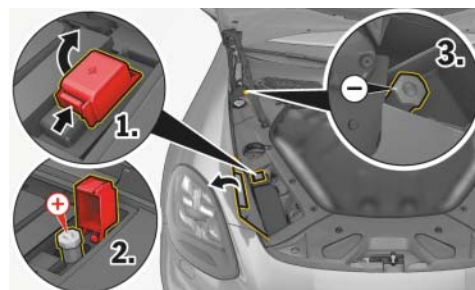
*Jump-start terminals*

Work Procedure: 1 Connect a battery charger with a current rating of at least 90 A, e.g. **Battery charger 90A**, to the jump-start terminals in the engine compartment and switch it on ⇒ *Jump-start terminals*.

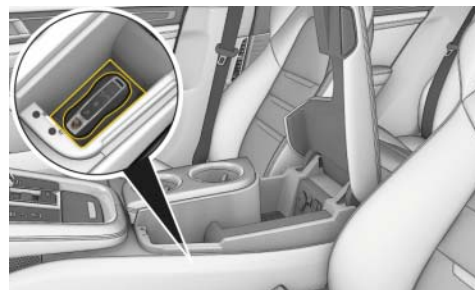
*Driver's key in storage compartment*

2 Place the driver's key with the back facing down in the front left storage compartment in the center console ⇒ *Driver's key in storage compartment*. This will guarantee an uninterrupted radio link between the vehicle and the driver's key.

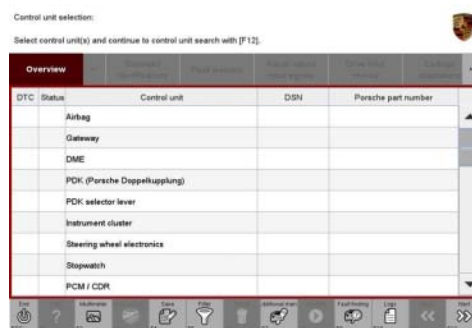
Control unit selection

1.6 Once you have erased the fault memories, select the **'Overview'** menu to return to the control unit selection screen ⇒ *Control unit selection*.

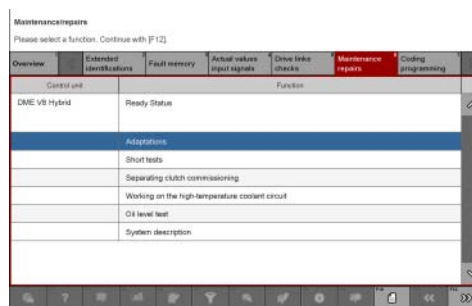
DME control unit adaptations

2.5 Select the **displayed adaptations individually and one after the other** and press •F12" ('Next') to confirm your selection. Then, start the selected adaptation by pressing •F8" ('Start') and follow the instructions on the PIWIS Tester.

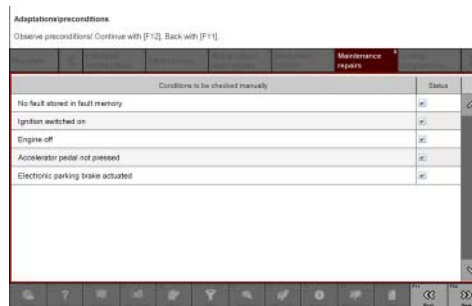
Adaptations: Observe the prerequisites

2.4 Comply with the preconditions displayed on the PIWIS Tester and press •F12" ('Next') to confirm ⇒ *Adaptations: Observe the prerequisites*.
