GROUP ENG	MODEL 2020MY Niro (DE P/HEV)
NUMBER 221	DATE August 2020

**SUBJECT: SERVICE ACTION: ACTIVE AIR FLAP (AAF)
MIL ON JUDGMENT LOGIC IMPROVEMENT (SA429)**

Upgrade Event Name**504. DE PE HEV/PHEV AAF MIL ON DTC JUDGMENT LOGIC IMPROVEMENT (P059F, P05B2)***** NOTICE**

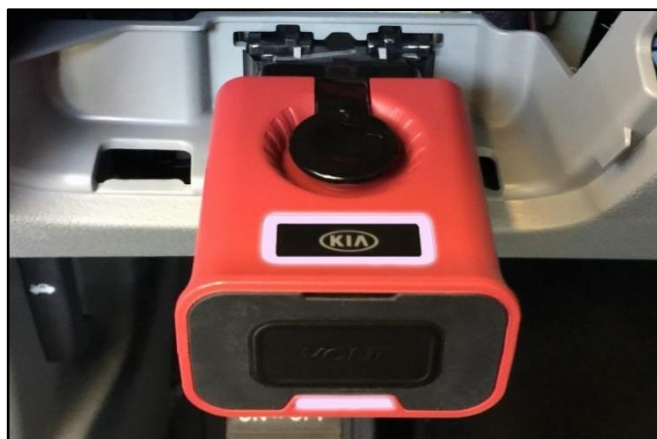
1. Connect the VCI-II to the OBD-II connector, located under the driver's side of the instrument panel.

The ECU upgrade function on KDS operates wirelessly. It is not necessary to perform the upgrade via USB cable.

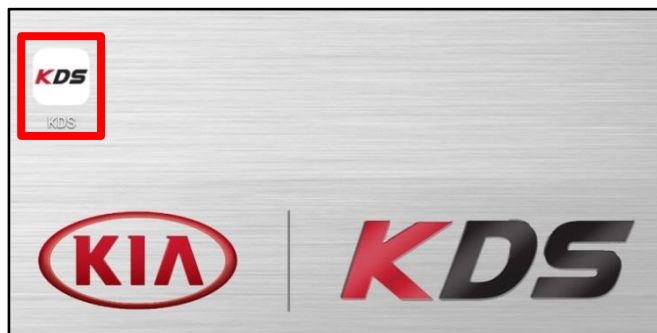
2. With the ignition ON, turn ON the KDS tablet. Select **KDS** from the home screen.

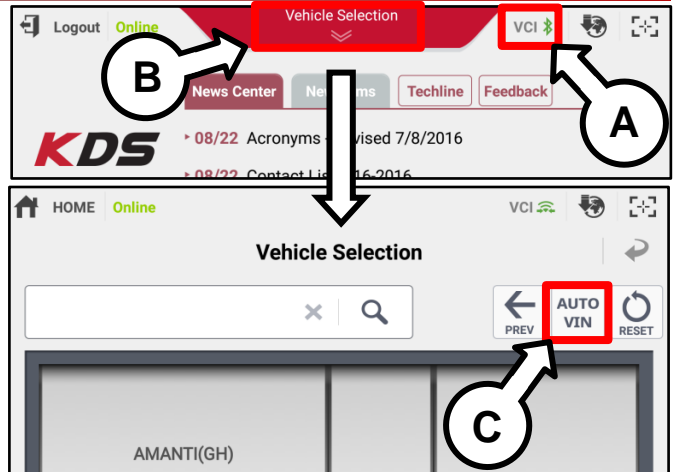
3. Confirm communication with VCI (A) and then configure the vehicle (B) using the **AUTO VIN** (C) feature.

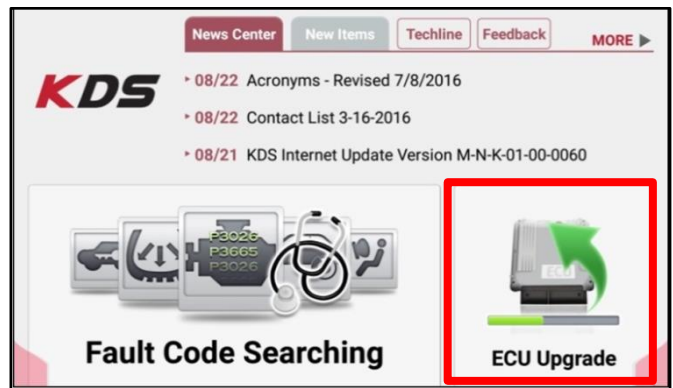
4. Select **ECU Upgrade**.

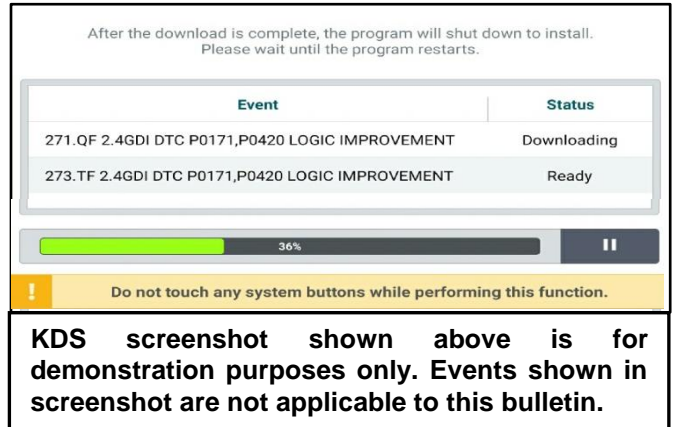
5. The KDS will check the server for recently uploaded Events and then automatically download the **Upgrade Event #504**.

*** NOTICE**
The vehicle must be identified in the Vehicle Selection to download an Event for that vehicle.

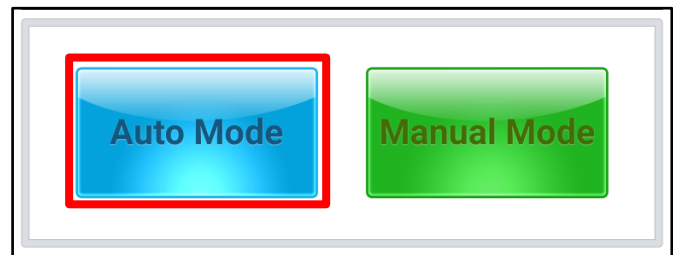
6. Select **Auto Mode**.

CAUTION
Do NOT attempt to perform a Manual Mode upgrade UNLESS Auto Mode fails. Always follow the instructions given on the KDS in either Auto or Manual mode.

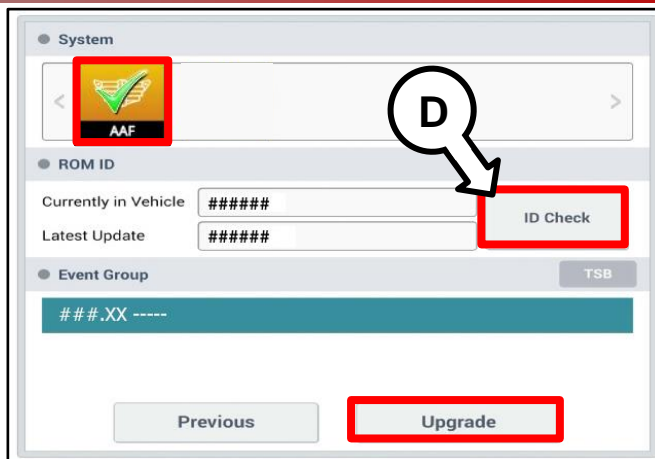
7. Select the **AAF** system under the System selection menu.

Select **ID Check** (D) and confirm that the latest update is available.

Select **Upgrade Event #504** and select the **Upgrade** to continue.

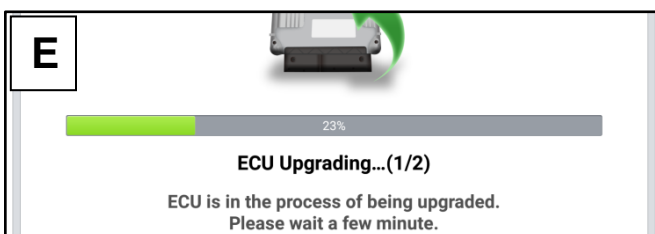
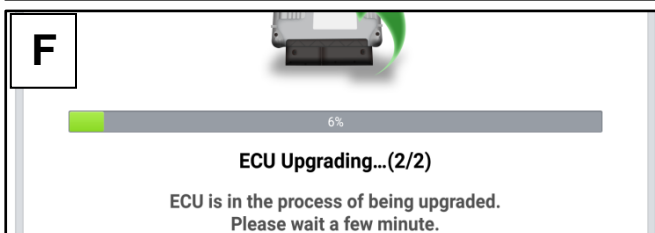
8. The ECU upgrade will begin and the progress of the upgrade will appear on the bar graph. Upgrade part (1/2) (E) will download the upgrade event to the VCI-II. Upgrade part (2/2) (F) will upgrade the ECU.

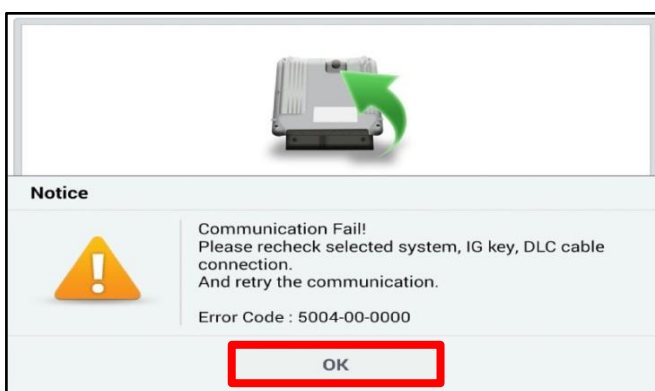
9. If a "Communication Fail" screen appears, verify that the VCI-II and KDS are communicating properly. Touch **OK** and restart the procedure from step 4.

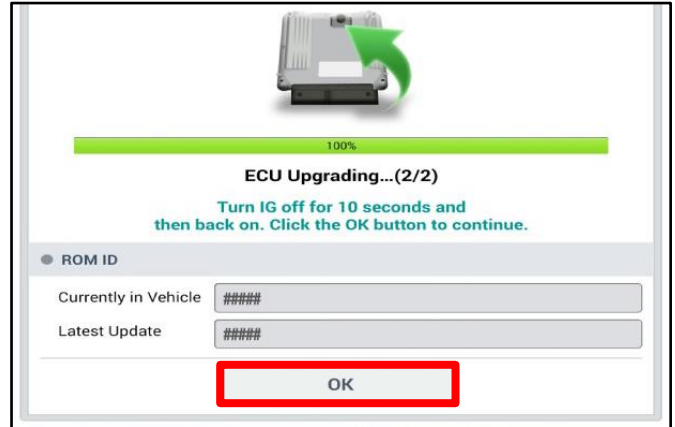
- When instructed on the KDS, turn the ignition **OFF** for ten (10) seconds then back on. Touch **OK** to continue.

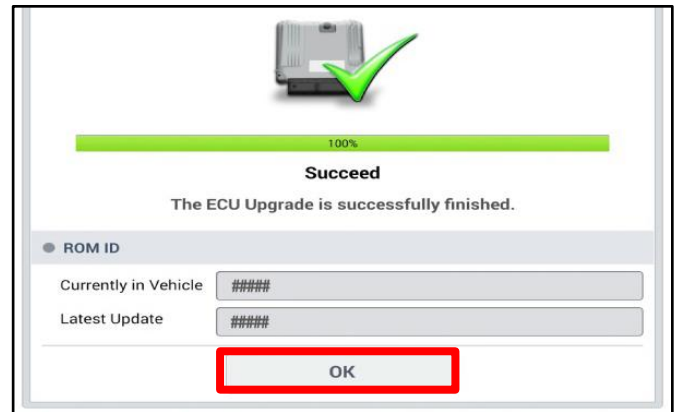
- Once the upgrade is complete, touch **OK** to finalize the procedure.

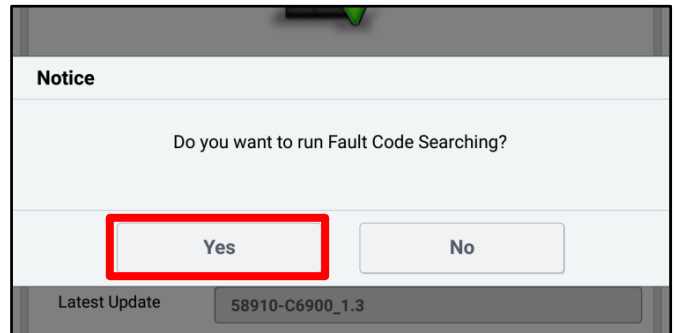
- When prompted, select **YES** to check for Diagnostic Trouble Codes (DTC) and erase any DTCs stored such as EPS, ESC, and TPMS that may have been set during the upgrade.
