<b>HYUNDAI</b> <b>Technical Service Bulletin</b>	GROUP <b>CAMPAIGN</b>	NUMBER <b>20-01-034H</b>
	DATE <b>AUGUST, 2020</b>	MODEL(S) <b>NEXO (FE)</b>
<b>SUBJECT:</b> RADIO PRESET RESETTING HEAD UNIT SOFTWARE UPDATE (SERVICE CAMPAIGN T5I)

**Description:** This bulletin describes the procedure to install an Audio Video Navigation (AVN) software update which corrects a condition in which the radio presets may reset during AVN start up.

**Applicable Vehicles:** Certain 2019 - 2020 MY NEXO (FE)

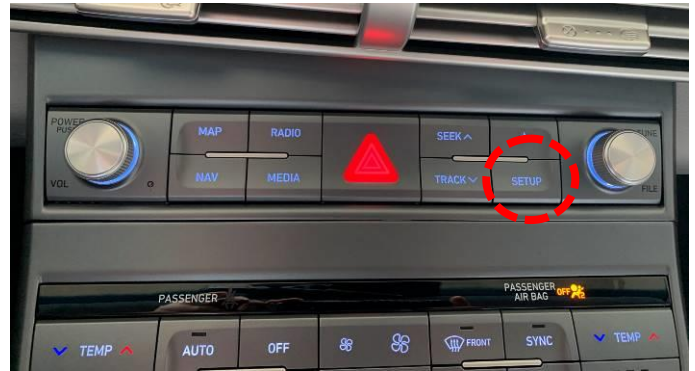
1. Turn the engine ON.
2. Wait until the radio is finished loading.

Press and hold the **SETUP** button.

Follow Steps 2-3 to access the Software Version.

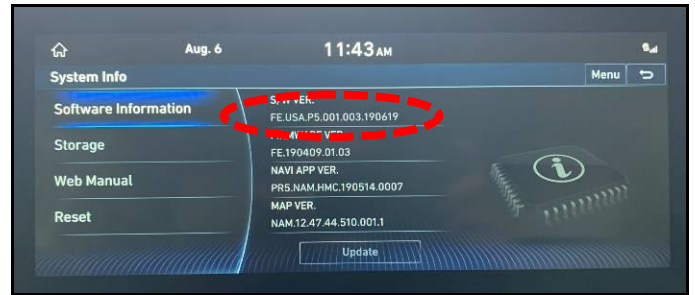
3. Verify that the **S/W Version** listed on the screen matches the older software version.

FE.USA.P5.001.002.190408  
or  
FE.USA.P5.001.003.190619

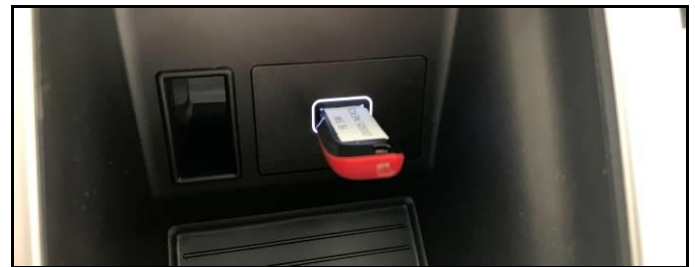
4. Insert the **S/W Update USB** into the USB port.

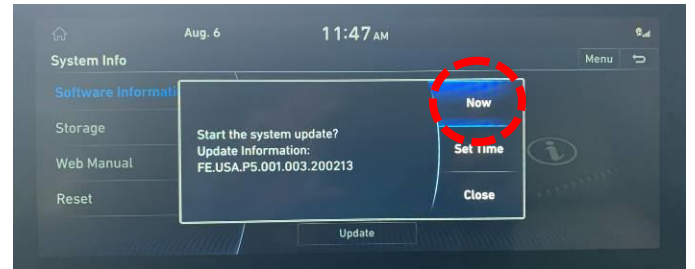
5. The **“Start the system update?”** message will appear.

Select **Now** to update.

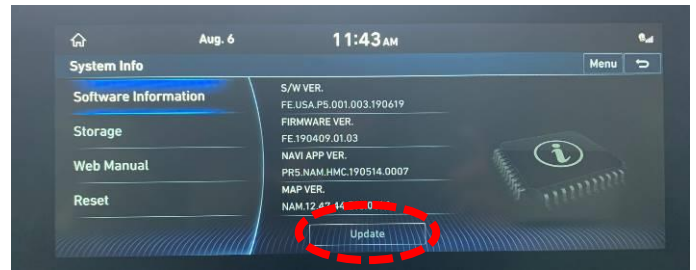
6. Select **Update**.

After selecting **Update**, it may take approximately 1 minute for the update to initiate.

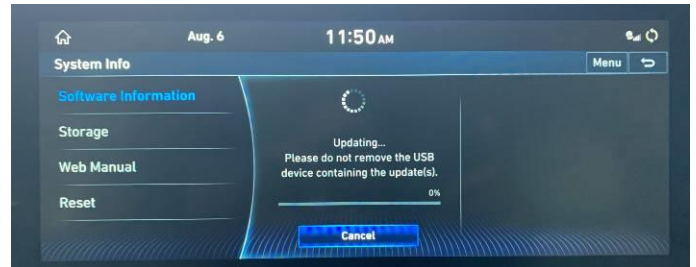
The system update will occur.

The update will take approximately 50 minutes.

Do not press buttons on the center console, remove the USB stick, or turn vehicle **OFF** while the update is running.

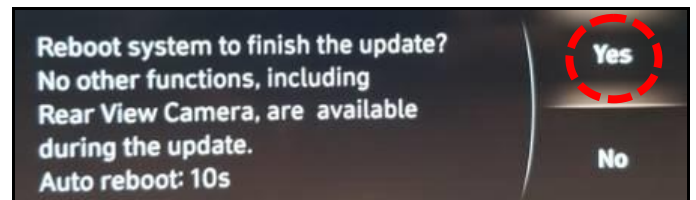
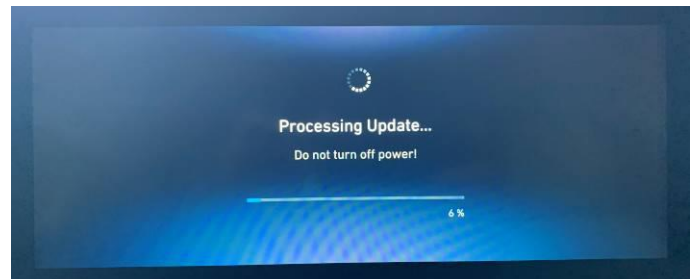
7. During the updating process, the system will auto reboot to finish the update.

Select **Yes** or do nothing and the system will automatically continue the update after 10 seconds.

Update continues after displaying the reboot message as seen on the right.

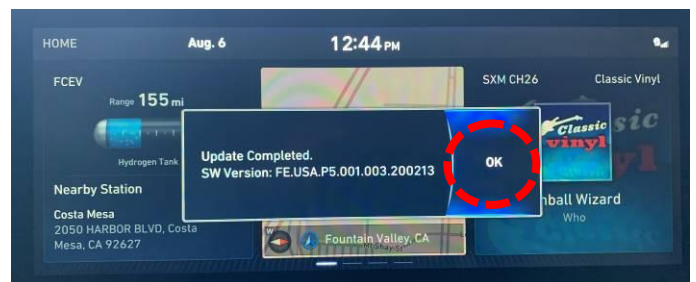
8. An **“Update Completed”** message will appear with the new Software Version number.

Press **OK**.

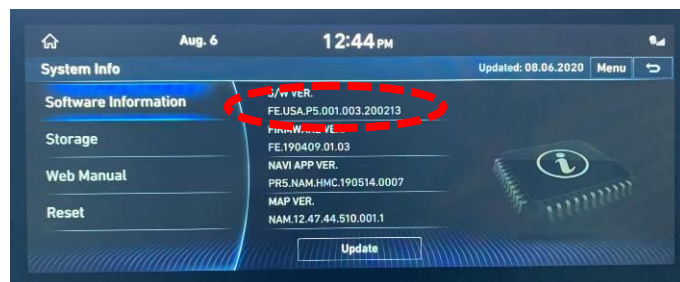
9. Even though the Software Version appeared on the Update Completed message, double check the Software Version number.

The new version should now be:  
FE.USA.P5.001.003.200213
